Fatality during cargo operations on board *Johanna C* Songkhla, Thailand 11 May 2016

SUMMARY

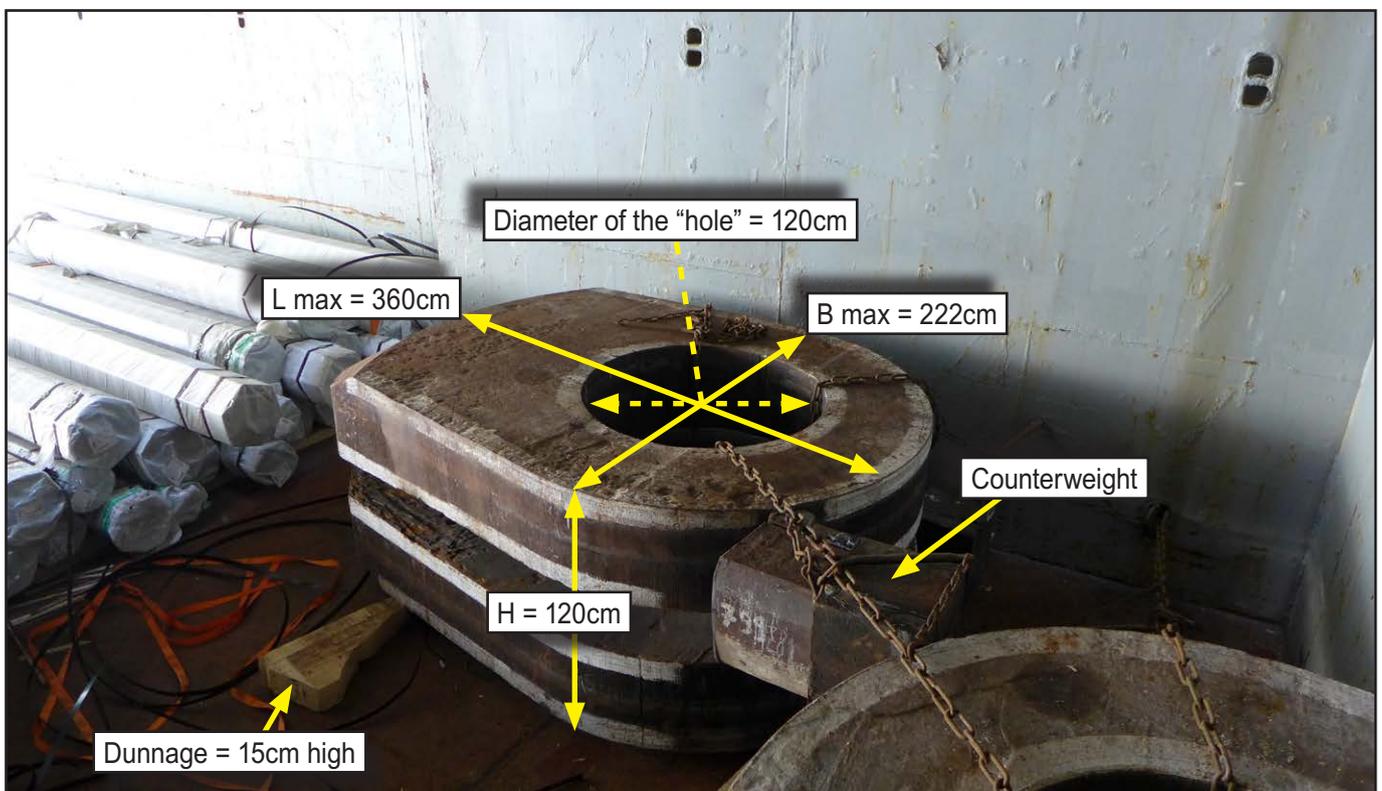
Figure 1: Crankshaft web dimensions

Johanna C arrived in Songkhla, Thailand during the morning of 10 May 2016. Cargo discharge commenced in the afternoon and was completed at 0355¹ the following morning. The vessel's crew and shore stevedores then prepared to shift 400 tonnes of heavy steel crankshaft webs (**Figure 1**) and 506 tonnes of steel pipes from hold No 2 to hold No 1 (**Figure 2**). The cargo transfer was necessary to put the vessel on an even keel draught of 5.5m in readiness for its next port, Xinhui, China.

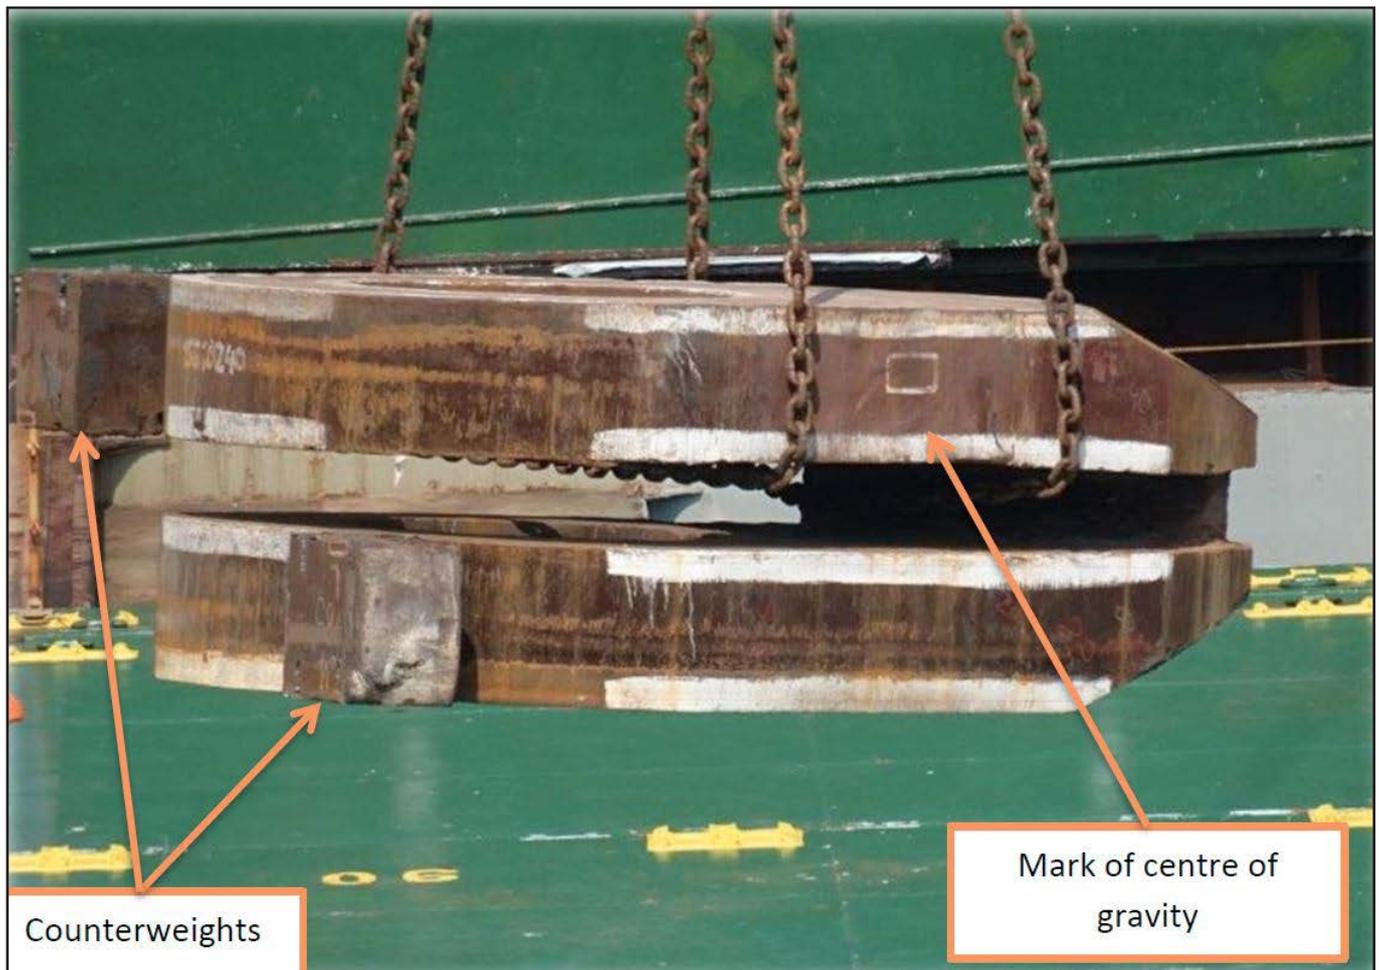
Figure 3: Crankshaft web being discharged (chain slings)

Between 1035 and 1800 on 11 May 2016, stevedores transferred the steel pipes from hold No 2 to hold No 1. As the transfer neared completion, *Johanna C*'s master briefed the vessel's duty crew members on the shifting of the crankshaft webs. The briefing included the method, sequence, safety and roles. The master emphasised the importance of slinging each crankshaft web at equal distances either side of the mark indicating its centre of gravity (**Figure 3**).

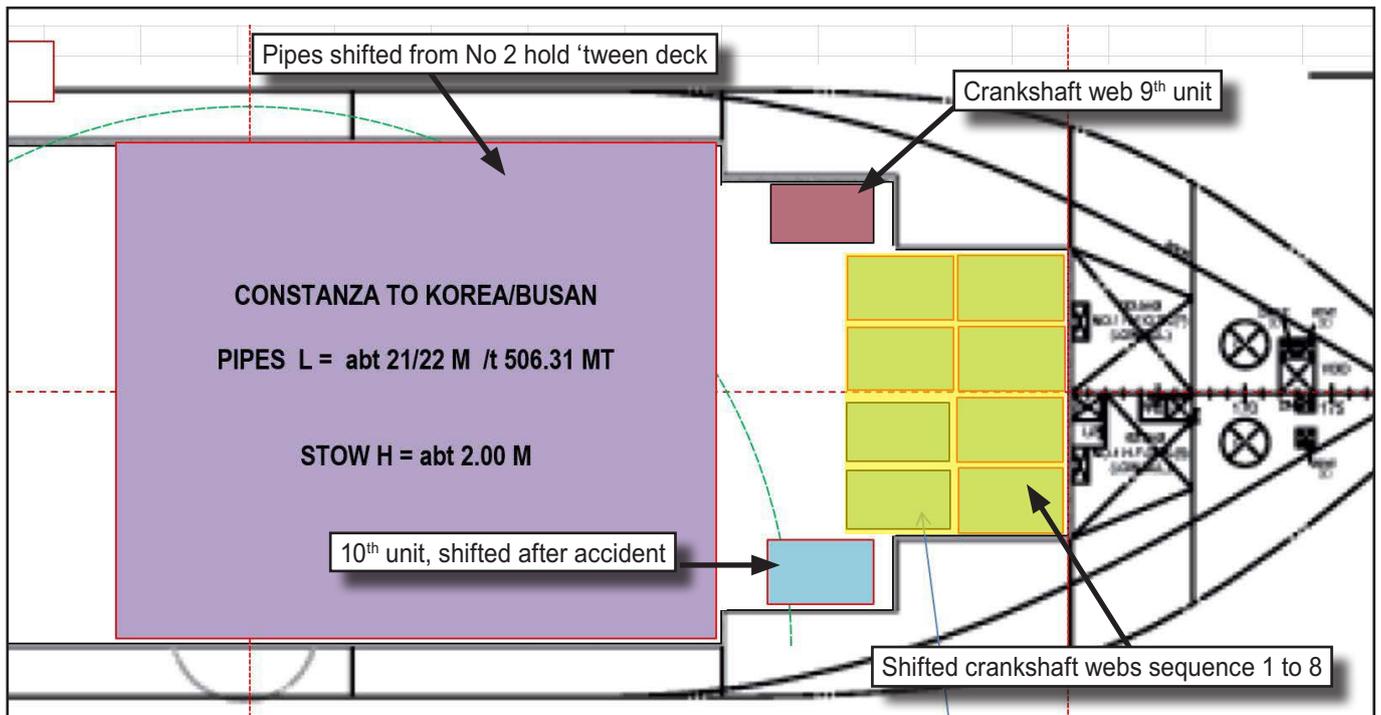
Figure 4: Disposition of cargo in hold 1

Shortly after 2230, the ninth crankshaft web was lowered into hold No 1 but it did not land square to the hold's port side bulkhead as intended (**Figure 4**). The crane driver slackened the slings but the chief officer quickly informed him via hand-held radio that the crankshaft web needed to be repositioned.

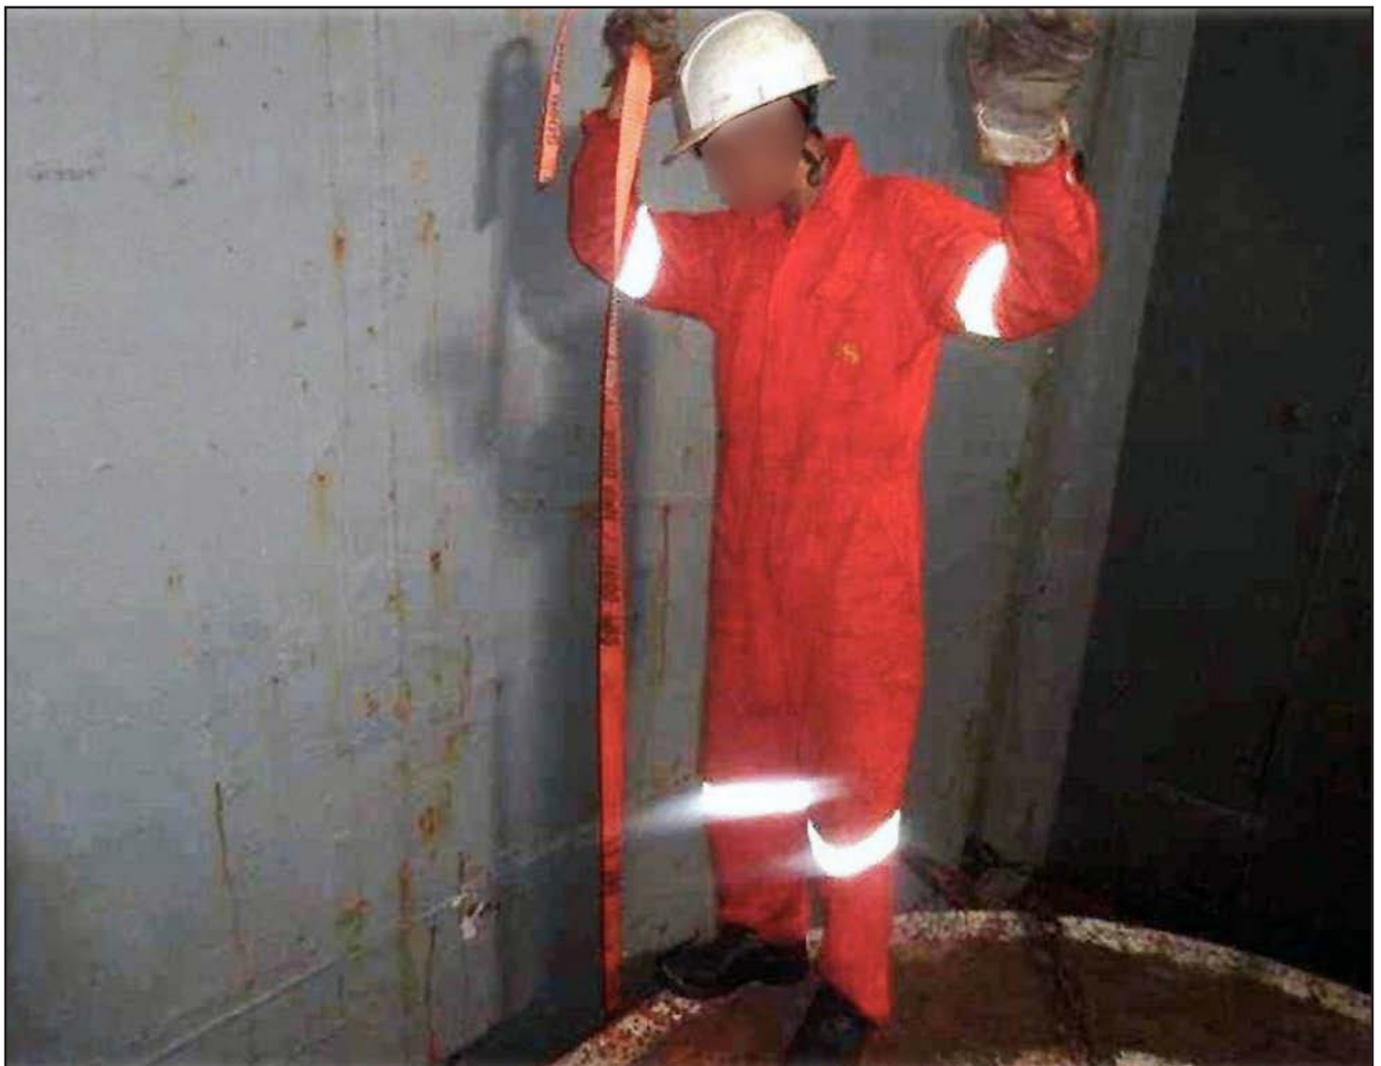
Figure 5: Position of chief officer prior to fall (simulation)

At approximately 2238, the chief officer climbed onto the top of the ninth crankshaft web. He held one of the slackened slings with his right hand (**Figure 5**) and instructed the crane driver by radio and then by hand signals to heave up slowly. Meanwhile, the OS held the slings on the inboard side of the crankshaft web to prevent them from moving out of position.

Standing on top of the crankshaft web, which was 1.35m above the deck and being lifted, was inherently unsafe and unnecessary. The web could either have been re-hoisted and re-landed without any change in work method, or it could have been secured where it landed, albeit slightly askew from its intended position. The chief officer's decision to reposition the web indicates that he wanted to complete the task as planned. However, that he took it upon himself to direct the repositioning from the web top shows that the risks of standing on a load under tension were not recognised. Alternatively, if they had been, they were either ignored or accepted.

- Following its own safety investigation, issued a Fleet Memorandum emphasising the importance of following onboard procedures and safe working practices. Among other things, the areas covered in the memorandum included:
 - Risk assessments
 - Travelling on top of loads
 - Proximity to slings and loads under tension
 - Work for third parties.

- Drafted amendments to the Code of Safe Working Practices for Seafarers, 2015 edition, that include the dangers of standing on top of a load being lifted. The draft amendments will be considered at the Code's next planned review in early 2017.

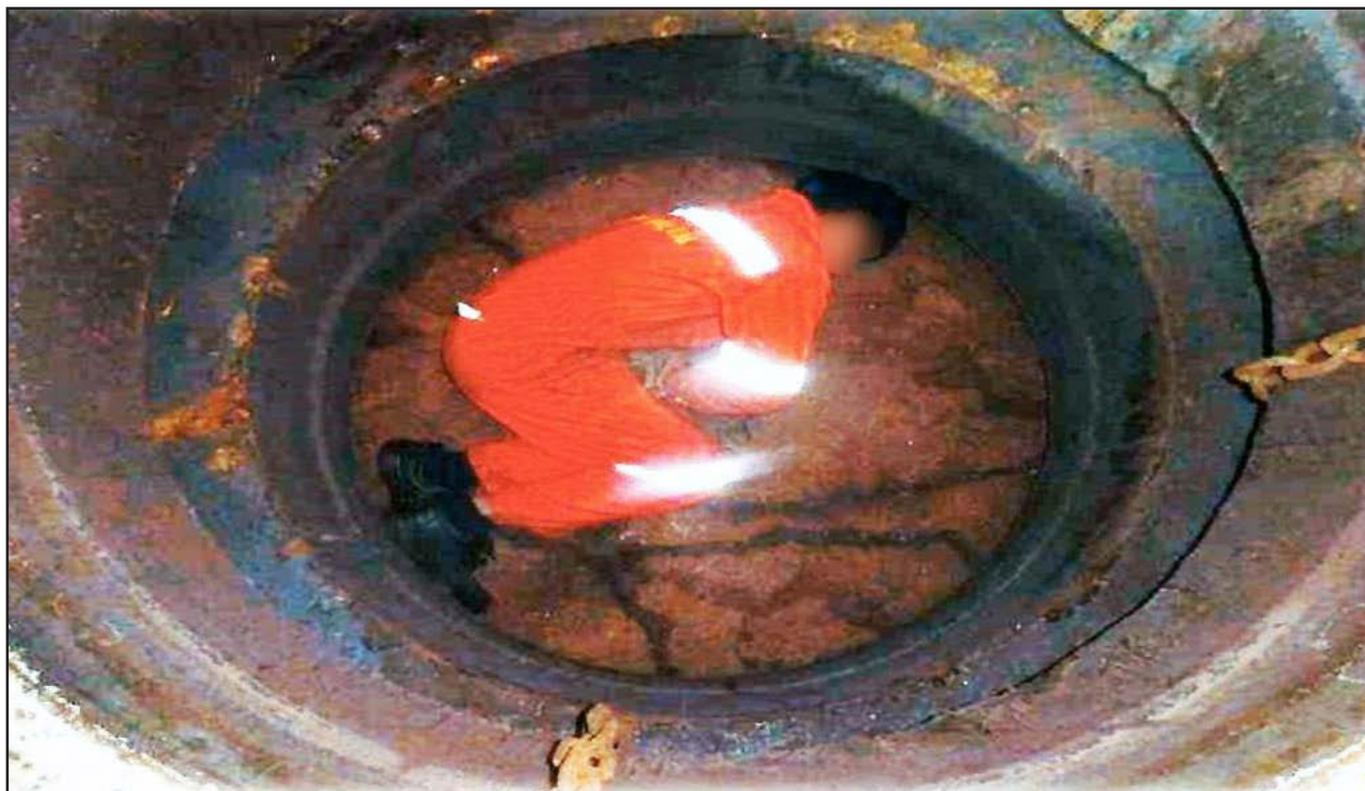
Figure 6: Position of chief officer after fall (simulation)

The engineer immediately alerted the master and crane driver via his hand-held radio. The crane driver slackened the slings and the OS climbed onto the crankshaft web. The chief officer was lying on his left side with his knees bent (**Figure 6**). He was semi-conscious and bleeding around the nostrils. The OS climbed down into the hole in the crankshaft web to attend to him.

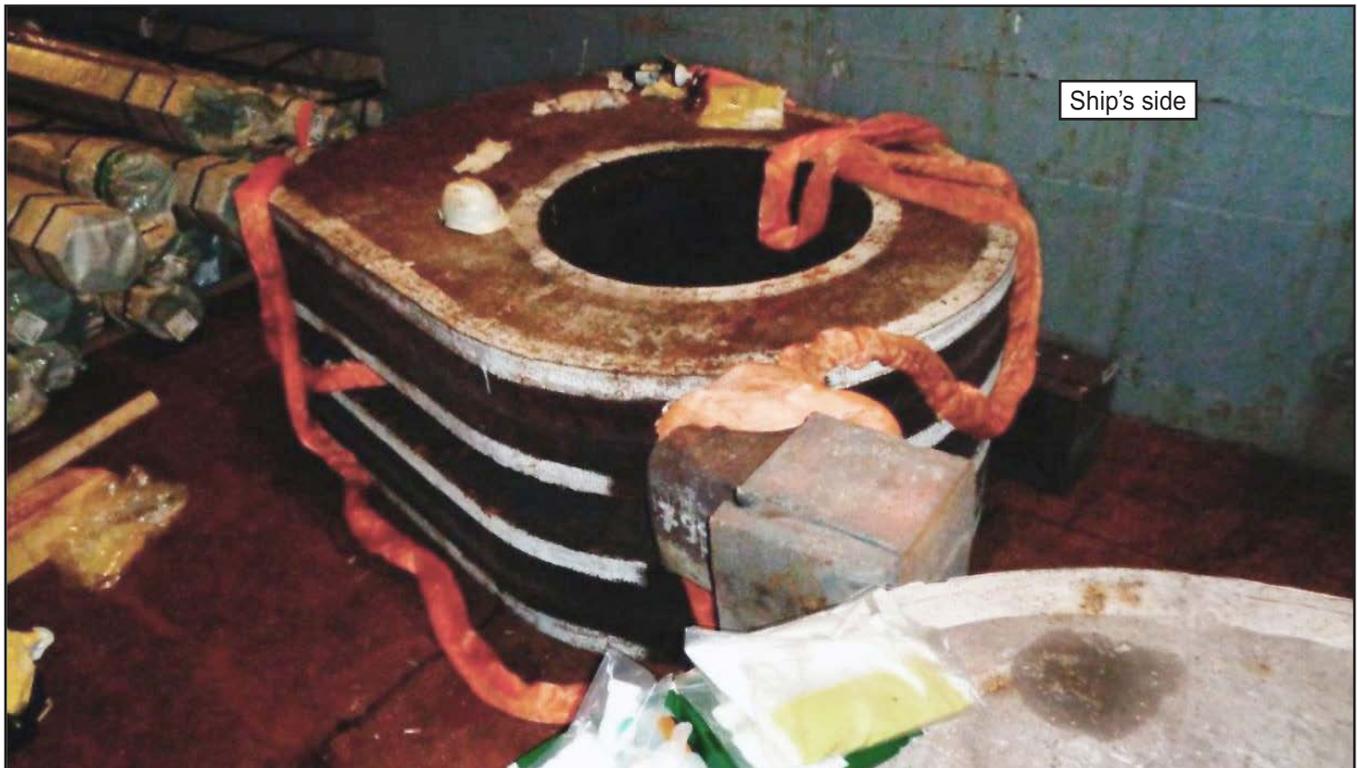
Figure 7: Position of crankshaft web post-accident

The position of the crankshaft web immediately after the chief officer fell is shown at **Figure 7**. The aft end of the crankshaft web was closer to the ship's side than the forward end. The mark that indicated the web's centre of gravity was painted only on the lower half and towards the aft end of the side closest to the vessel's port side.

The two 12m endless synthetic webbing slings used to transfer the camshaft webs into hold No 1 (**Figures 5 and 7**) had a marked working load limit of 30 tonnes. The slings had been supplied as new in Turkey on 24 March 2016 and had not been used before 11 May 2016. No test certificates for the slings were held on board. Following the accident, the slings were found to be in good condition with no cuts or abrasions.

The slings were slackened only a few centimetres after the ninth crankshaft web was landed, but this could have been sufficient for them to move out of position with respect to the centre of gravity mark. As the mark was on the lower half of the web's outboard side (**Figure 7**), it would not have been visible to the OS who was standing on the inboard side. It would also have been difficult to see when viewed from above as the aft end of the web was close to the ship's side. If the slings were incorrectly positioned when they were tensioned, the load would have become un-balanced. As a result, the likelihood of at least one of the slings slipping and causing the crankshaft web to drop at one end would have increased significantly.
