## ACCIDENT

<b>Aircraft Type and Registration:</b>	Westland Scout AH1, G-BYRX	
<b>No &amp; Type of Engines:</b>	1 Rolls-Royce Nimbus MK 10501 turboshaft engine	
<b>Year of Manufacture:</b>	1966 (Serial no: F9640)	
<b>Date &amp; Time (UTC):</b>	29 December 2015 at 1430 hrs	
<b>Location:</b>	Near Barn Farm, Ruddington, Nottinghamshire	
<b>Type of Flight:</b>	Private	
<b>Persons on Board:</b>	Crew - 1	Passengers - 1
<b>Injuries:</b>	Crew - None	Passengers - 1 (Minor)
<b>Nature of Damage:</b>	Helicopter damaged beyond economic repair	
<b>Commander's Licence:</b>	Private Pilot's Licence	
<b>Commander's Age:</b>	76 years	
<b>Commander's Flying Experience:</b>	1,444 hours (of which 380 were on type) Last 90 days - 44 hours Last 28 days - 1 hour	
<b>Information Source:</b>	AAIB Field investigation

## Synopsis

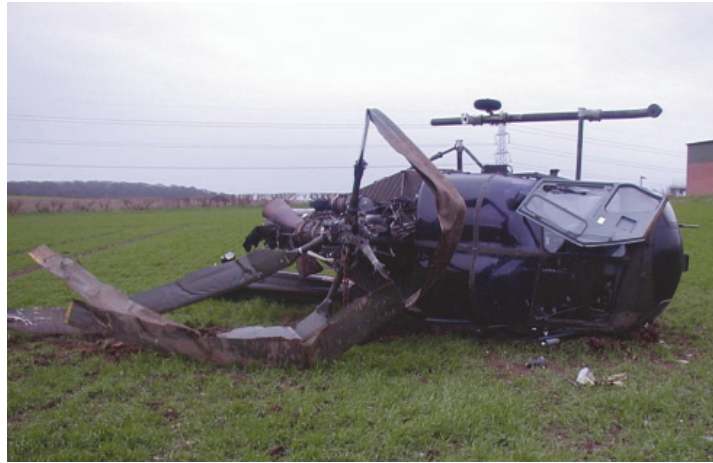
**Figure 1**

Position of helicopter after the accident

The damage to the helicopter was consistent with the pilot's account of it having landed heavily on its tail before coming to rest on its right side. The tail boom and skids had broken away, and the main and tail rotor blades had been destroyed. The damage to the tail rotor assembly and main rotor system dynamic components was consistent with the rotor being driven under power when the main rotor blades struck the ground.
