Report on the investigation of
the fatal man overboard from the
ocean rowing boat

Toby Wallace

North Atlantic Ocean

14 February 2016

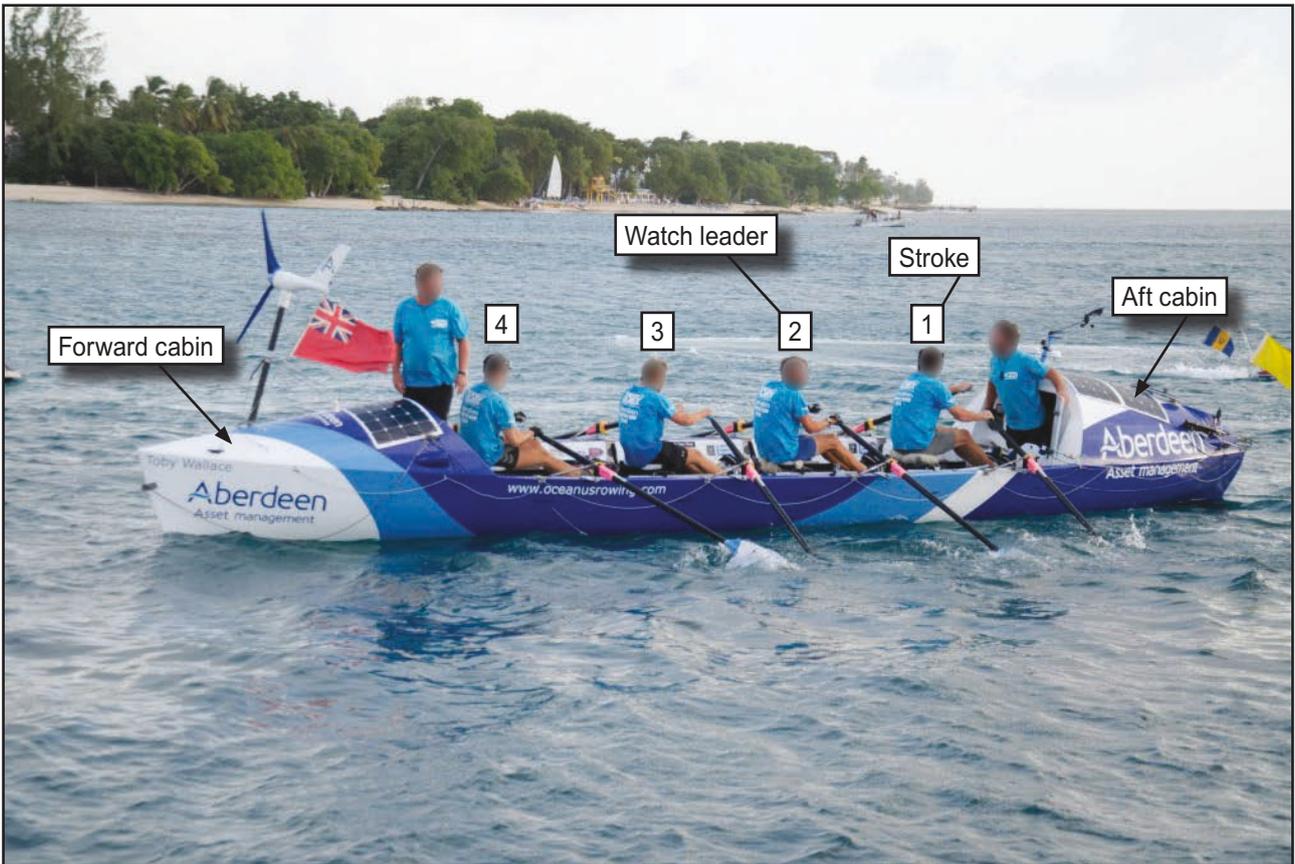
Figure 2: Rowing positions

Toby Wallace's crew were divided equally into two watches. The skipper was in charge of one watch and the first mate was in charge of the other. The rowers in each watch were allocated one of four rowing positions (**Figure 2**). The stroke² sat furthest aft (position 1). When on watch, the skipper sat immediately behind the stroke (position 2) and the mate sat in the bow seat (position 4).

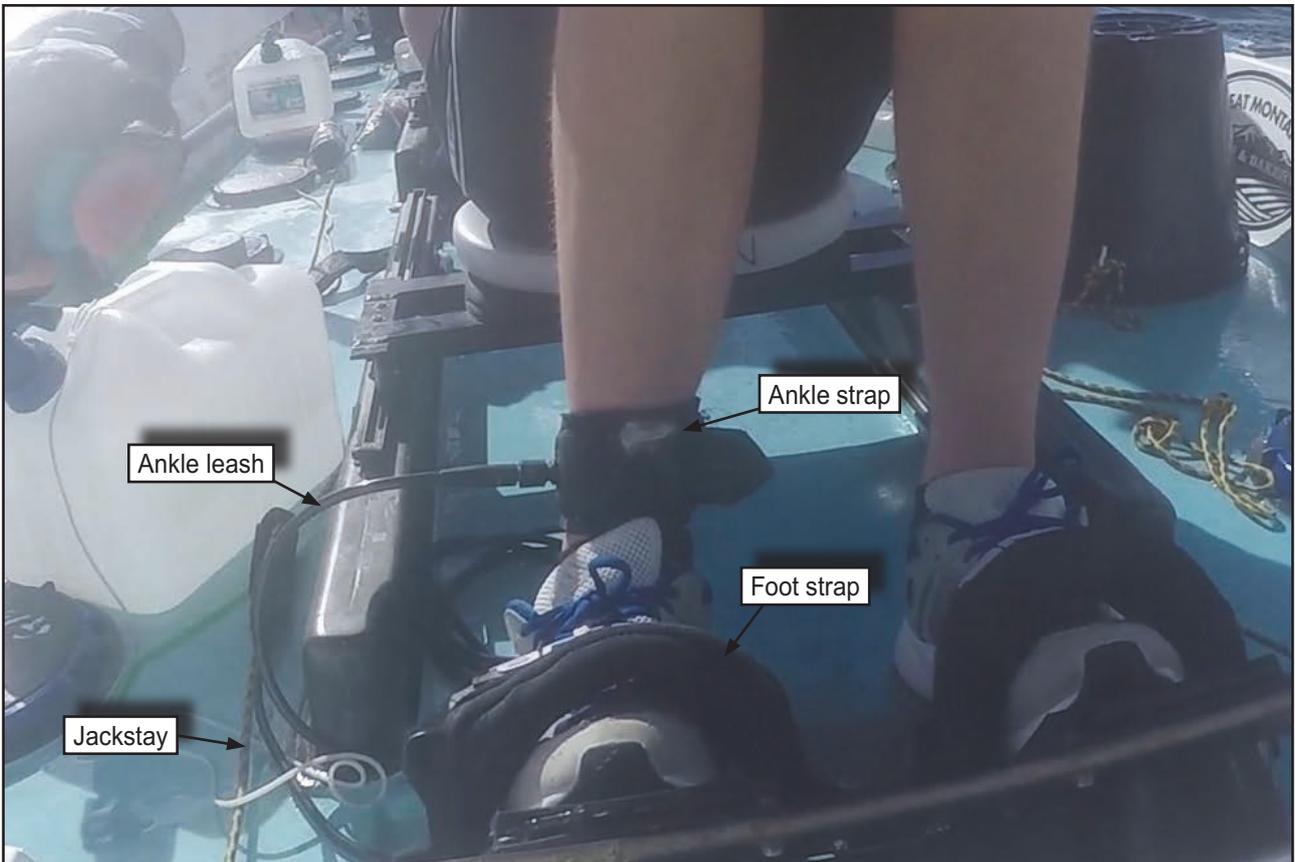
Figure 3: Ankle leash and foot straps

The ankle leashes were provided on board *Toby Wallace* (**Figure 3**) to prevent the rowers from becoming separated from the boat in the event of capsize. The leashes were approximately 3m in length, which was sufficient to allow the wearer to keep clear of the boat as it self-righted.

The leashes were manufactured from plastic coated cord with straps fitted with Velcro¹⁶-type hook and loop fastenings at each end. The ankle strap was wider than the strap secured to the jackstay line on the port side of the deck. The jackstay line was made from 10mm Dynema rope (breaking strength 4650kg).

However, the type of ankle leashes used on board *Toby Wallace* were the type widely used by surfers and paddle boarders. They were not manufactured or tested to meet any national or international safety standards and the velcro-type fastenings would have been prone to degrade over time through use, immersion and ultra-violet light. In addition, although the breaking strength of the jackstay running along the deck to which they were attached was over 4.5t, the breaking strength of its fixing points was not known. Therefore, both the leash and the jackstay had potential weaknesses that impacted on their reliability.

When Mike fell into the water, *Toby Wallace* was still making approximately 3kts of headway. Consequently, it is possible that sufficient force was generated to separate the Velcro-type fastenings, which might have degraded over time in the marine environment or might not have been securely fastened from the outset.

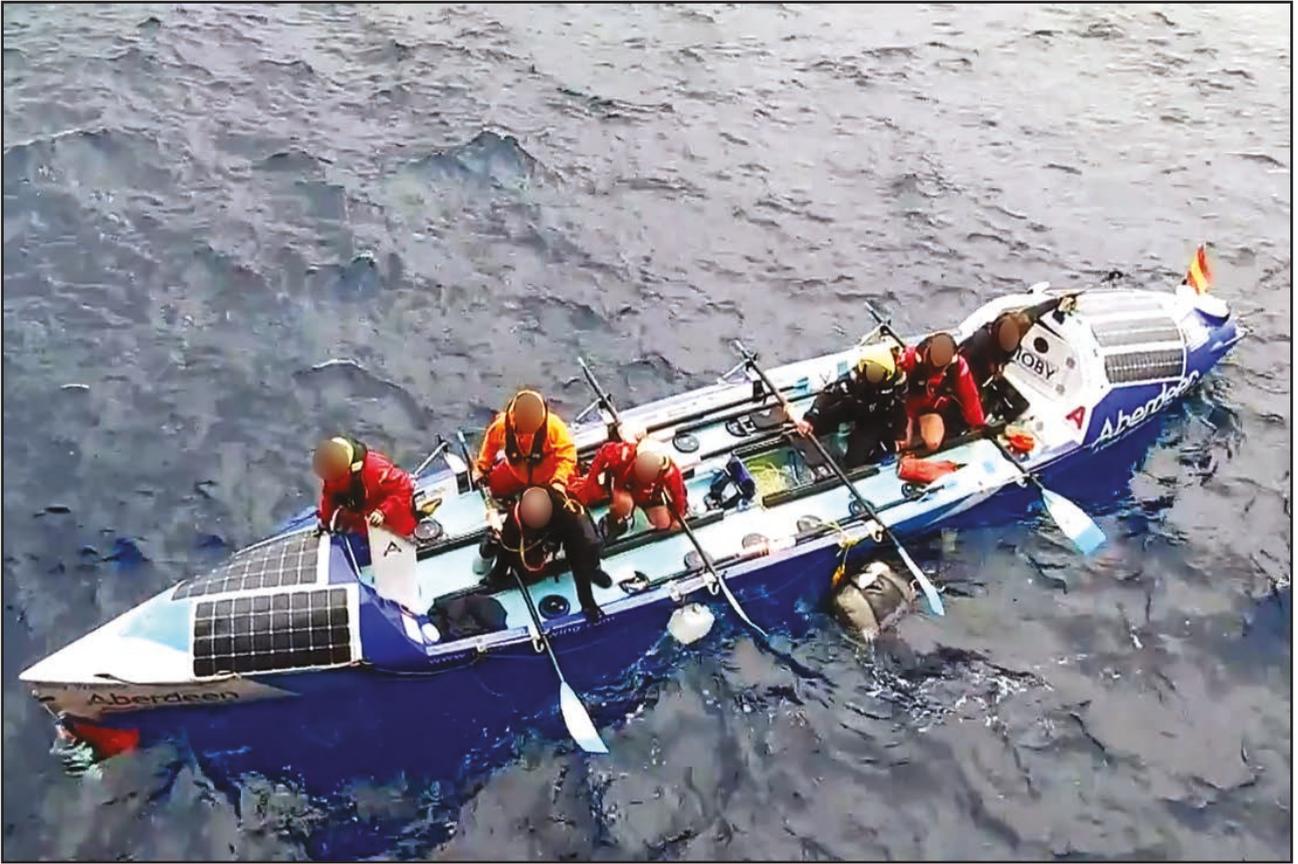
Figure 4: *Toby Wallace* before abandonment

At 2000, *Toby Wallace's* crew were recovered on board *Sea Pearl* (**Figures 4 and 5**), leaving *Toby Wallace* to drift (**Figure 6**). *Sea Pearl* arrived in Macapa, Brazil, 6 days later. The last transmission received from *Toby Wallace's* AIS was on 9 May, when the boat was approximately 500 miles north-east of the British Virgin Islands.
