Report on the investigation of the collision

City of Rotterdam

Primula Seaways

3 December 2015

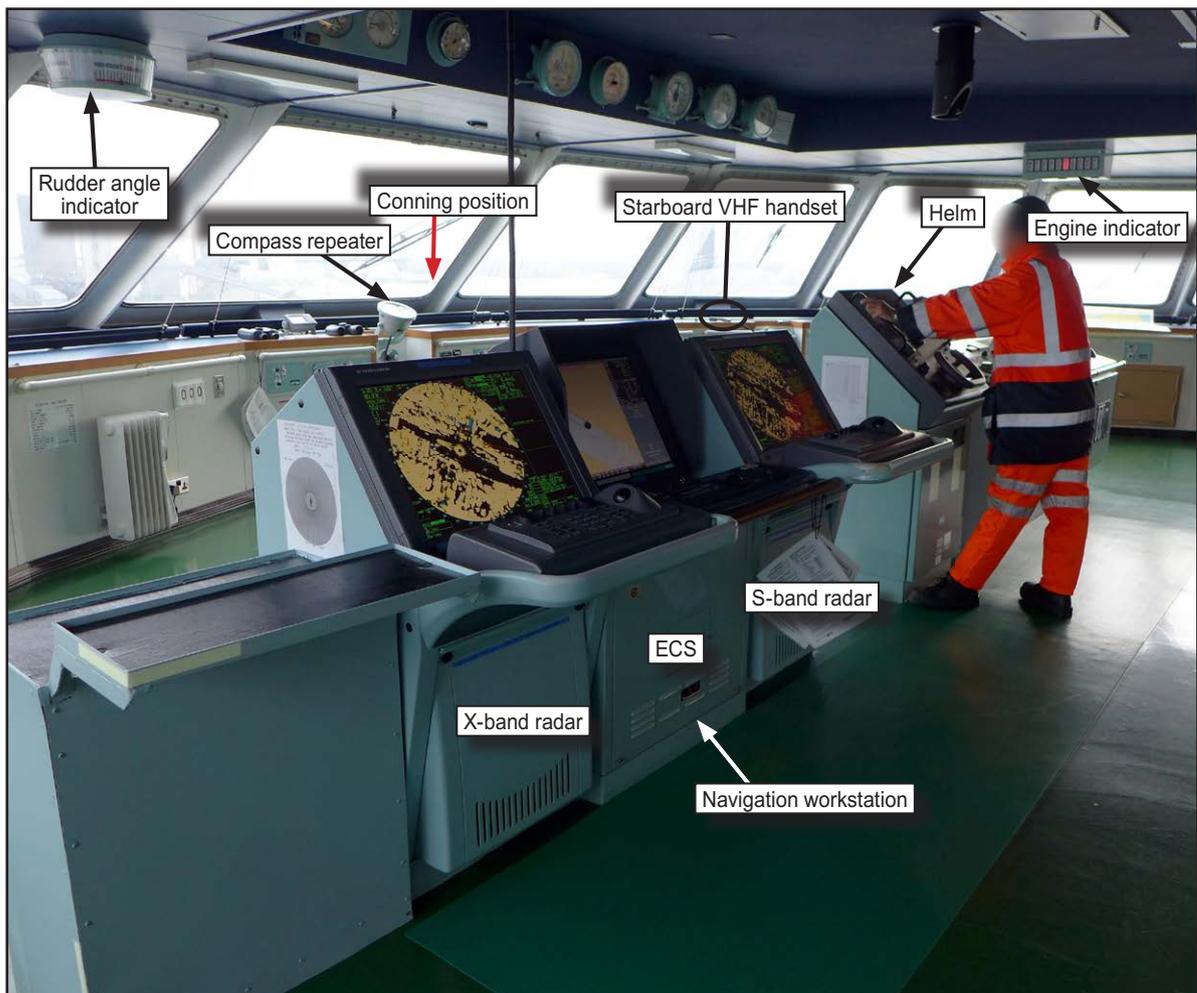
Figure 2: *City of Rotterdam* - bridge (from port side)

During the exchange, the master advised the pilot to stand at either the forward centreline conning station or behind the navigation workstation (**Figure 2**). He also pointed out to the pilot a length of cord on the centre window that indicated the vessel's centreline. The master and the pilot also discussed the potential effects of the wind. The vessel was high-sided and in ballast, and the wind was gusting up to 40 knots from the south-south-west. The pilot anticipated that the vessel would experience a high drift rate throughout its passage, but more so once passed Grimsby where it was more exposed and the effect of the tidal stream would be more pronounced.

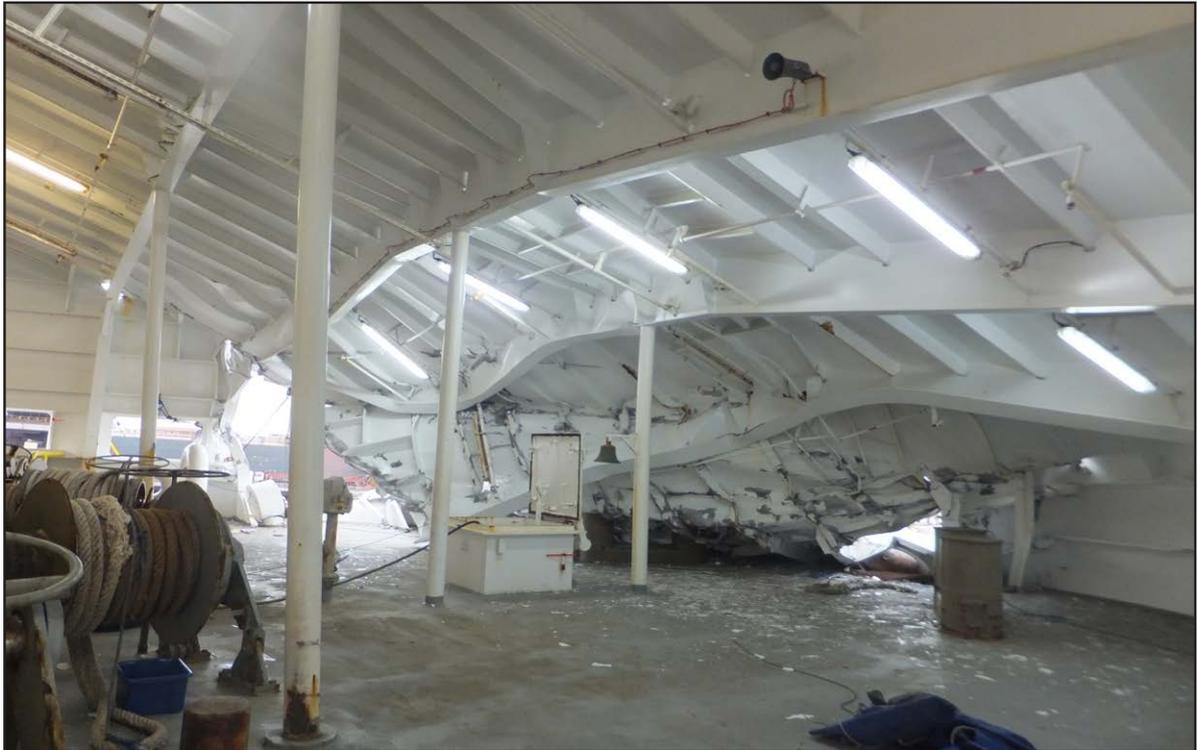
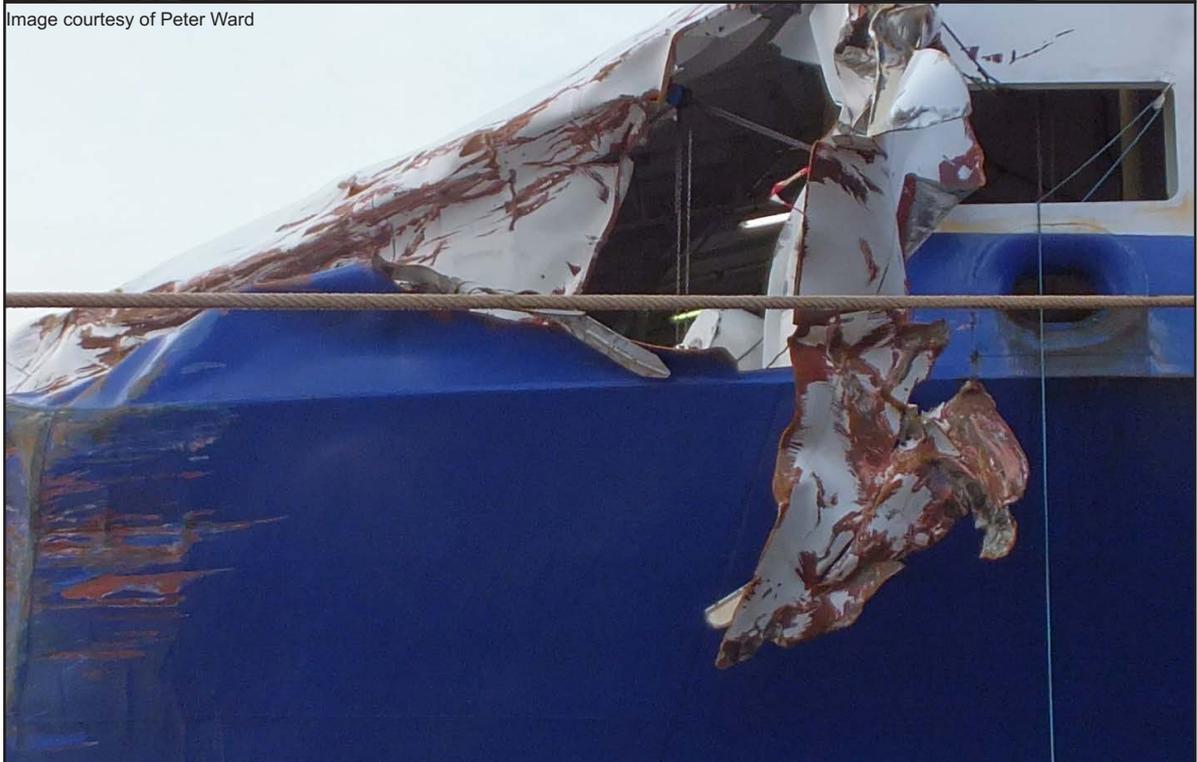
Figure 10: *Primula Seaways* damage

Primula Seaways suffered damage to its bow above the waterline (**Figure 10**). *City of Rotterdam's* bow was damaged in way of the forward mooring deck, the forward hydraulic room, and car decks 5 and 6 (**Figure 11**). The port side bilge keel and plating was also depressed and damaged, which resulted in water ingress to number 4 port ballast tank. The vessels were surveyed by classification society and Maritime and Coastguard Agency (MCA) surveyors. Following temporary repairs

in Immingham, both vessels proceeded to a ship repair yard on the River Tyne for permanent repair. The estimated cost of returning *Primula Seaways* to service was US\$3 million. *City of Rotterdam* spent 2 months in dry dock, but the cost of the vessel's repair was not disclosed.

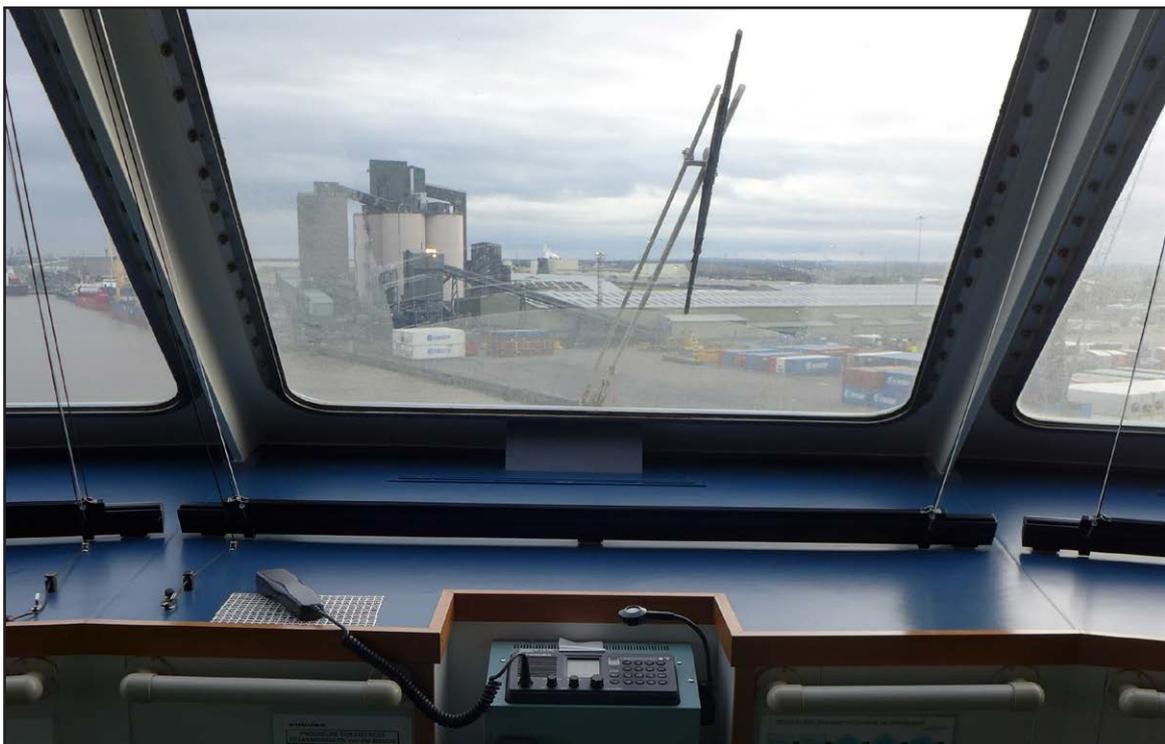
Figure 15: *City of Rotterdam* - same view, from off-axis window (starboard VHF)

Relative motion illusion deceives a viewer into thinking that the observed view is the direction of travel. In this case, the pilot was looking through the window above the starboard VHF radio, which was 33° off-axis from the centreline. As it was dark, the inward slope of the window removed all objects in the periphery, and there were no visual clues, such as a forward structure or bow tip, the illusion would have been compelling.

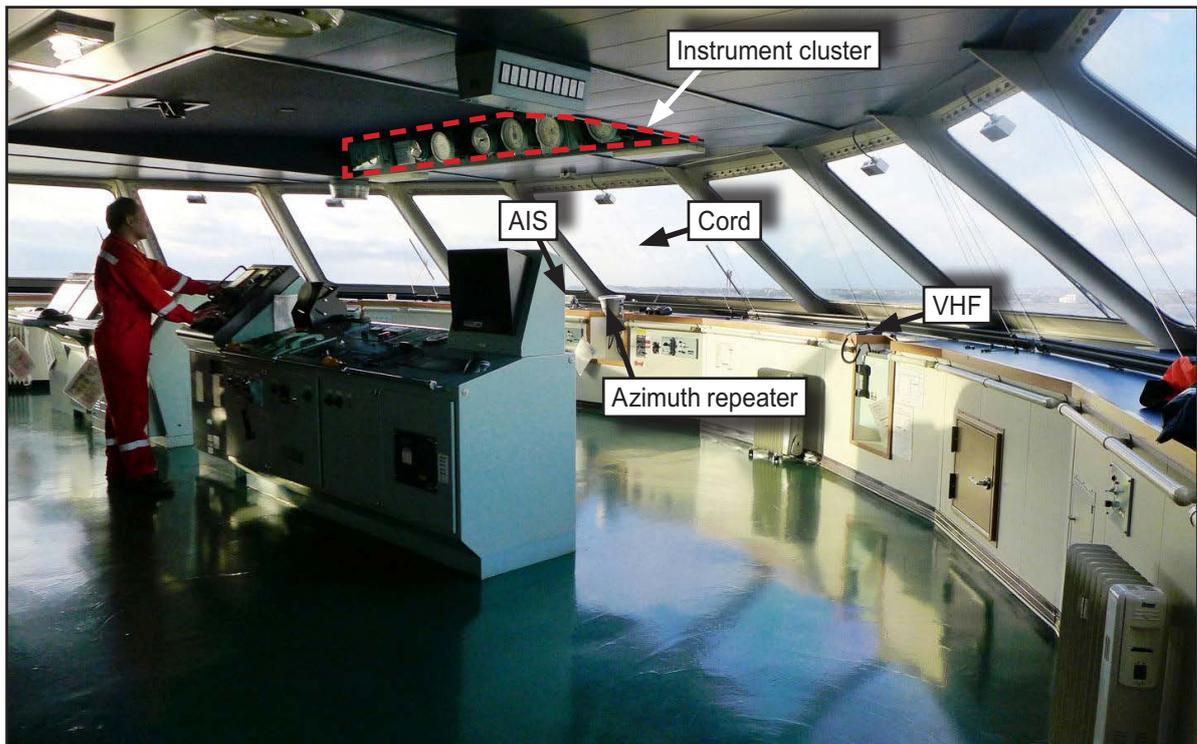
Figure 16: *City of Rotterdam* - bridge from starboard side

Recommendation 95) and it was possible to sight the azimuth repeater and the rudder angle indicator. However, the propulsion, wind and speed indicators on the deck head in front of the helmsman (**Figure 16**) were set back and were not readable as required by SOLAS V/19.2.5.4.

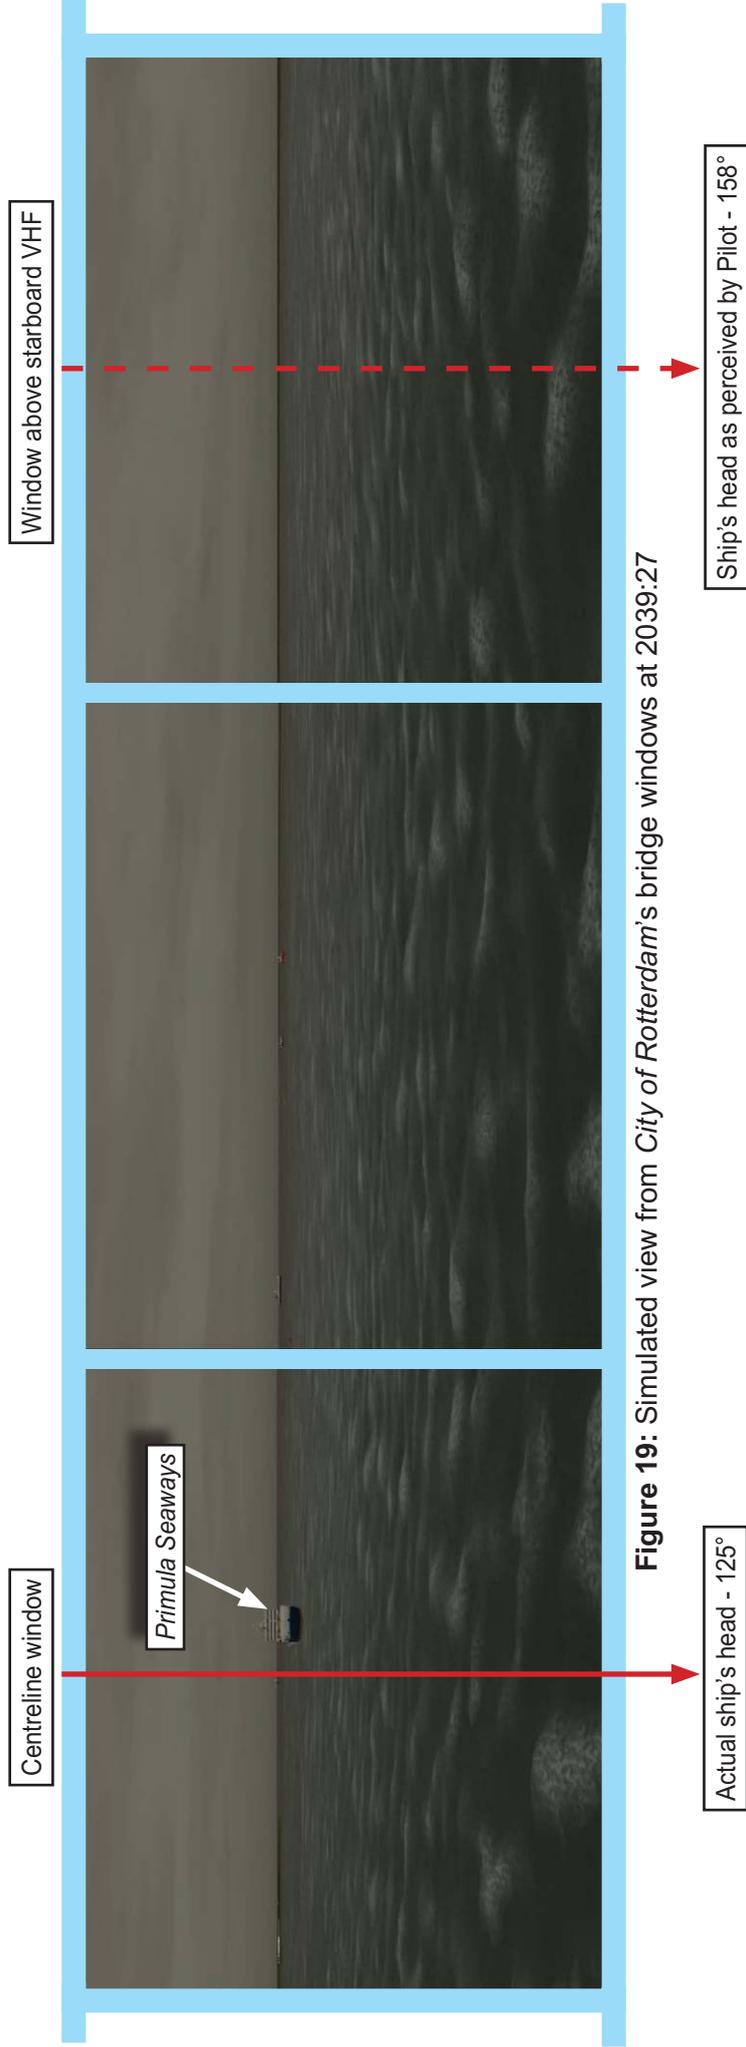
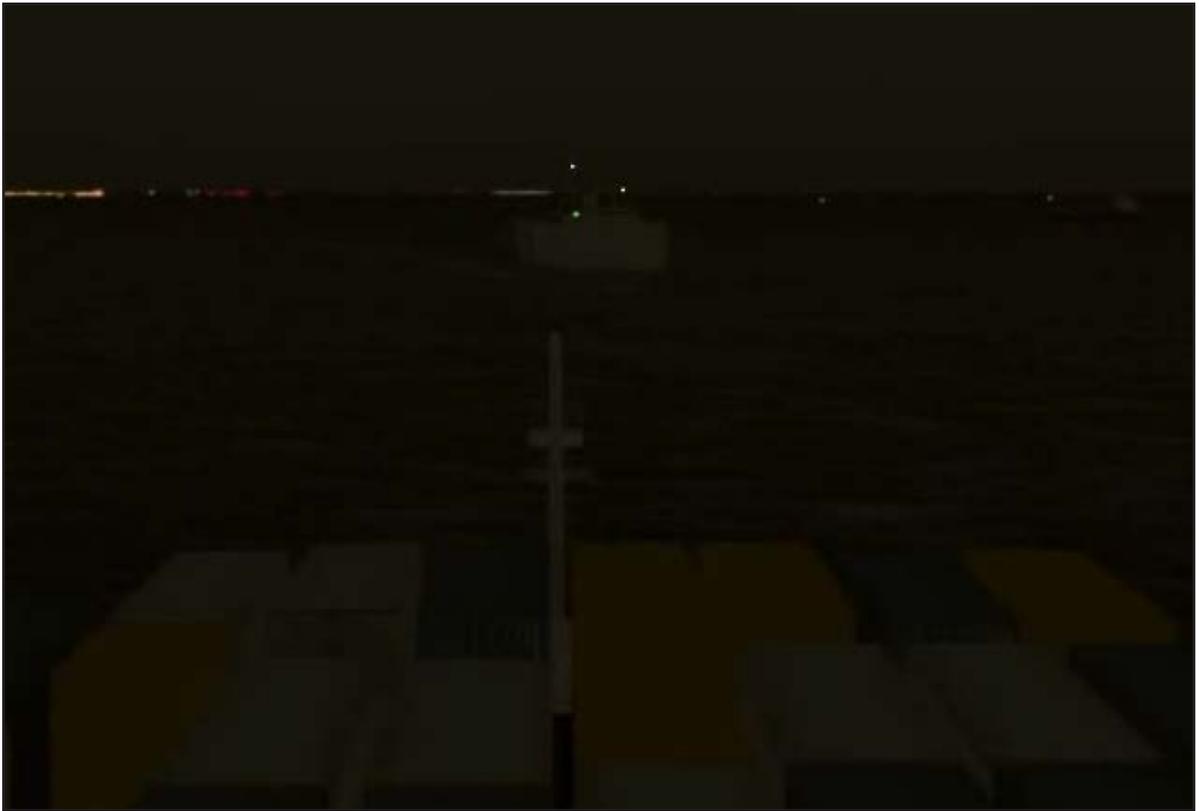
Figure 19: Simulated view from *City of Rotterdam's* bridge windows at 2039:27

Figure 20: Simulated night-time view from *Primula Seaways* at 2039:27, *City of Rotterdam* is showing its two masthead lights and green sidelight

The simulations of the accident (paragraph 1.11) showed that, when the ferry's speed was reduced at 2038:25, a course alteration to starboard would have caused the ferry to cross *City of Rotterdam*'s bow while an alteration to port would have exacerbated the situation if the pilot manoeuvred the car carrier as stated (**Figures 8 and 18**). Doubt clearly existed and, as the vessels were only 1nm apart and closing at a speed of 28.5kts, a more substantial reduction in speed was warranted. By the time full starboard helm was applied and the engine was set to 'full astern' at 2039:37, the vessels' closing speed was still 26kts and they were only 0.5nm apart (**Figures 19 and 20**).
