Rail Accident Investigation: Interim Report 2

**Fatal accident involving the derailment of a tram
at Sandilands Junction, Croydon
9 November 2016**

Report IR1/2017
February 2017

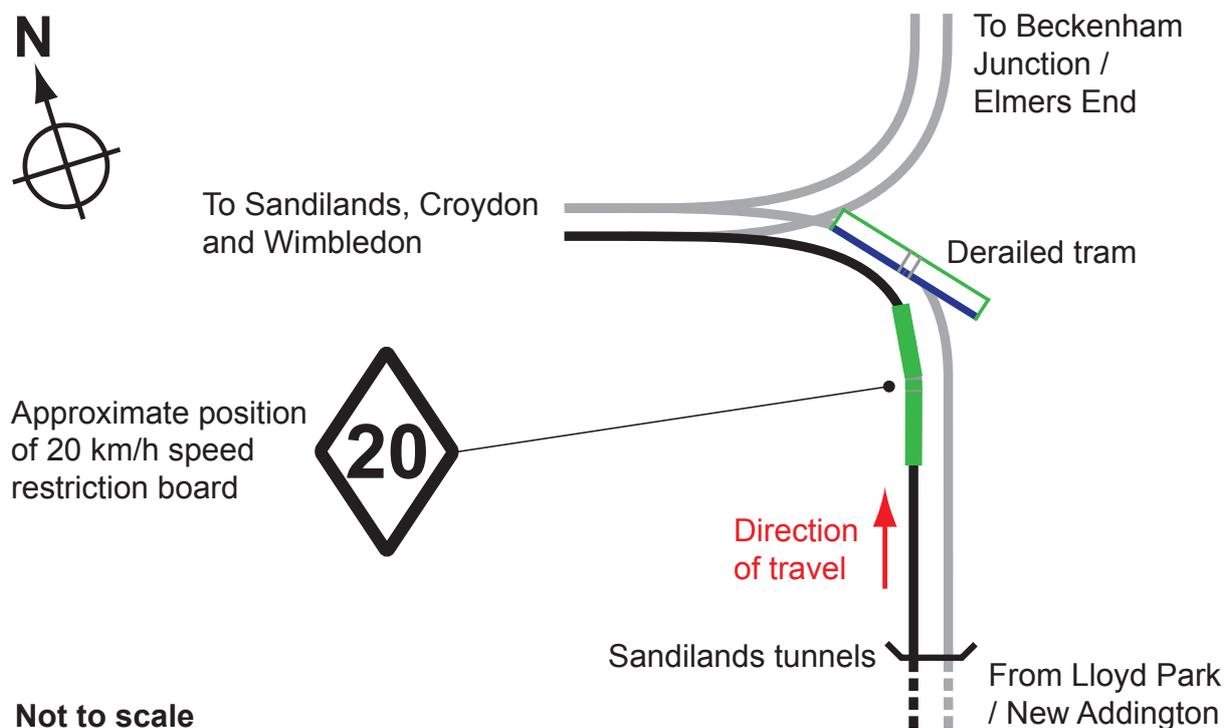
Figure 2: Diagram of accident location

- 15 The maximum permitted speed for trams approaching the area from Lloyd Park was 80 km/h (50 mph) until the curve near to Sandilands Junction, at which point it dropped to 20 km/h (13 mph). A reflective sign denoted the commencement of the 20 km/h speed restriction; it was located close to the start of the curve and approximately 24 metres before the point of derailment.

- 22 Tram 2551 departed from New Addington at 05:53 hrs, calling at six stops including Lloyd Park. After leaving Lloyd Park it negotiated a right-hand curve with a 20 km/h (13 mph) speed restriction at the correct speed, and then travelled at up to 80 km/h (50 mph) (in accordance with prevailing speed restrictions), as it ran towards its next stop at Sandilands.
- 23 The tram entered the curve on the approach to Sandilands Junction at a speed of approximately 73 km/h (46 mph). As it encountered the curve it derailed and turned over onto its right-hand side, coming to a stand with the front cab approximately 25 metres beyond the point of derailment, and 49 metres beyond the speed restriction sign.

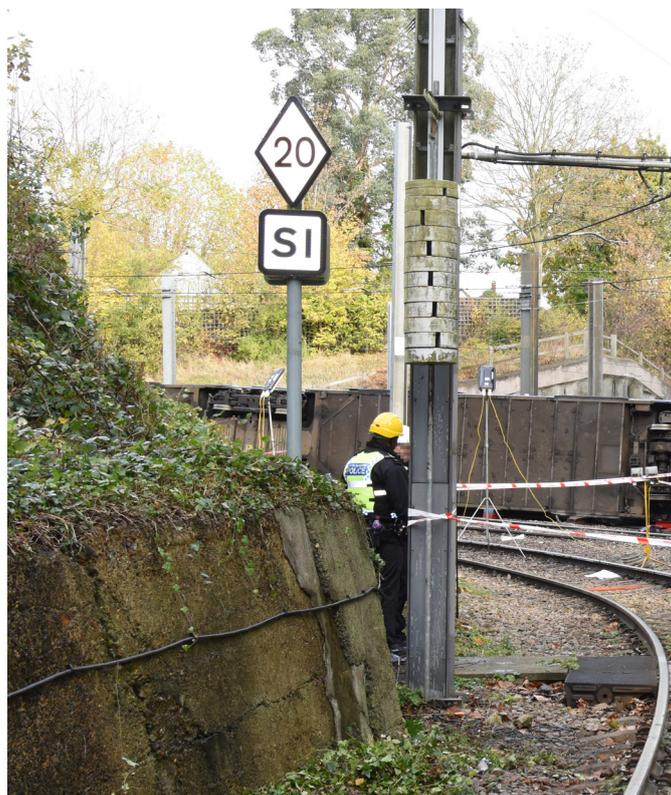
Not to scale

Figure 3: Speed restriction sign. The legend 'SI' under the speed figure indicates the location of a section isolator, an insulated joint in the overhead electrical power line

- 32 RAIB observations and measurements indicate that tram drivers approaching Sandilands Junction from the direction of the tunnel during the hours of darkness, in clear conditions, can sight the curve and read the speed restriction sign from around 90 metres with headlights on main beam, and from around 60 metres with dipped beam.

- 33 The point at which the curve can be sighted and the sign becomes readable in clear conditions is therefore about 90 - 120 metres beyond the point at which a full service brake application must start in order to reduce speed from 80 km/h to 20 km/h (full service brake deceleration is around half emergency brake deceleration²). At the time of the accident the readability of the speed restriction sign is likely to have been adversely affected by heavy rain.

- 34 There was no sign to indicate to drivers where they should begin to apply the brake for the Sandilands curve; they were expected to know this from their knowledge of the route.

‘The factors that led to the over-speeding are still under investigation. Until these factors are better understood, and before the junction re-opens to passenger operation, the RAIB advises London Trams and Tram Operations Ltd to jointly take measures to reduce the risk of trams approaching Sandilands Junction from the direction of New Addington at an excessive speed. Options for consideration should include the imposition of a further speed restriction before the start of the existing 20 km/h speed restriction around the curve and/or additional operational signs.’

42 The RAIB has been informed that London Trams introduced additional speed restrictions on the approach to Sandilands junction and at other locations in response to this advice. Following this, passenger services on the tramway through the junction resumed on 18 November 2016. London Trams has since installed chevron warning signs on the curve and on other similarly tight bends.
