January 2017

## Levonorgestrel Intrauterine Delivery System - Mirena®

### Information about an observed Insertion Tube Defect UK Batch TU01BPE

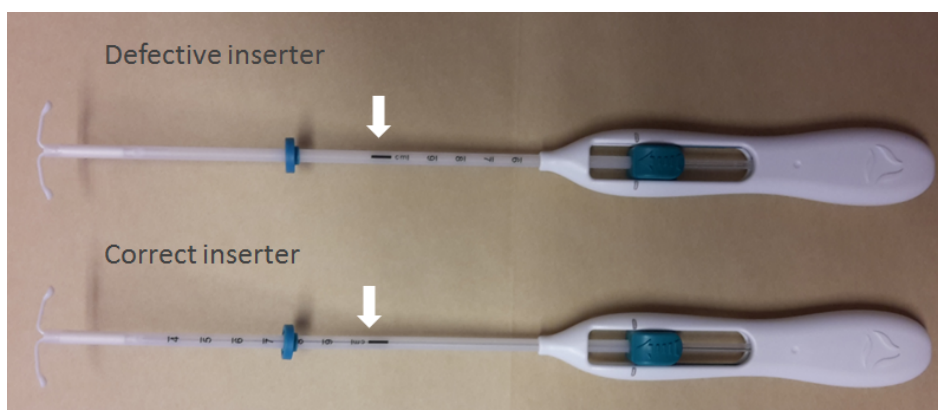
Bayer has received two complaints concerning Mirena® inserters with an inverted mounted insertion tube (please refer to the picture below).

The insertion tube is mounted inversely to the inserter handle. This results in an incorrectly positioned and invertedly appearing scale on the tube. Please refer to the picture below:

The “cm” scale should start at the tip of the insertion tube and increase towards the handle of the inserter.

- Check the batch number before use
- If the batch number is TU01BPE, ensure the insertion tube is correctly mounted (please see picture below)
- Only use Mirena® with a correctly mounted insertion tube
- The use of a Mirena® with an inversely mounted insertion tube may potentially lead to incorrect insertion depth (too deep or not deep enough) and an incorrect position of Mirena®. This may decrease the effectiveness of Mirena or result in adverse events. For example, if the inserter is advanced too far, uterine perforation may occur.

**Only use a Mirena with a correctly mounted insertion tube;** please refer to picture above. Even though the chances that you will encounter an inserter with misplaced inserter tube and inverted scale are considered low, Bayer asks you to thoroughly check the inserter prior to use. If the inserter is found to be defective please contact the Medical Information department using the contact details below.
