ACCIDENT

Aircraft Type and Registration:	DA 40 Diamond Star, G-CBFA	
No & Type of Engines:	1 Lycoming IO-360-M1A piston engine	
Year of Manufacture:	2001 (Serial no: 40.063)	
Date & Time (UTC):	16 July 2016 at 1546 hrs	
Location:	Old Warden Aerodrome, Bedfordshire	
Type of Flight:	Private	
Persons on Board:	Crew - 1	Passengers - 2
Injuries:	Crew - None	Passengers - None
Nature of Damage:	Nose landing gear leg, nose wheel, propeller and possible damage to engine	
Commander's Licence:	Private Pilot's Licence	
Commander's Age:	42 years	
Commander's Flying Experience:	269 hours (of which 38 were on type) Last 90 days - 26 hours Last 28 days - 21 hours	
Information Source:	Aircraft Accident Report Form submitted by the pilot

Synopsis

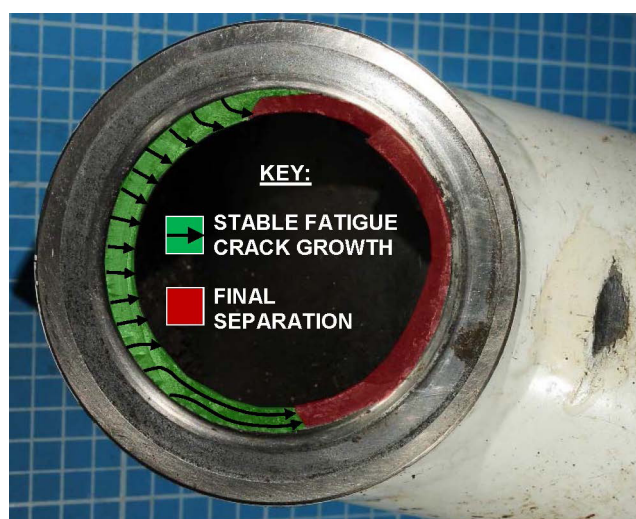
Figure 1

The fracture surfaces were examined by a metallurgical consultant, who concluded that the failure was due to a fatigue fracture which had progressed approximately half way across the part, Figure 1. At this point the nose leg had failed in overload, resulting in separation of the nosewheel assembly.

Failed part of nose gear leg, view looking up with forward to the left showing fatigued area (green) and crack growth

'It is difficult to tell something about the number of landings, the distance the aircraft has to taxi on ground that a fatigue fracture can propagate as shown in the pictures. It is also possible that the propagation of fatigue or forced fracture was favored by one or more hard landings.'

The failure of the leg is similar to previously known failures and the crack occurred in the area highlighted for inspection by AD A-2005-005. The failure occurred 33 flight hours after the last inspection and there was no evidence that the maintenance organisation had incorrectly carried out the inspection.
