**ACCIDENT**

<b>Aircraft Type and Registration:</b>	1) Piper PA-28-151 Cherokee Warrior, G-CCZV 2) Piper PA-28-161 Cherokee Warrior III, G-BZBS
<b>No &amp; Type of Engines:</b>	1) 1 Lycoming O-320-D3G (MODIFIED) piston engine 2) 1 Lycoming O-320-D3G piston engine
<b>Year of Manufacture:</b>	1) 1977 (Serial no: 28-7715089) 2) 2000 (Serial no: 2842080)
<b>Date &amp; Time (UTC):</b>	30 September 2016 at 1443 hrs
<b>Location:</b>	Near Elstree Aerodrome, Hertfordshire
<b>Type of Flight:</b>	1) Training 2) Private
<b>Persons on Board:</b>	1) Crew - 1                      Passengers - None 2) Crew - 1                      Passengers -1
<b>Injuries:</b>	1) Crew - None                  Passengers - N/A 2) Crew - None                  Passengers - None
<b>Nature of Damage:</b>	1) Damaged left landing gear wheel, tyre and fairing 2) One propeller blade bent, tyre marks on left wing
<b>Commander's Licence:</b>	1) Student 2) Private Pilot's Licence

**Synopsis**

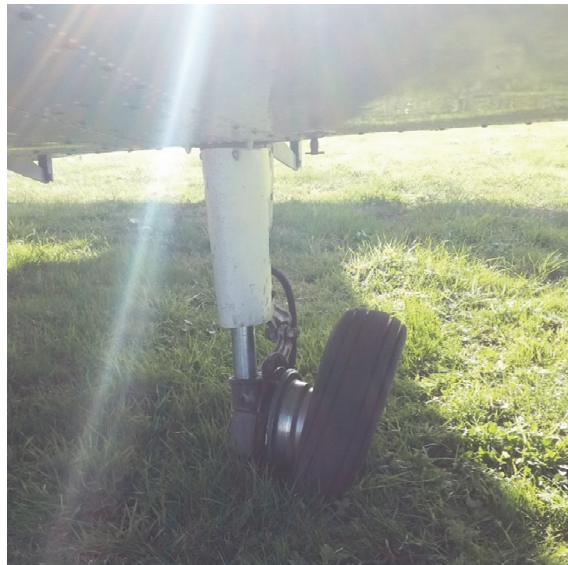
**Figure 1**

what he described as excellent visibility<sup>1</sup>. Near the junction of the M1 and M25 motorways, at approximately 2,000 ft (using a pressure setting of 1010 hPa), he contacted Elstree Information on the radio and, after receiving instructions to join for Runway 26, looked inside the cockpit to set the QFE (999 hPa) on the altimeter. While his attention was inside the cockpit he heard a “substantial thump” to the left wing of his aircraft and saw a “flash” of an aircraft passing by. He realised that he had been involved in a collision but the aircraft and engine appeared to be performing normally and he continued to Elstree and landed. After landing, damage was observed to the left landing gear, wheel and tyre as shown in Figures 1 and 2.

G-CCZV left landing gear

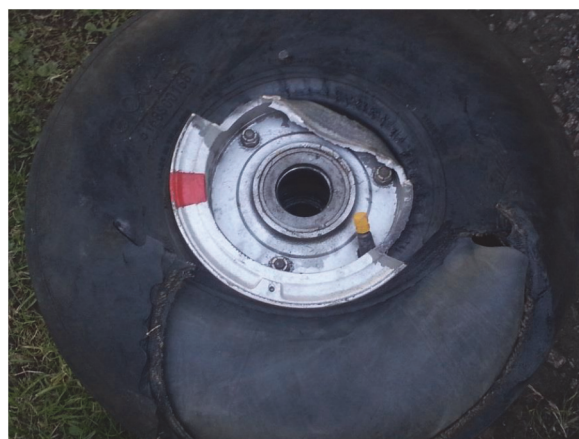
**Figure 2**

G-CCZV left wheel and tyre

Figures 2 and 3 show that G-BZBS’s propeller blade struck G-CCZV’s left wheel and tyre and Figure 4 shows that G-CCZV’s left tyre then struck the upper surface of G-BZBS’s wing. The tracks of the aircraft were approximately 148°M (G-CCZV) and 274°M (G-BZBS) giving a closing angle of approximately 54° which, given that the aircraft were flying straight and level at constant speed and altitude, would have remained constant in the lead-up to the collision. Neither pilot saw the other aircraft in time to take avoiding action. It is likely that the poor into-sun visibility, the constant angle between the tracks of the aircraft, and the fact that the attention of both pilots was inside their respective cockpits before the collision, contributed to the breakdown of the see-and-avoid principle for flight in Class G (uncontrolled) airspace<sup>45</sup>.

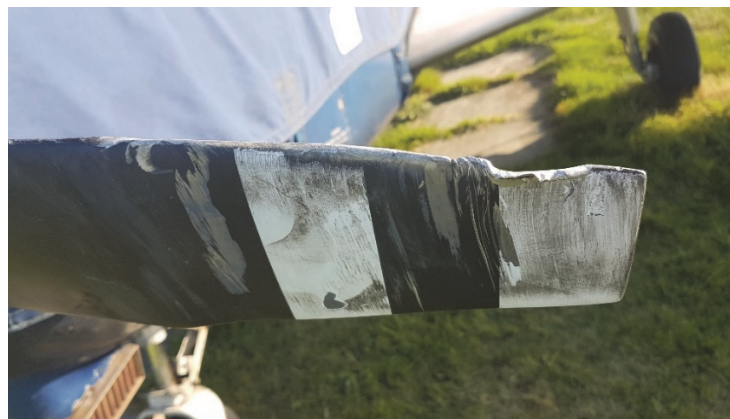
G-BZBS was flying from Stapleford Aerodrome to White Waltham Aerodrome, and was on a track from abeam Banbury Reservoir VRP<sup>2</sup> to Bovingdon VOR<sup>3</sup> at 2,200 ft on a pressure setting of 1021 hPa. The pilot reported that he was flying towards a “bright sun” which was low in the sky and reducing visibility in the direction of flight. He looked at his map to verify his position before calling Farnborough LARS on the radio when he saw a “flash” overhead and felt an impact. Although aircraft controllability was not affected, he declared a PAN on the Farnborough LARS frequency and stated his intention to divert to Elstree Aerodrome where he landed without further incident. After landing, damage was observed to the aircraft’s propeller blade and left wing upper surface as shown in Figures 3 and 4.

**Figure 3**  
G-BZBS propeller blade

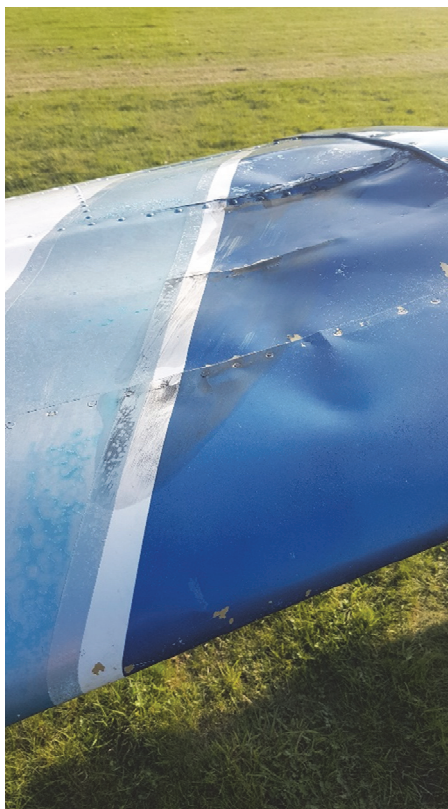
**Figure 4**  
G-BZBS left wing
