ACCIDENT

Aircraft Type and Registration:	Schleicher ASW 27-18E (ASG 29E) glider, G-VLCC	
No & Type of Engines:	1 Solo Type 2350 two-stroke engine	
Year of Manufacture:	2007 (Serial no: 29511)	
Date & Time (UTC):	21 July 2016 at 1043 hrs	
Location:	Moundsmere, near Basingstoke, Hampshire	
Type of Flight:	Private	
Persons on Board:	Crew - 1	Passengers - None
Injuries:	Crew - 1 (Fatal)	Passengers - N/A
Nature of Damage:	Glider destroyed	
Commander's Licence:	British Gliding Association Gliding Certificate	
Commander's Age:	60 years	
Commander's Flying Experience:	1,800 hours gliding (of which 3 were on type) Last 90 days - 16 hours Last 28 days - 0 hours	
Information Source:	AAIB Field Investigation

Synopsis

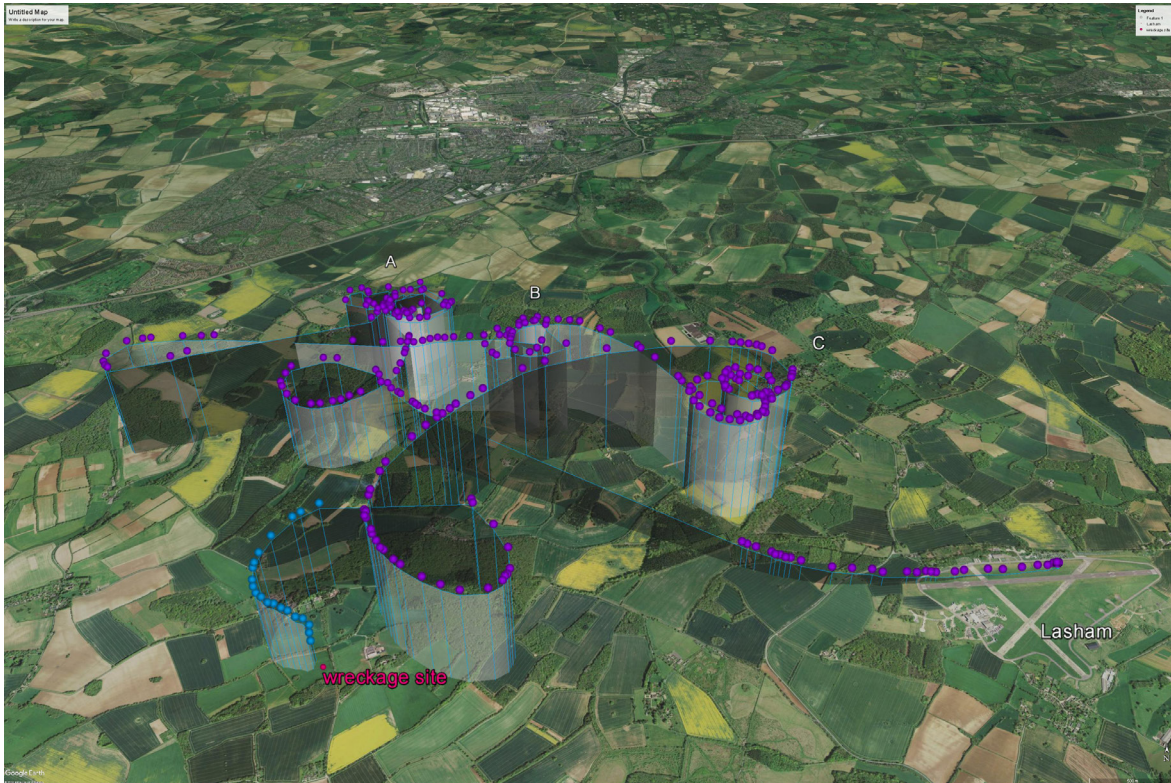
Figure 1 shows the track of the glider beginning on the ground at Lasham at 0953 hrs (airborne at 1020 hrs) to about 550 ft above the accident site at 1043:20 hrs, 4.5 km west of the airfield. The flight time from tug release was about 21 minutes. The recorded height, vertical speed and turn rate for these points is presented as a time history at Figure 2 and includes a calculation of ground track angle based on the angle between its present position point and the previous point.

The figures show that, following the tug release at just under 2,400 ft amsl (about 1,900 ft aal), G-VLCC turned to the left, to the north of the release point, where it commenced a climb to 3,270 ft, gaining about 810 ft [A]. The glider then tracked west then east, descending to 2,910 ft. It then climbed again to 3,370 ft [B] before descending to 3,200 ft. The final climb was to 3,920 ft amsl [C].

G-VLCC then descended at between 400 and 500 ft/min, initially tracking west, in a gentle (about 1°/s) turn to the left. After about 90 seconds (now tracking south and descending through 3,250 ft) the turn tightened, taking the glider onto an easterly track, then tightened further to about 4°/s onto a north-north-westerly track where it levelled off at 3,050 ft for about 25 seconds. From the top of the final climb to this point the glider's path over the ground was 3 nm, which it covered in 167 seconds giving an average groundspeed of 65 kt. The FLARM ground-receiver then lost contact for 35 seconds; however, the straight-line distance travelled during this period was 0.55 nm which indicates an average groundspeed slightly greater than 57 kt.

Flight track of G-VLCC with area of climbing marked at A, B & C and the last 35 seconds of recordings in light blue (Figure 3). The distribution of points varies as not all of the FLARM broadcasts were detected by the ground-receiver

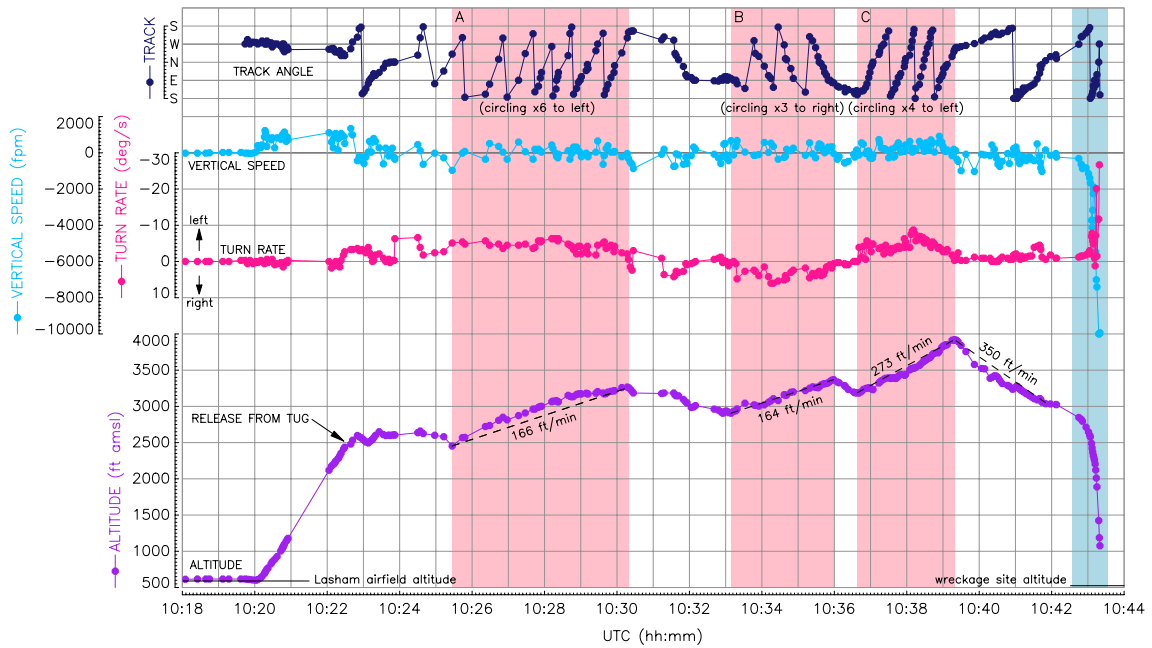
Figure 2

FLARM flight data with the last 35 seconds of recordings highlighted in light blue (Figure 3) – the highlighted areas in pink indicate when G-VLCC was climbing

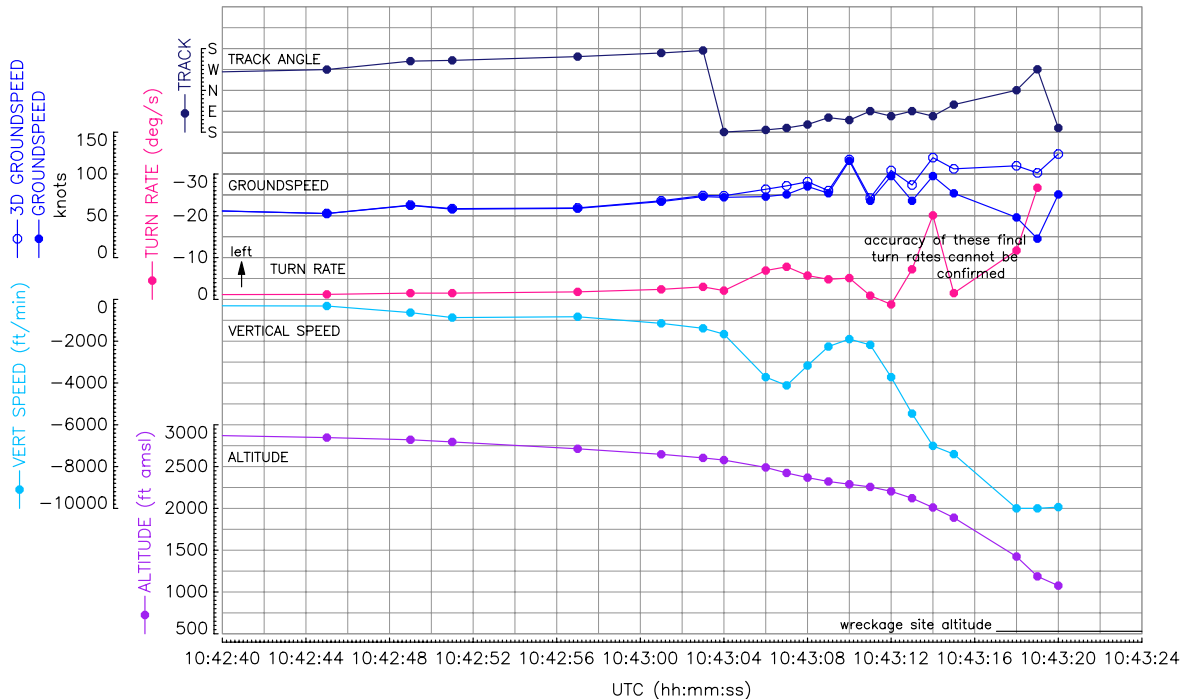
Figure 3 shows the FLARM flight data once contact was regained, with G-VLCC at 2,850 ft on a south-westerly track, gently descending and turning, through to the end of the recording 35 seconds later. Groundspeed (calculated from distance travelled and time taken between points) is also presented, together with a parameter labelled '3D' groundspeed that incorporates the component of vertical speed.

FLARM flight data – last 35 seconds of recordings

G-VLCC continued to turn and descend, reaching a descent rate of 1,660 fpm after 19 seconds and this rapidly increased to 4,000 fpm over the next 3 seconds. There was a similar marked increase in the turn rate during this period. Over the next 3 seconds the descent rate reduced to 2,000 fpm; however, within another 4 seconds it had increased to over 7,000 fpm, with the glider now about 1,500 ft above the ground. The calculated groundspeed throughout the last 35 seconds was always greater than 50 kt and for the last 18 seconds it was greater than 70 kt.

Ground-receiver contact was then lost for a couple of seconds before regaining contact for three last points to be recorded. The last point positioned the glider about 550 ft agl, near the accident site and the groundspeed and vertical speed combined indicate the glider hit the ground with a speed in excess of 100 kt.

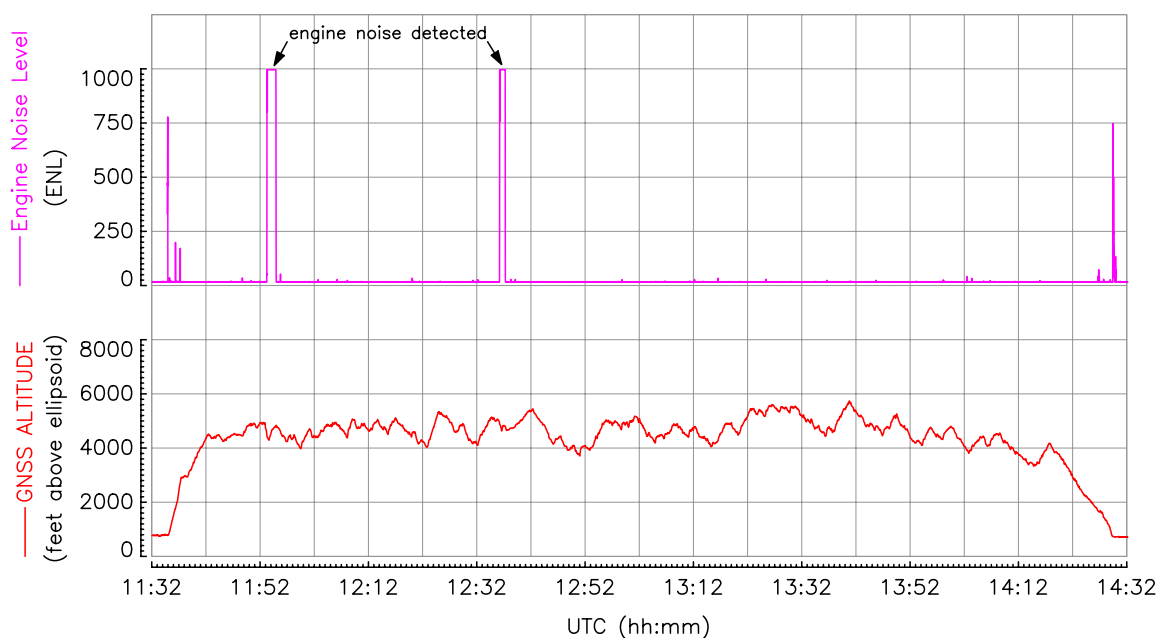
Figure 4

A copy of the downloaded log files from the LX8080 for the two previous flights by the pilot was provided by the owner of the glider, so that the Engine Noise Level (ENL) data could be examined, to establish whether the sustainer engine had been used on either of these flights. With the exception of the pilot's first flight in G-VLCC on 11 April 2015, there was no evidence that the engine may have been used. The flight data for the 11 April 2015 flight (Figure 4) shows that significant noise was detected twice when the glider was airborne – the first lasting 100 seconds and the second 60 seconds. However, when analysing the phase of flight (position and altitude), climb rate and speeds immediately prior to and during these periods of high ENL values, only the first was consistent with use of the engine. It is therefore probable that the engine was used in the first period (100 seconds) and it is only a possibility for the second.

Data from flight on 11 April 2015 showing when noise from the engine may have been detected
