INCIDENT

Aircraft Type and Registration:	Airbus A320-214, G-EZWX	
No & Type of Engines:	2 CFM56-5B4/3 turbofan engines	
Year of Manufacture:	2014 (Serial no: 6192)	
Date & Time (UTC):	27 July 2016 at 0729 hrs	
Location:	In-flight from Heraklion, Greece, to London Gatwick	
Type of Flight:	Commercial Air Transport (Passenger)	
Persons on Board:	Crew - 6	Passengers - 177
Injuries:	Crew - None	Passengers - None
Nature of Damage:	Damage to trimmable horizontal stabiliser (THS) mini reduction gear	
Commander's Licence:	Airline Transport Pilot's Licence	
Commander's Age:	55 years	
Commander's Flying Experience:	17,000 hours (of which 6,000 were on type) Last 90 days - 217 hours Last 28 days - 82 hours	
Information Source:	Aircraft Accident Report Form submitted by the pilot and further enquiries by the AAIB

Synopsis

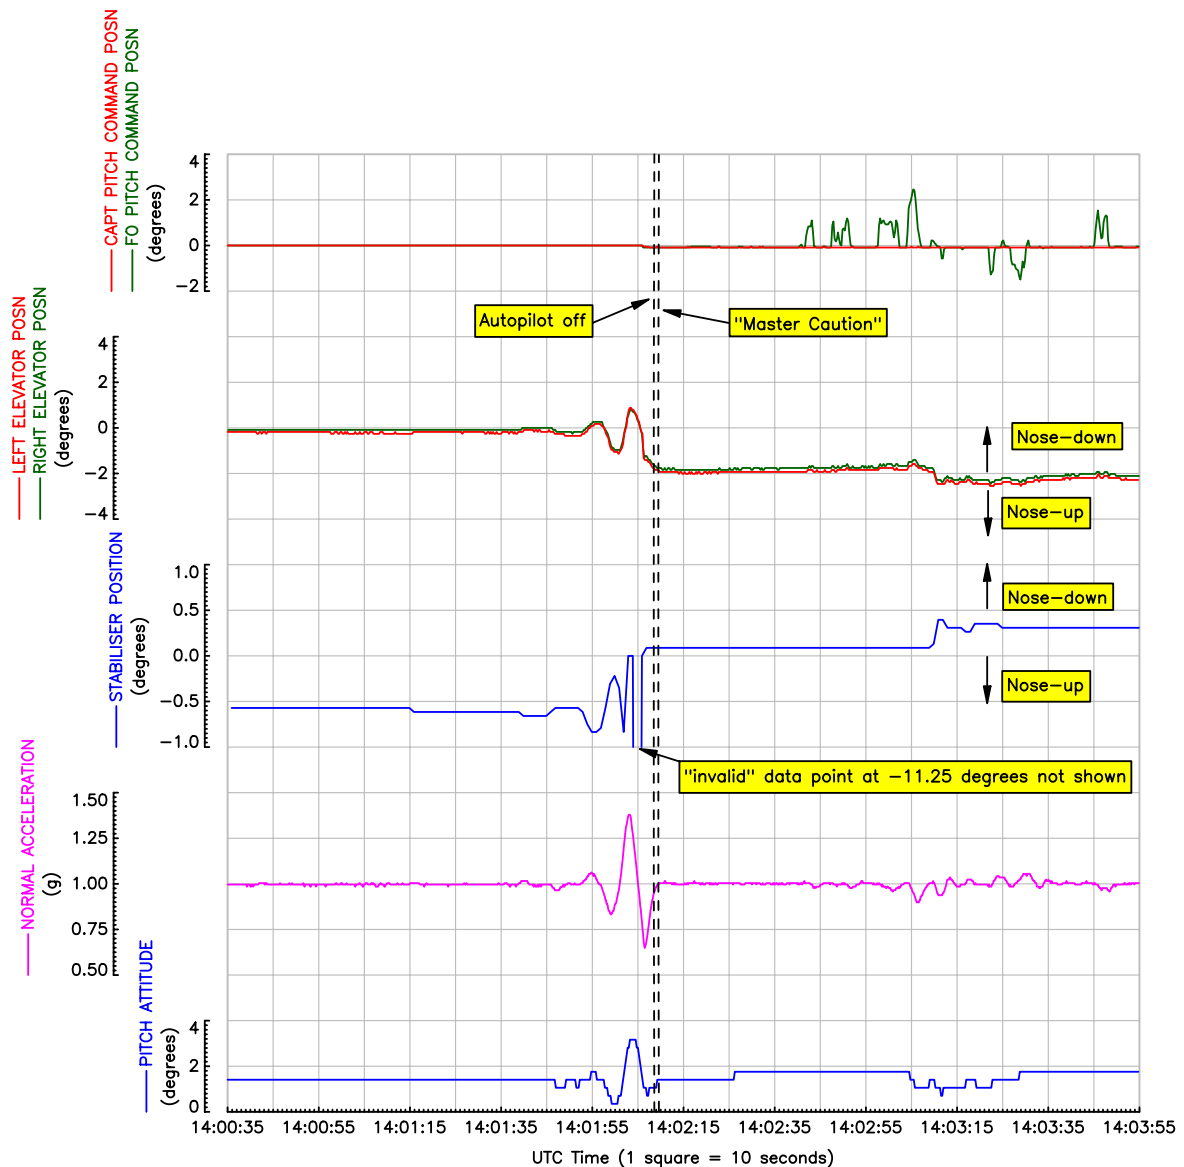
Figure 1

The flight data recorder (FDR) data showed that from about 1401:50 UTC to 1402:10 the aircraft experienced oscillations in pitch and in normal acceleration before the aircraft returned to steady flight (Figure 1).

The maximum normal acceleration achieved was 1.37 g and the minimum acceleration was 0.65 g over a 4-second period. It was during these oscillations that the elevator aileron computer (ELAC) parameters showed that a handover from ELAC 2 to ELAC 1 had occurred in quick succession at 1402:06. The autopilot disengaged two seconds later.

The oscillation in pitch was caused by an oscillation in the stabiliser position, for which the elevator automatically tried to compensate. The stabiliser then settled in a position that was about 0.6° more nose-down than before the upset, while the elevator settled at a position about 2° more nose-up.

Salient FDR parameters at the time of the stabiliser malfunction

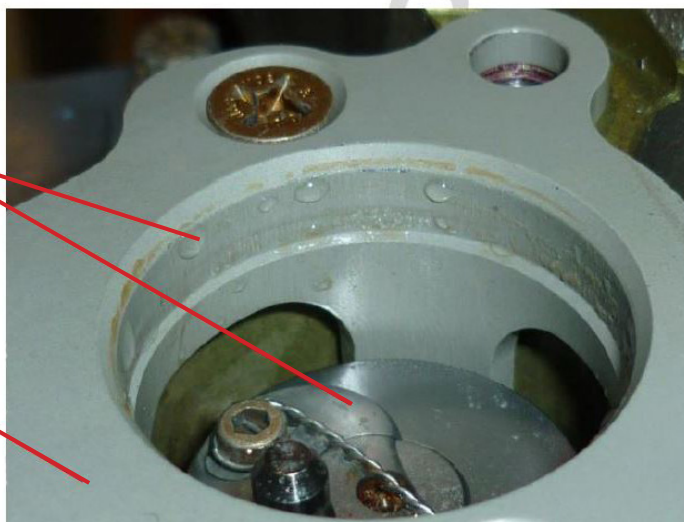
Figure 2

The THSA was sent to the component manufacturer for examination. They discovered that the mini reduction gear assembly was not driving the COM transducer, so the COM transducer could not sense the commanded stabiliser position. About 2 ml of water was found inside the mini reduction gear liner/cavity, which was an unusual finding (Figure 2).

Water inside mini reduction gear liner/cavity

The output shaft of the mini reduction gear was found to be jammed and disassembly of the unit revealed damage to the gears.

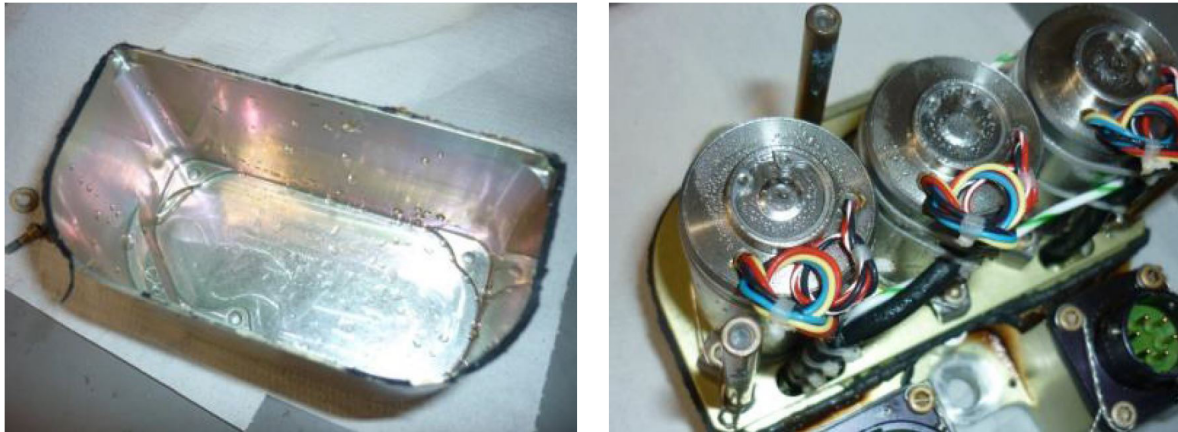
Figure 3

The COM transducer was opened which also revealed the unexpected presence of water (Figure 3). Corrosion was also found within the transducer housing. The seals and sealant used to seal the component were in satisfactory condition. However, a leak check of the seal was not conducted before the transducer was opened as the manufacturer was not expecting water to be present. According to the manufacturer this was the first instance of water ingress into this component.

Water inside THSA COM transducer, cover (left) and internal RVDTs (right)

According to the THSA manufacturer and the aircraft manufacturer the failure of the THSA was most probably due to water ingress into the THS COM transducer which then migrated into the mini reduction gear. The water in the mini reduction gear probably froze during flight and movement of the THSA caused torque on the gear to damage the mini reduction gear. The stabiliser would have moved as commanded and been sensed by the MON transducer but there would have been no movement sensed by the COM transducer; this discrepancy was detected and the system logic then prevented any further electrical commands to the THSA.
