SERIOUS INCIDENT

Aircraft Type and Registration:	DHC-8-402 Dash 8, G-ECOF	
No & Type of Engines:	2 Pratt & Whitney Canada PW150A turboprop engines	
Year of Manufacture:	2008 (Serial no: 4216)	
Date & Time (UTC):	30 October 2016 at 1340 hrs	
Location:	Belfast City Airport	
Type of Flight:	Commercial Air Transport (Passenger)	
Persons on Board:	Crew - 4	Passengers - 77
Injuries:	Crew - None	Passengers - None
Nature of Damage:	Heat damage to tail cone	
Commander's Licence:	Airline Transport Pilot's Licence	
Commander's Age:	35 years	
Commander's Flying Experience:	6,370 hours (of which 6,190 were on type) Last 90 days - 211 hours Last 28 days - 68 hours	
Information Source:	Aircraft Accident Report Form submitted by the pilot and additional AAIB inquiries

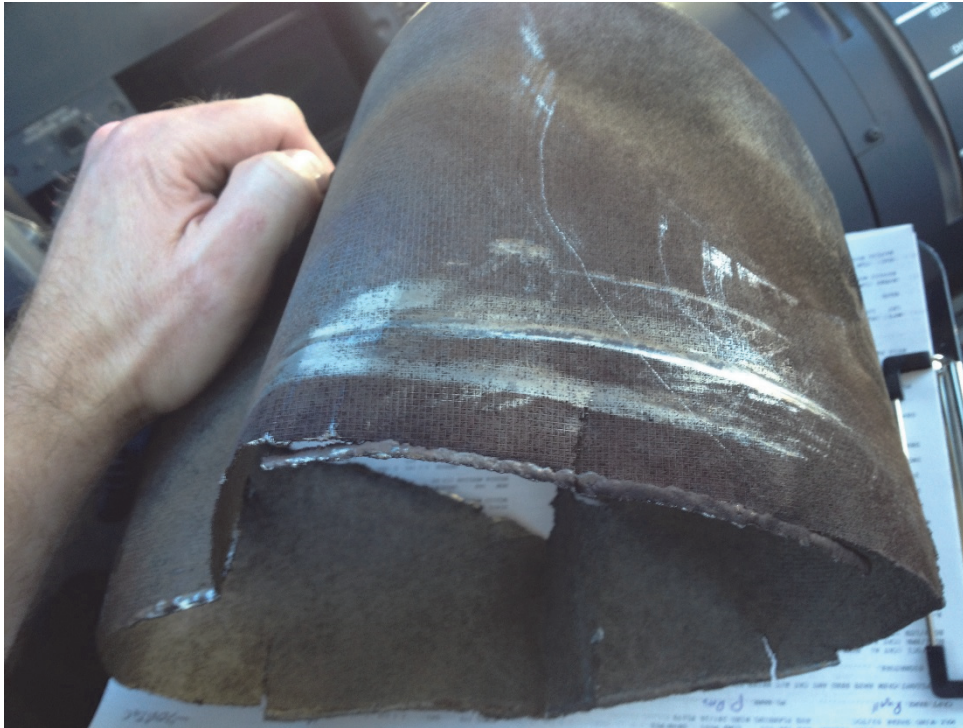
Debris item photographed by crew after discovery

Although the ejected piece of liner was not available for examination, Figure 1 shows what appears to be fretting or abrasion damage on the outer surface.

The nature of the failure was not determined, although chances of obtaining more information may have been improved had the ejected piece of the duct liner been correctly identified and retained. There were some marks visible in photographs taken of this item, although it could not be concluded if they were the result of in-service fretting or abrasion during installation.

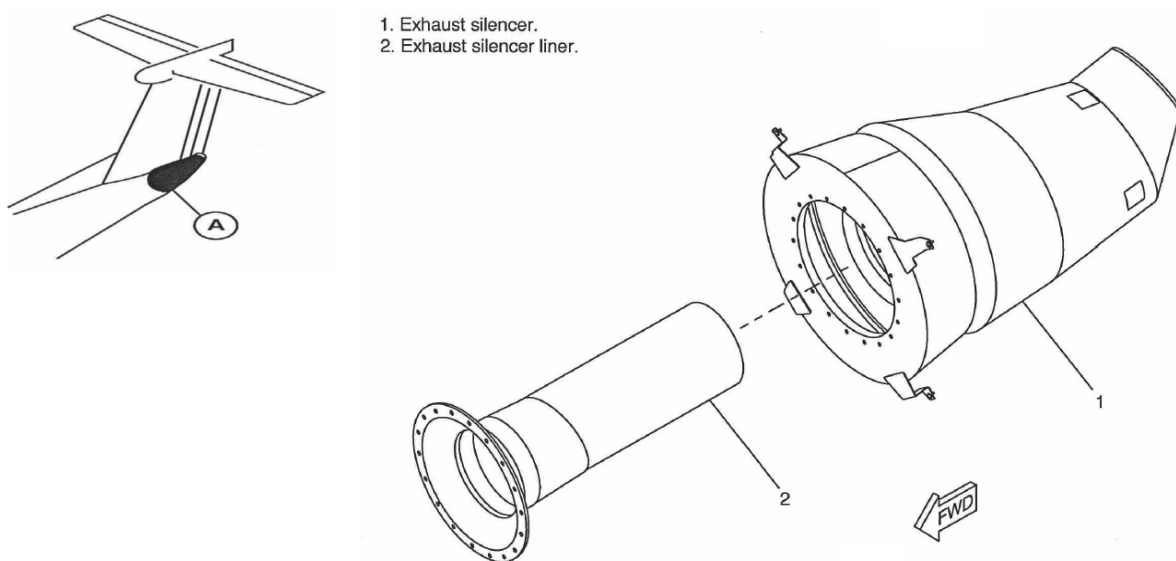
Figure 2

The APU is located within a bay in the tail cone on this aircraft type. An exhaust duct, fabricated from titanium, is installed within the aft section of the tail cone. Within this is a duct liner made from a fibre-metal acoustic material; it is elliptical in section, supported on frames within the duct and bolted to it at its forward end (Figure 2).

APU exhaust duct and liner

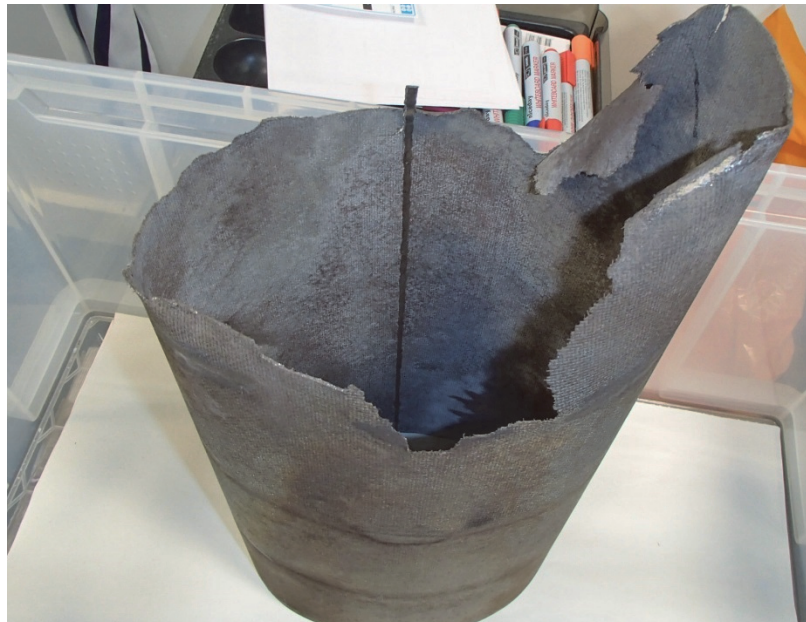
Figure 3

It was apparent that the front half of the liner had partially disintegrated and that the item discovered on the ground at Birmingham was a circumferential section from the front end, having separated both at the junction with the bolted ring and several inches aft. The portion of the liner that remained within the duct was removed, possibly causing some additional distortion (Figure 3).

Recovered part of the exhaust duct liner
