ACCIDENT

Aircraft Type and Registration:	Flight Design CTSW, G-CGVG	
No & Type of Engines:	1 Rotax 912ULS piston engine	
Year of Manufacture:	2011 (Serial no: 8575)	
Date & Time (UTC):	8 October 2016 at 1638 hrs	
Location:	Hunsdon Airfield, Hertfordshire	
Type of Flight:	Private	
Persons on Board:	Crew - 1	Passengers - 1
Injuries:	Crew - None	Passengers - None
Nature of Damage:	Damage to left wingtip, left landing gear leg and surrounding structure	
Commander's Licence:	National Private Pilot's Licence	
Commander's Age:	62 years	
Commander's Flying Experience:	1,534 hours (of which 867 were on type) Last 90 days - 38 hours Last 28 days - 19 hours	
Information Source:	Aircraft Accident Report Form submitted by the pilot

Synopsis

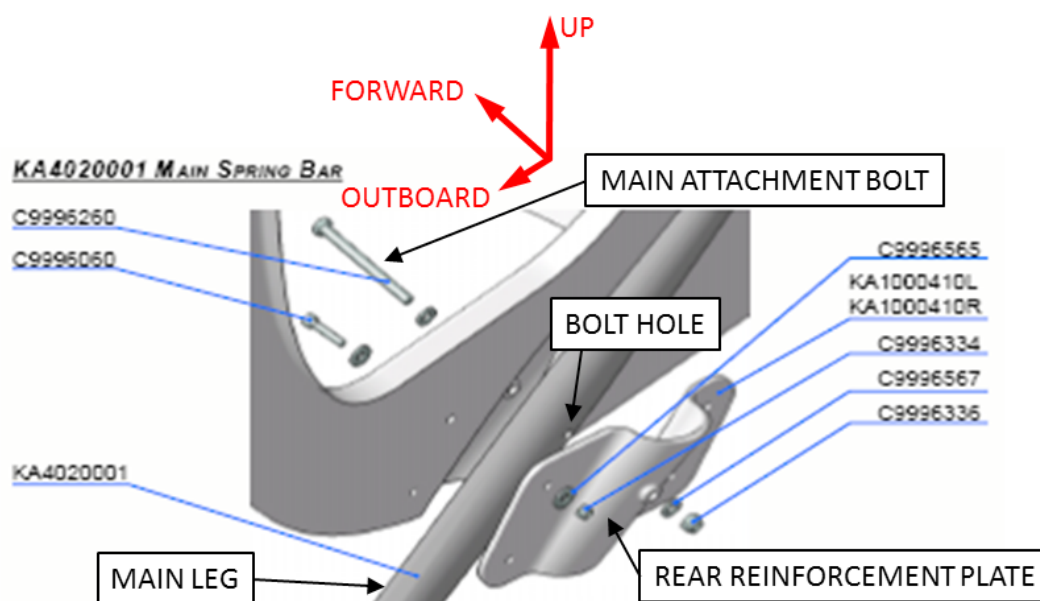
Figure 1

by an M8 steel main attachment bolt. The main attachment bolt passes through a fuselage frame, a hole drilled through the leg and a glassfibre rear reinforcement plate, which covers the leg in this area (Figure 1).

CTSW left main landing gear leg and support structure

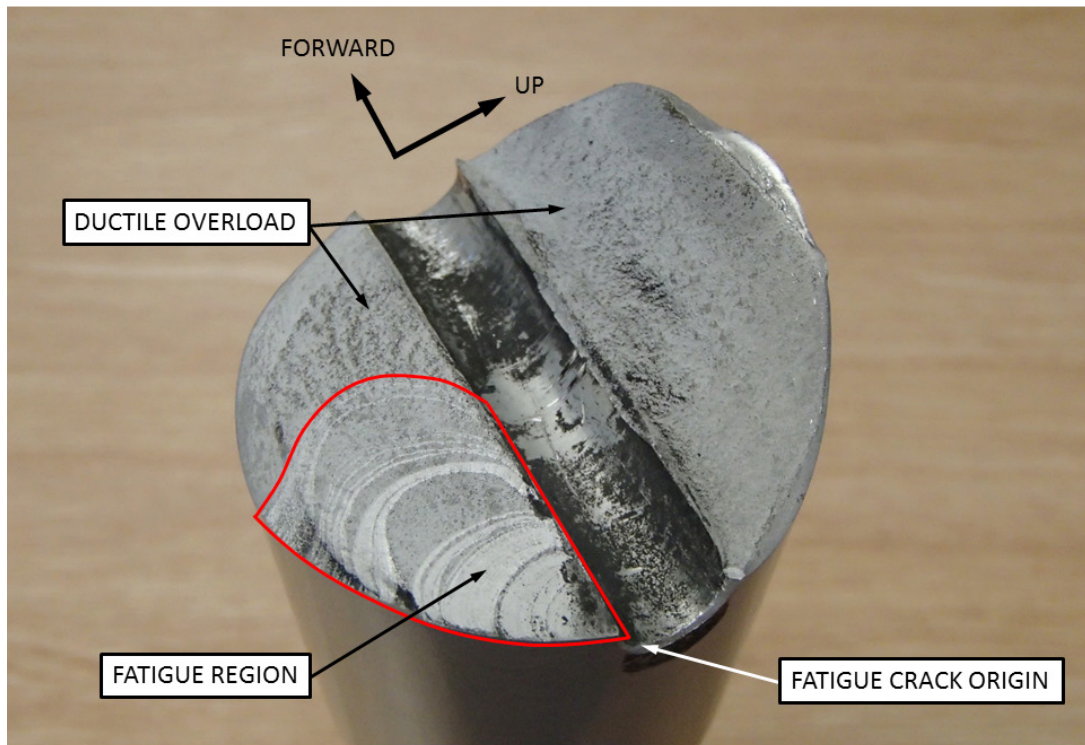
Figure 2

The landing gear leg had failed due to a fatigue crack propagating from the aft lower edge of the main attachment bolt hole (Figure 2). The crack had propagated through approximately 60% of the thickness of the lower section of the leg, before the leg subsequently failed in ductile overload.

Fracture surface of upper part of the left main landing gear leg

The left main landing gear leg collapsed due to propagation of a fatigue crack originating at the aft edge of the main attachment bolt hole. It was unclear for how long the leg had been cracked, and no heavy landings had been reported that would have triggered removal of the leg for dye penetrant inspection as per SB CT123. As the aircraft was manufactured in 2011, it was not subject to the main landing gear leg dye penetrant inspection at 300 flying hours as required by SB CT123. It is not known whether the leg was dye penetrant inspected in situ at 300 flying hours, as required by the CTSW Operator's Manual, as the relevant aircraft records had been lost.

In response to this accident the UK agent intends to issue Service Bulletin CT145, which requires removal and dye penetrant crack inspection of the main landing gear legs of all CT2K and CTSW aircraft at intervals of 300 flying hours. Service Bulletin CT145 will supersede SB CT123. Service Bulletin CT145 will also introduce modification M309, in which the edges of the main attachment hole in the legs are peened, leaving residual compression stress at the hole edges intended to suppress fatigue crack initiation. Service Bulletin CT145 continues to include the requirement to inspect the legs for cracks and straightness following heavy landing events.
