Rail Accident Report

**Near miss between a train and a track worker at
Shawford
24 June 2016**

Report 05/2017
March 2017

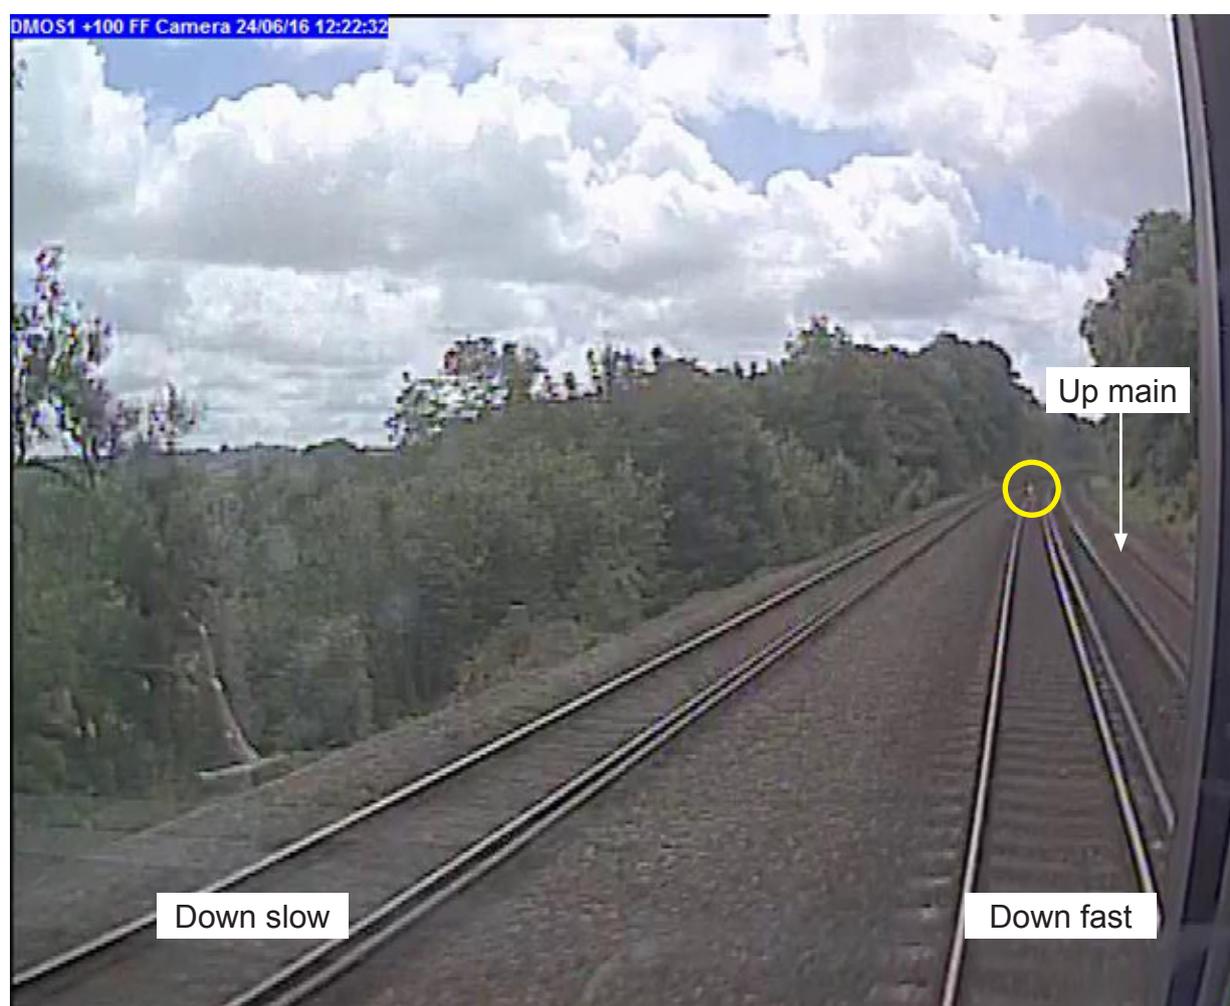
33 The forward facing CCTV footage recorded by train 1T29 shows that the track worker was standing in the down fast line as the train approached (figure 7). The track worker was stationary and was not looking up for approaching trains. This was because he was distracted by looking at the handheld GPS unit instead. The CCTV footage also shows the track worker did not respond at all when the train first sounded its horn. Witness evidence suggests that it would have been audible to him.

Figure 7: Forward facing CCTV image when train 1T29 was two seconds away from the track worker (courtesy of South West Trains)

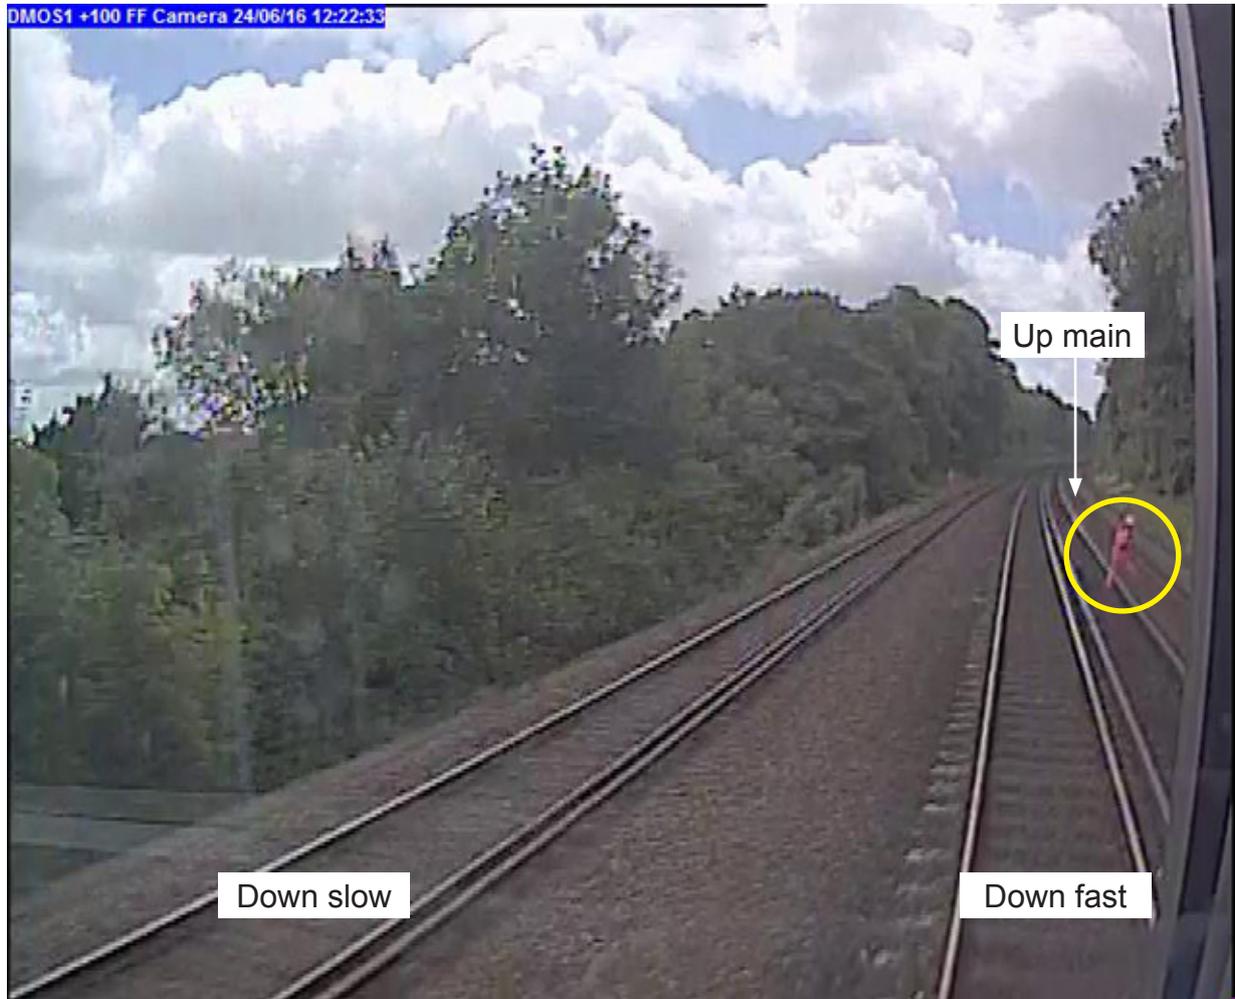
- 34 The footage shows the track worker moved clear of train 1T29 one second before the train arrived at his position, or about 35 metres in terms of distance (figure 8). When the track worker moved, he went towards the up cess. This meant he stepped over the live conductor rail for the down fast line, over a second live conductor rail into the up main line and then moved into the up cess. The up main line that he crossed was open to traffic; however, the nearest train on this line was a freight train that was about four minutes running time away.

Figure 8: Forward facing CCTV image when train 1T29 was one second away from the track worker (courtesy of South West Trains)
