# Rail Accident Report

## Fatal accident near David Lane tram stop 15 August 2016

Report 06/2017  
April 2017

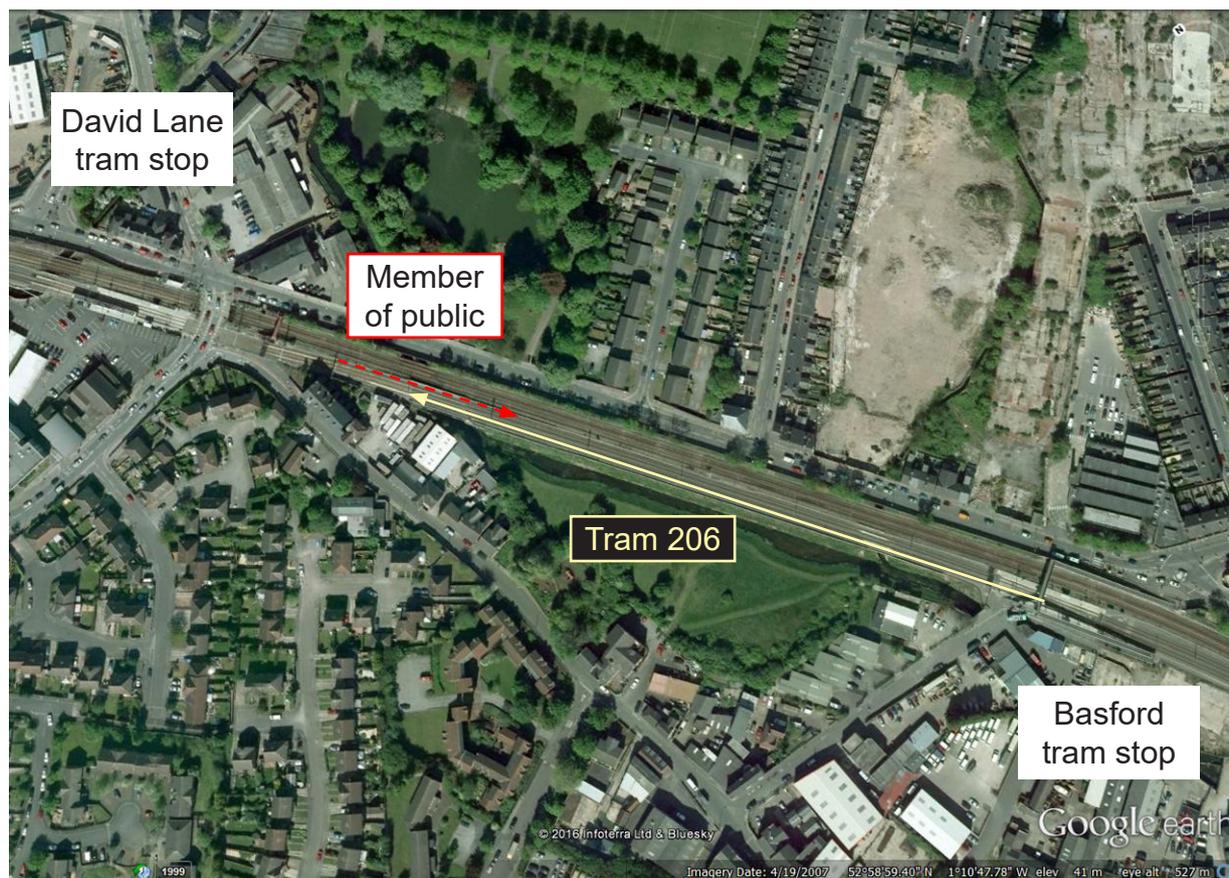
Figure 7: Passage of tram 206 at 22:48 hrs

- 19 The next tram through the area between the tram stops was tram 206 heading northbound from Basford to David Lane tram stop (figure 7). Soon after departing from Basford tram stop, the driver identified that there was a person on the adjacent line ahead of his tram. He proceeded cautiously at a reduced speed and passed the member of the public. At 22:48:18 hrs, the driver of tram 206 called the control room<sup>3</sup> and spoke to SDS3 to report encountering a person walking southbound on the southbound track a 'couple of hundred metres' from David Lane tram stop.

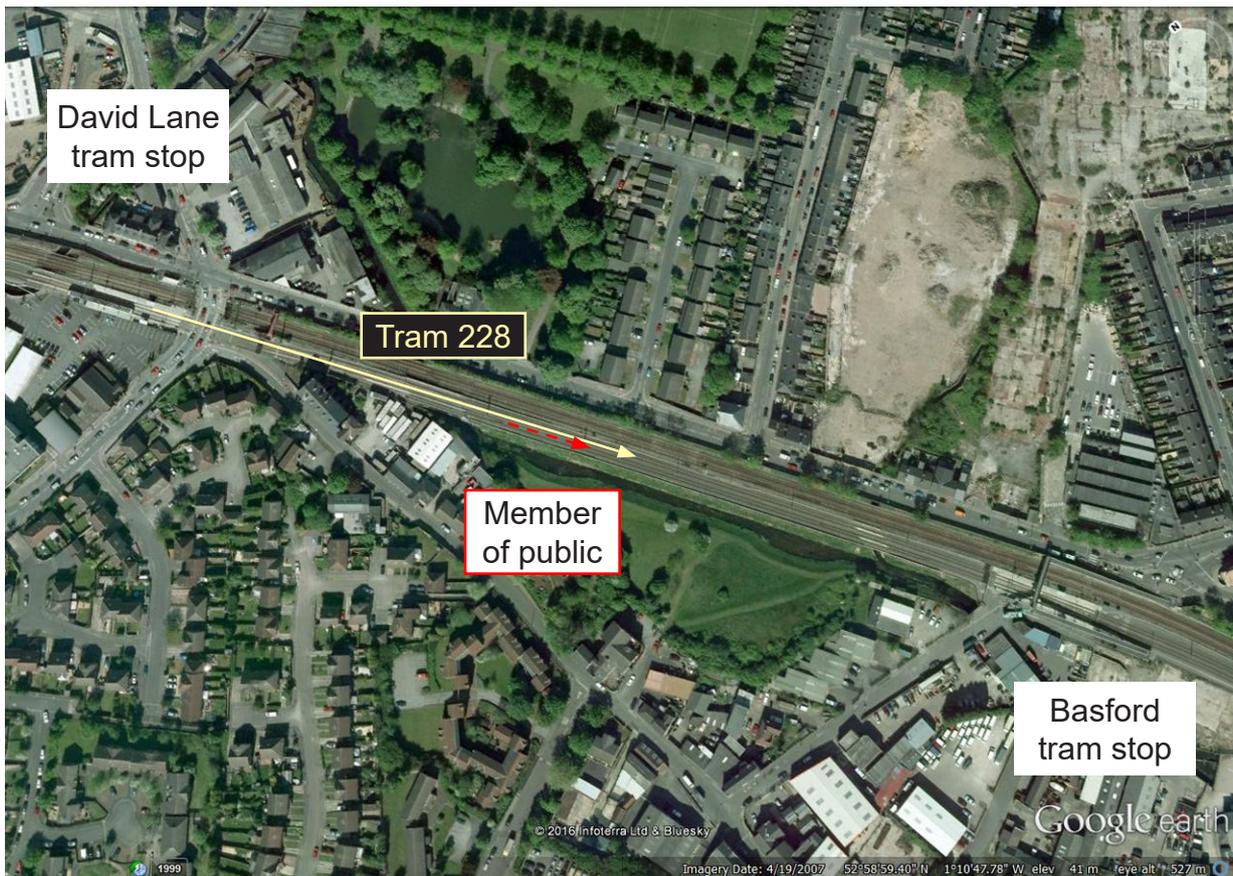
Figure 8: Passage of tram 228 between 22:49 hrs and 22:51 hrs

- 20 At 22:48:45 hrs and while the conversation between the driver of tram 206 and SDS3 was still taking place, SDS2 placed a call to the next tram through the area, which was tram 228 (heading southbound). Having overheard the report from the driver of tram 206, SDS2 instructed the driver of tram 228 to exercise caution through the area between David Lane and Basford tram stops. Tram 228 was on its approach to David Lane tram stop at the time of the call.
- 21 At 22:49:34 hrs, tram 228 stopped at David Lane tram stop (figure 8). At 22:49:49 hrs, tram 228 departed from David Lane tram stop at low speed. The CCTV footage from that tram shows that the member of the public was still walking southbound but that he was now in the area between the two tramway lines (an area known as the *six-foot*). Tram 228 approached the member of the public from behind at walking pace.

- 22 At 22:50:51 hrs, the member of the public reached one of the overhead power line stanchions located in the six-foot and held onto it. As he was now standing still, the driver of tram 228 decided that it was safe to pass, still driving at walking pace. Tram 228 is fitted with rearward facing cameras which look along the sides of the tram (they are used by drivers at the tram stops to confirm that it is safe to close the doors). The footage from one of these cameras shows that the member of the public left the stanchion shortly after the front of tram 228 passed him and started walking alongside tram 228. At 22:51:18 hrs, the rear of tram 228 passed the member of the public who then disappeared from the footage into darkness.

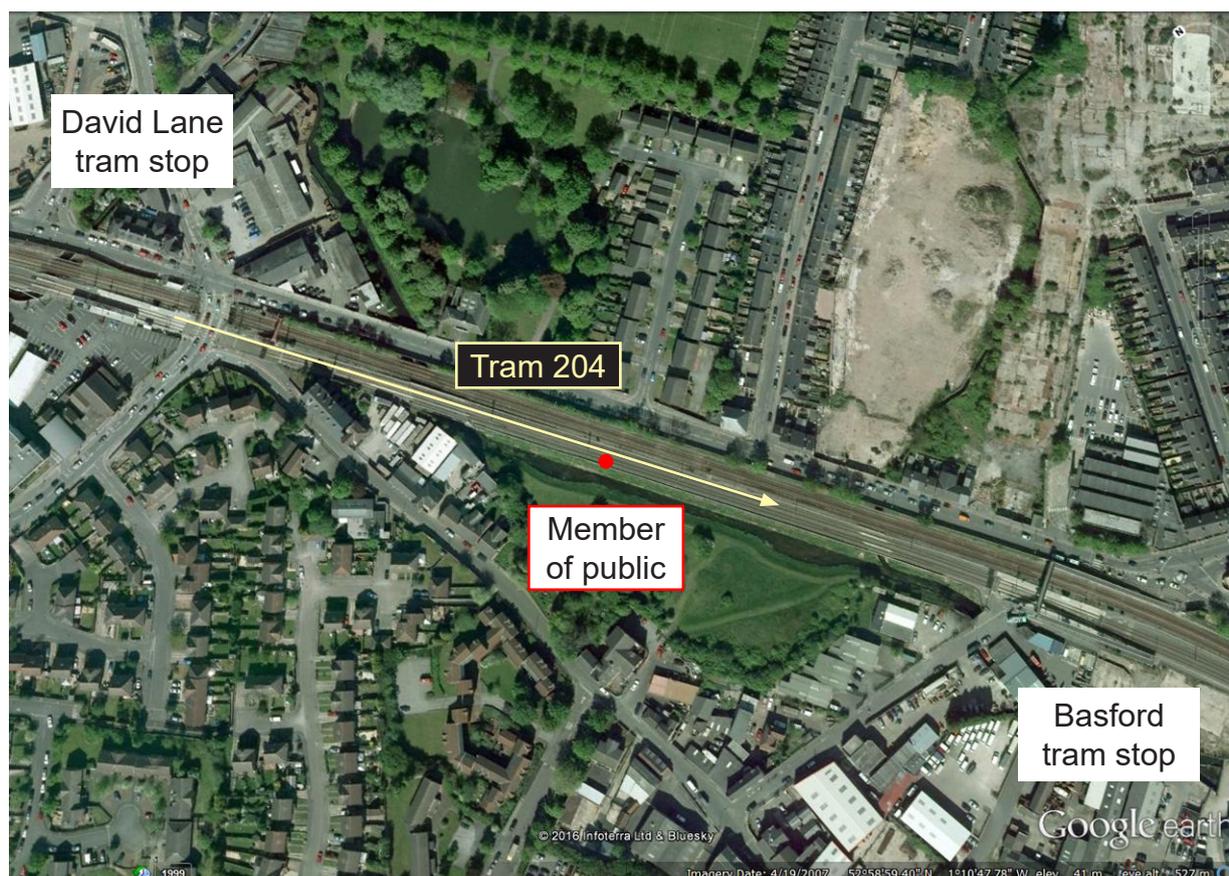
Figure 9: Passage of tram 204 at 22:56 hrs

- 28 At 22:56:09 hrs, tram 204 left David Lane tram stop heading towards Basford at normal speed (figure 9). Tram 204 reached Basford tram stop at 22:57:00 hrs, just as tram 225 was about to depart. As instructed, the driver of tram 204 placed a call with the control room at 22:57:10 hrs during which he was asked by SDS3 to exercise caution between Basford and Wilkinson Street.

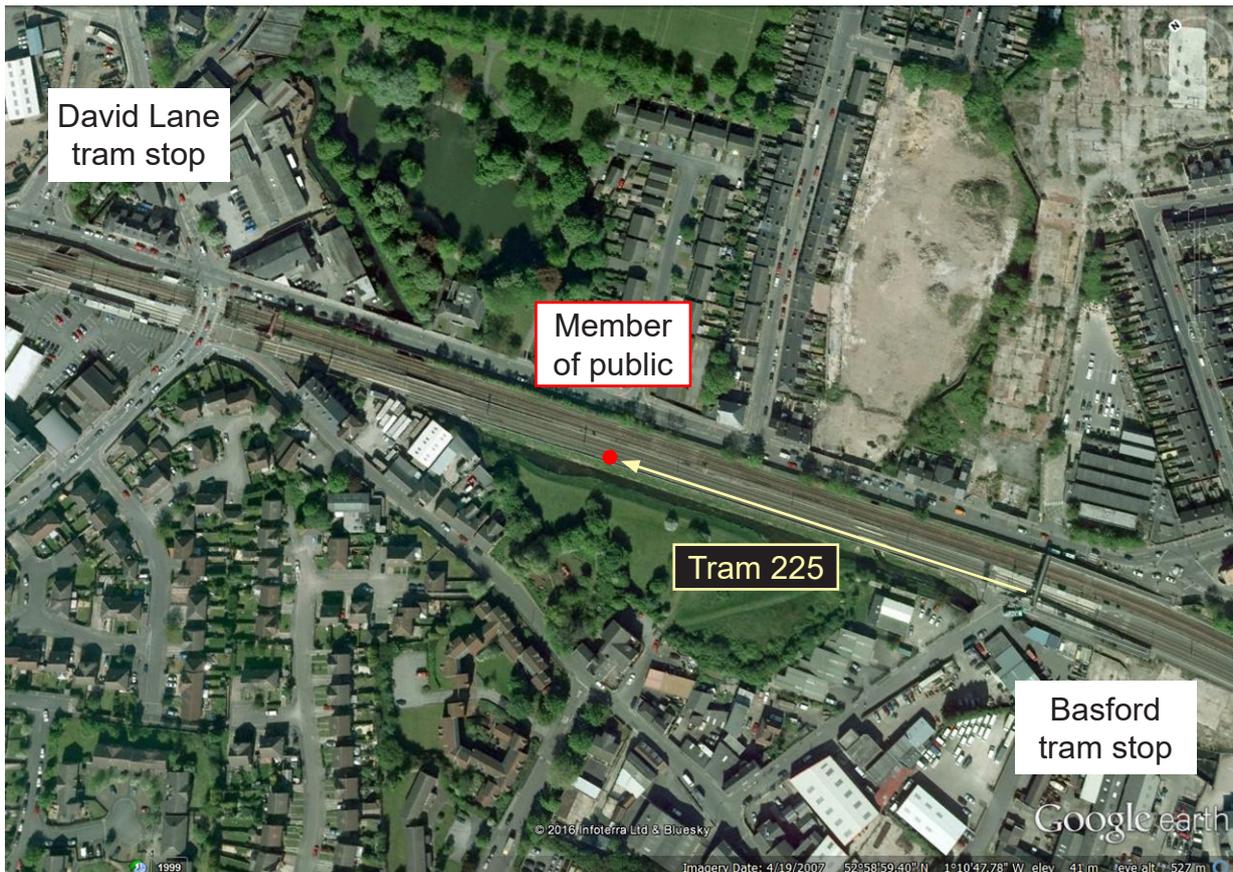
Figure 10: Passage of tram 225 at 22:57 hrs

- 29 At 22:57:02 hrs, tram 225 left Basford tram stop (figure 10). The tram accelerated and reached a speed of approximately 50 km/h about 130 metres away from Basford tram stop at which point the driver stopped accelerating.
- 30 Approximately 180 metres from Basford tram stop, the on-tram data recorder (OTDR) shows that the driver started to apply the service brake. This was in response to the driver detecting that there was something in between the rails on the track used by his tram (an area known as the *four-foot*). The driver was unaware that this was the member of the public who was now lying in the four-foot of the northbound track close to the position where he was last seen on the footage from tram 228.

- 31 At 22:57:25 hrs, one second after applying the service brake, tram 225 struck the member of the public at a speed of 48 km/h. One second later, the OTDR shows that the driver applied the emergency brake and the tram came to a stop 42 metres from the point of collision.
