Rail Accident Investigation Branch

# Rail Accident Report

**Collision between a train and tractor at  
Hockham Road user worked crossing, near  
Thetford  
10 April 2016**

Report 04/2017  
March 2017

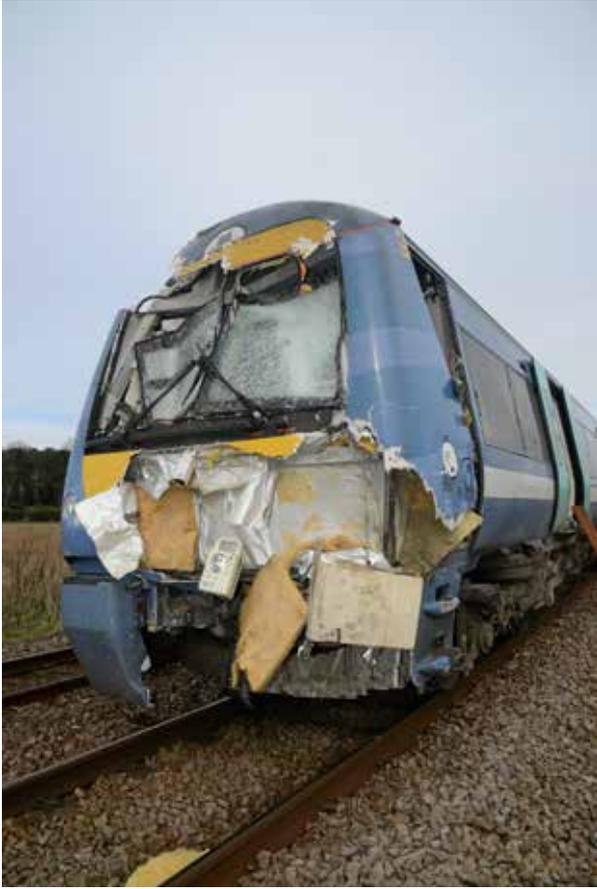
- 32 The train did not derail, but sustained substantial damage to the driving cab. It travelled 410 metres beyond the crossing before stopping (figures 10 to 14). The tractor and animal feeder trailer separated, causing the feed trailer discharge auger (a feeder pipe for discharging foodstuffs or grain) to spin around and strike the side of the train several times, breaking windows and puncturing the outer body side skin. The main part of the trailer came to rest next to the tractor unit in the up side cess, clear of the running lines (figures 16 and 17).

Figure 10: External damage to front of train 1K77

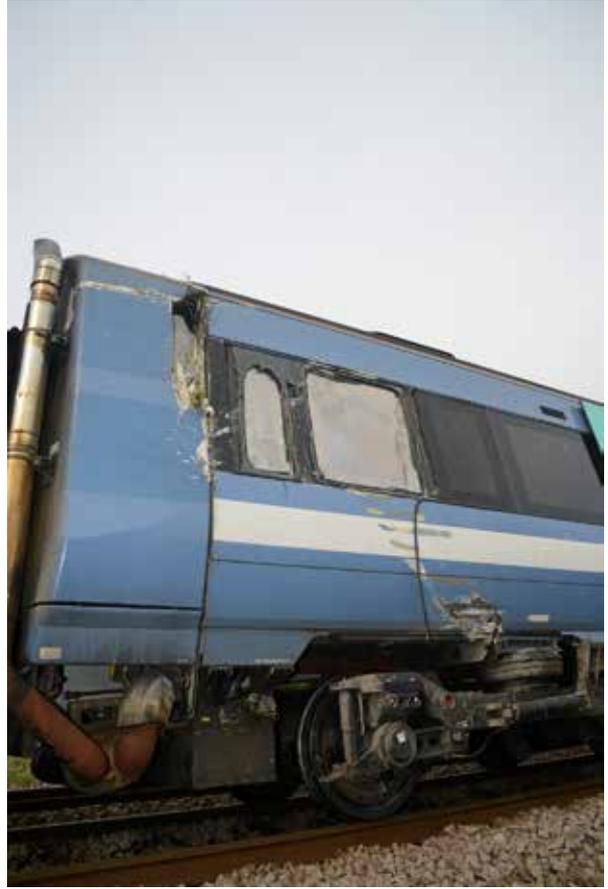
Figure 11: External damage to side of train 1K77

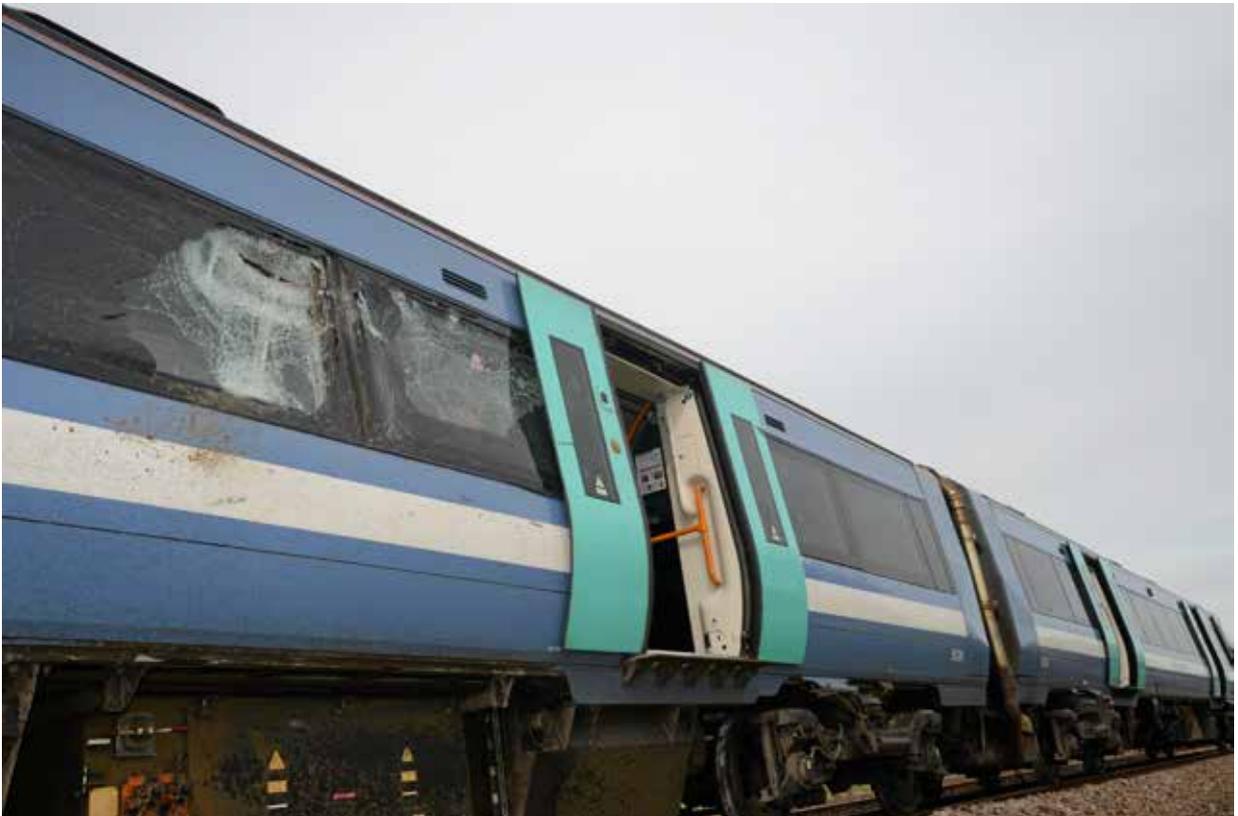
Figure 12: External damage to side of train 1K77

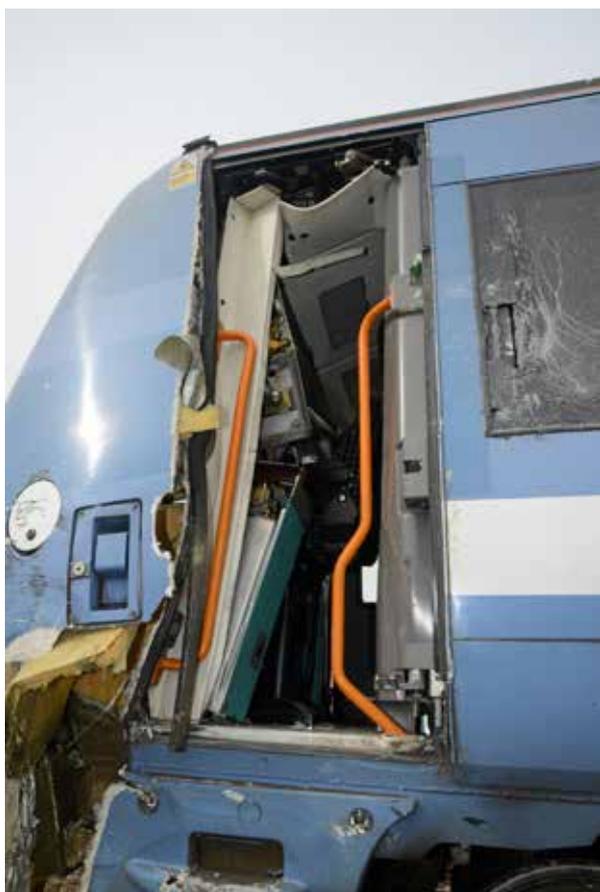
Figure 13: External damage to side of train 1K77

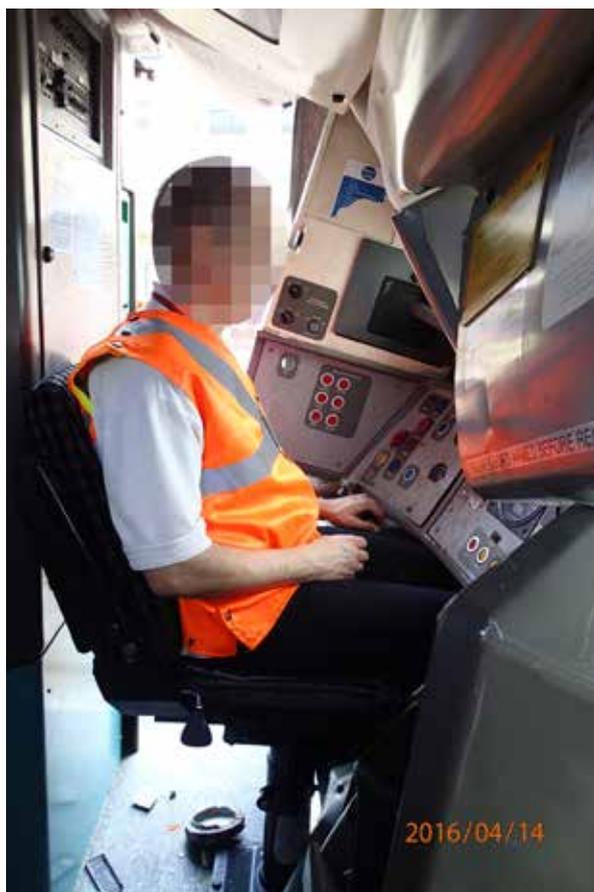
Figure 14: Internal view of cab distortion of train 1K77

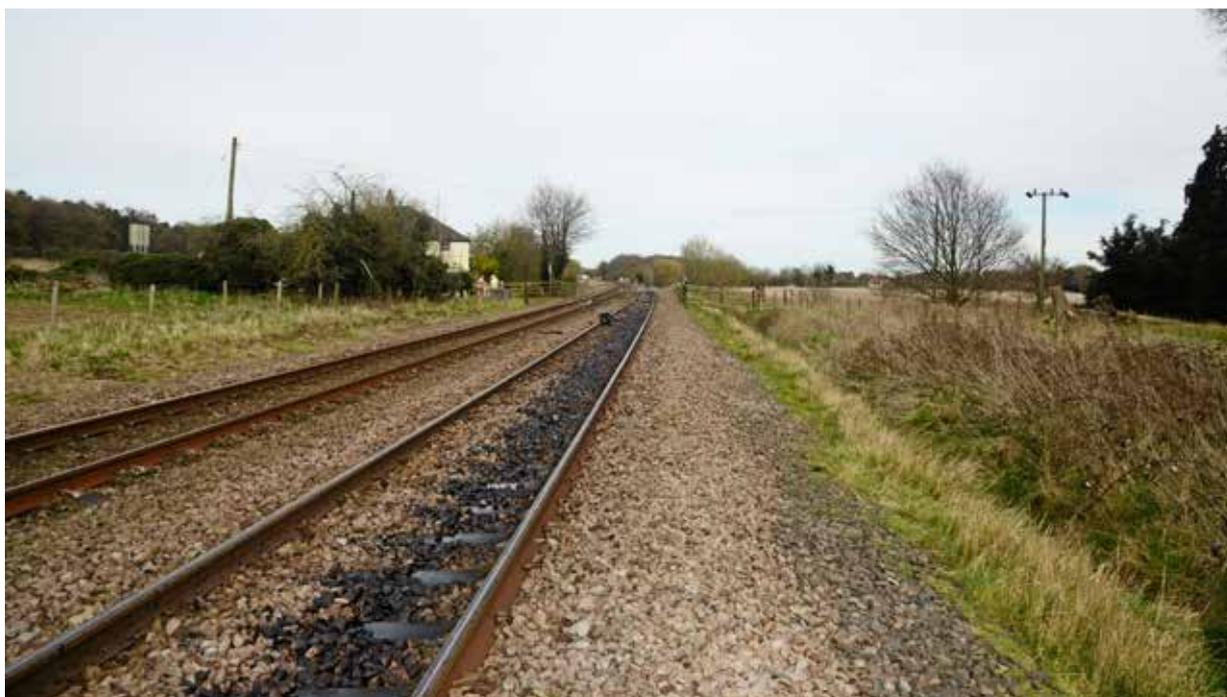
33 The tractor's offside wheel and hub assembly broke away from the tractor, and was dragged along the underside of the train, causing a large quantity of diesel fuel, 75 litres of engine oil, and 60 litres of hydrostatic fluid to escape (figure 15).

Figure 15: View from the rear of train 1K77 looking towards Hockham Road UWC

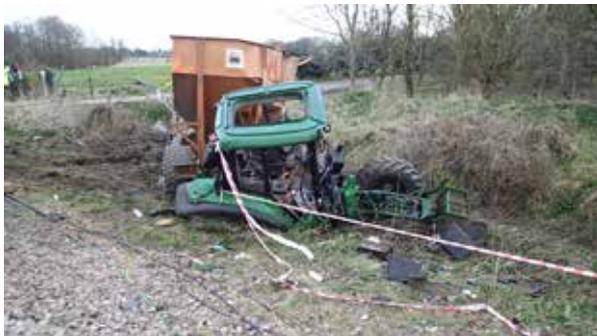
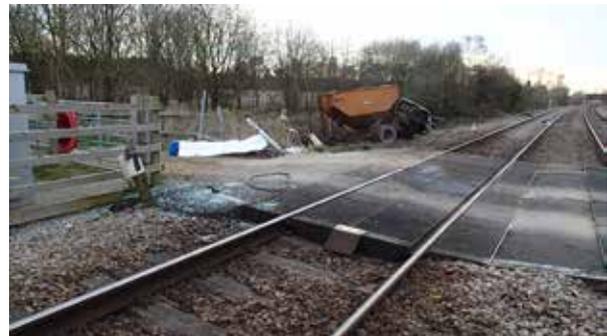
Figures 16 and 17: Remains of tractor and trailer in the up cess after the accident

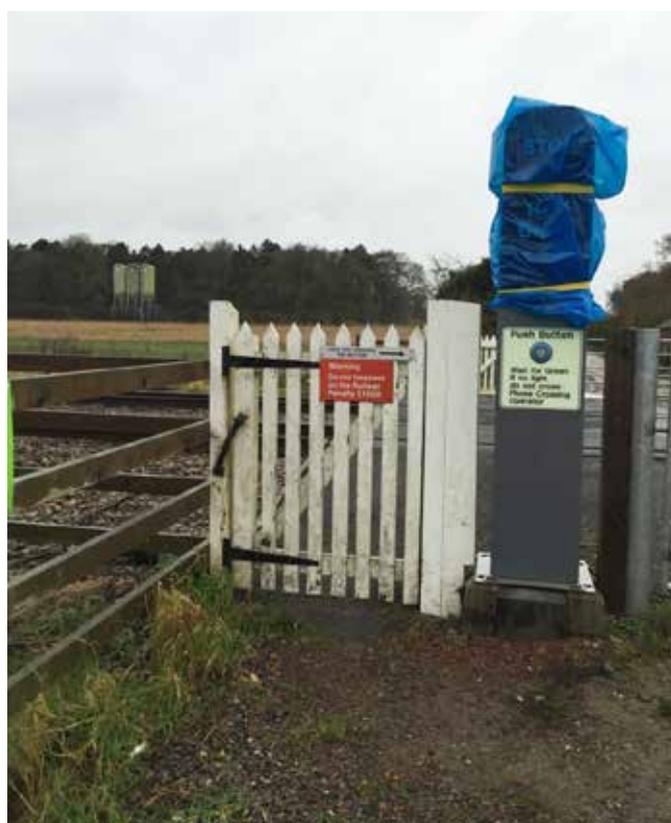
Figure 19: Decommissioned EBI Gate system – image taken on 08/12/2015 (Courtesy of Network Rail)

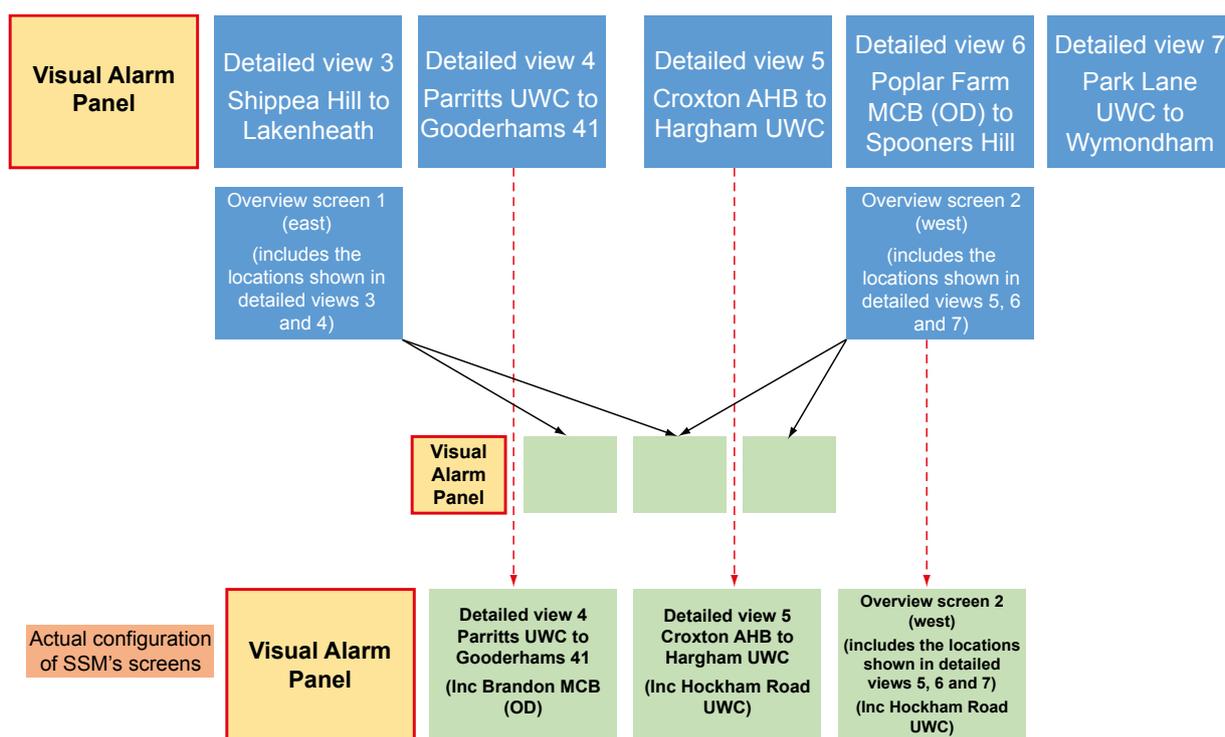
Figure 21: Diagram showing the possible configurations (overview and detailed screen) available to the signaller (in blue) and the actual screen views (in green) visible on the Thetford workstation at the time of the accident

- 126 The Thetford workstation had only three screens, rather than four as originally designed (paragraphs 111 to 116, **Recommendation 2**, see paragraph 135(c)).
- 127 The information displayed to a signaller is not designed to help them judge when it is safe to allow a user to cross at a UWC (paragraph 117, **Recommendation 1**).

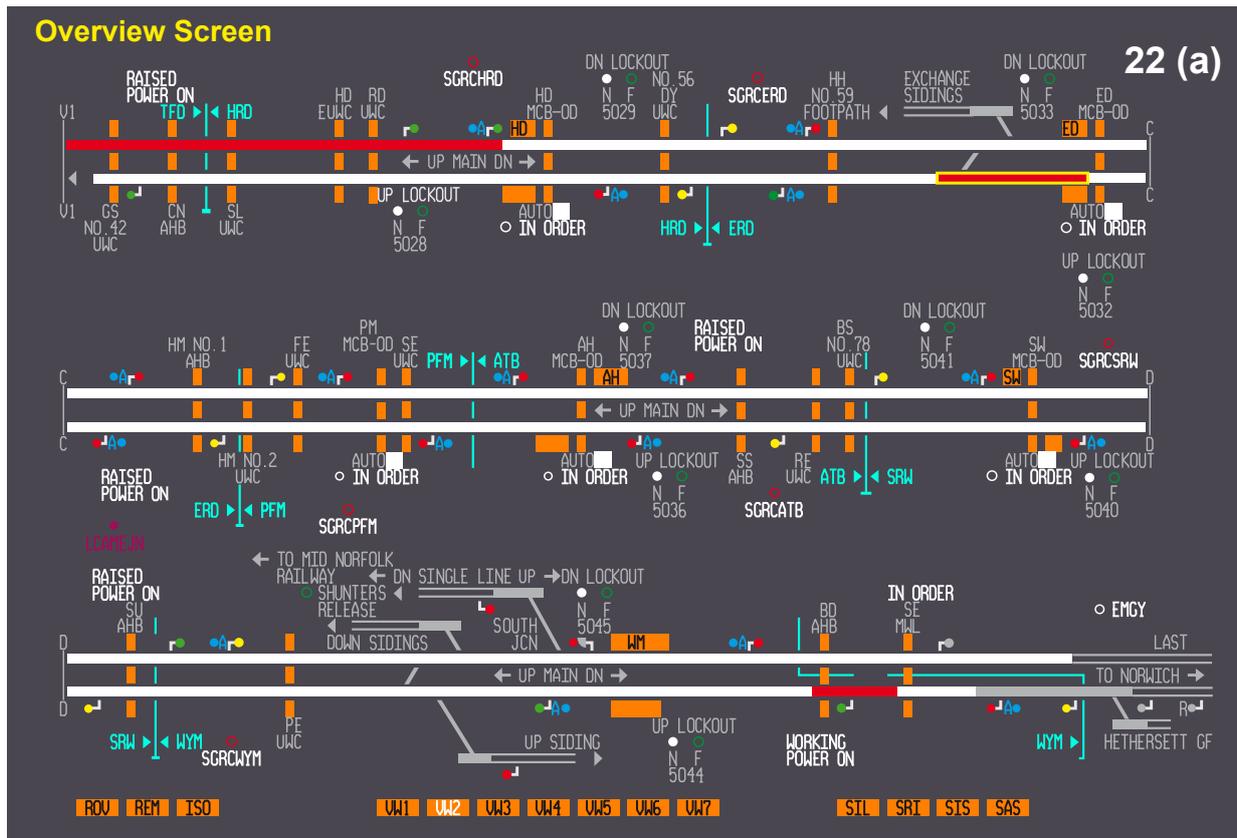
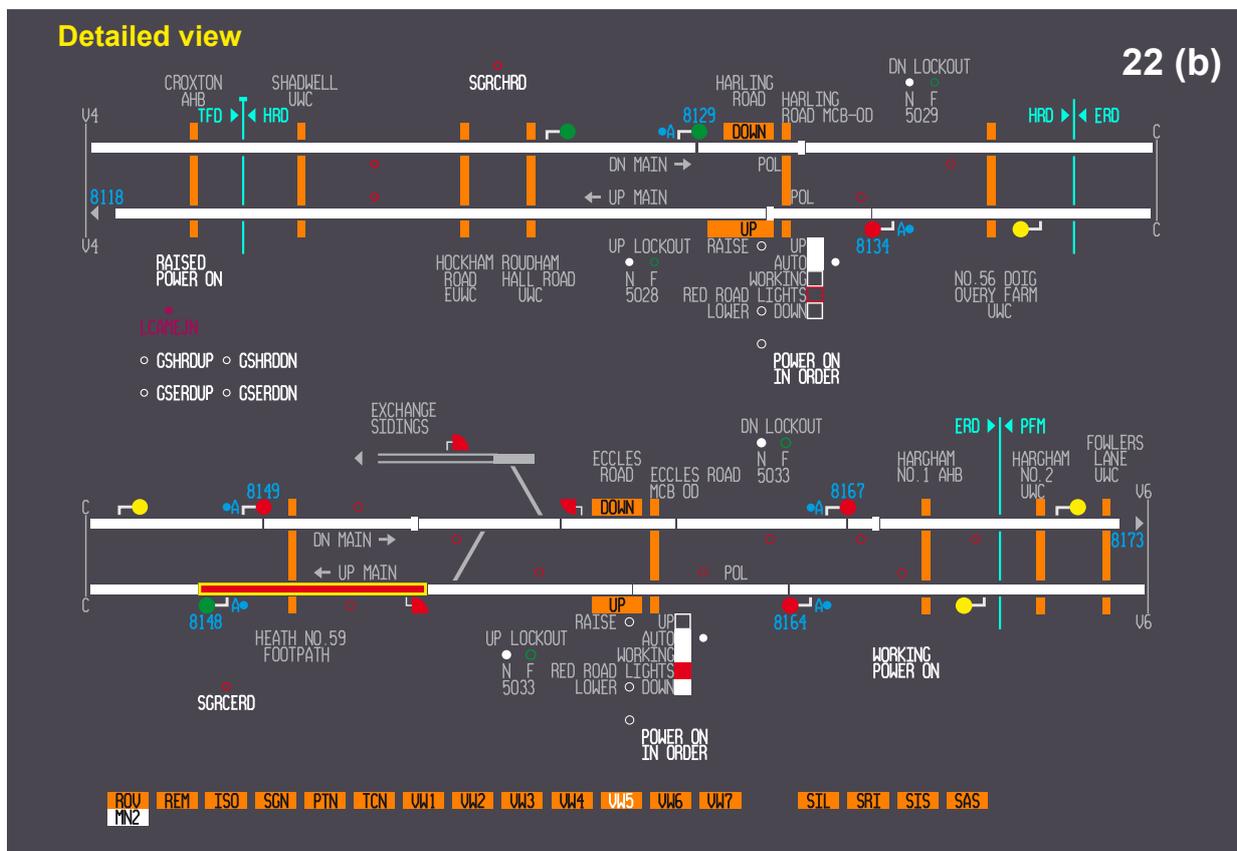
Figures 22 (a) and (b): overview and detailed views with train 1K77 travelling past Eccles Road MCB (OD) crossing at 12:24:46 hrs. Note: train 1K77 was shown as plain red on the VDU display. Highlight (yellow border) added by RAIB.

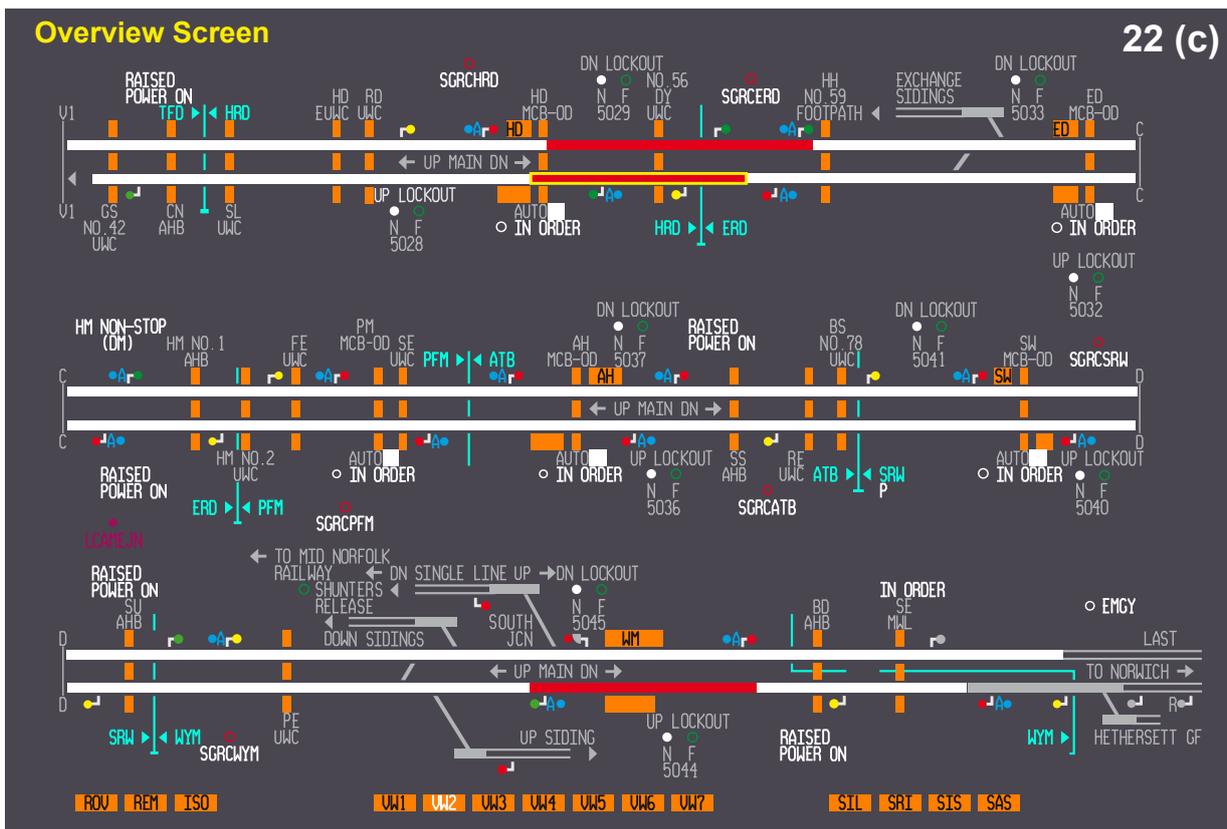
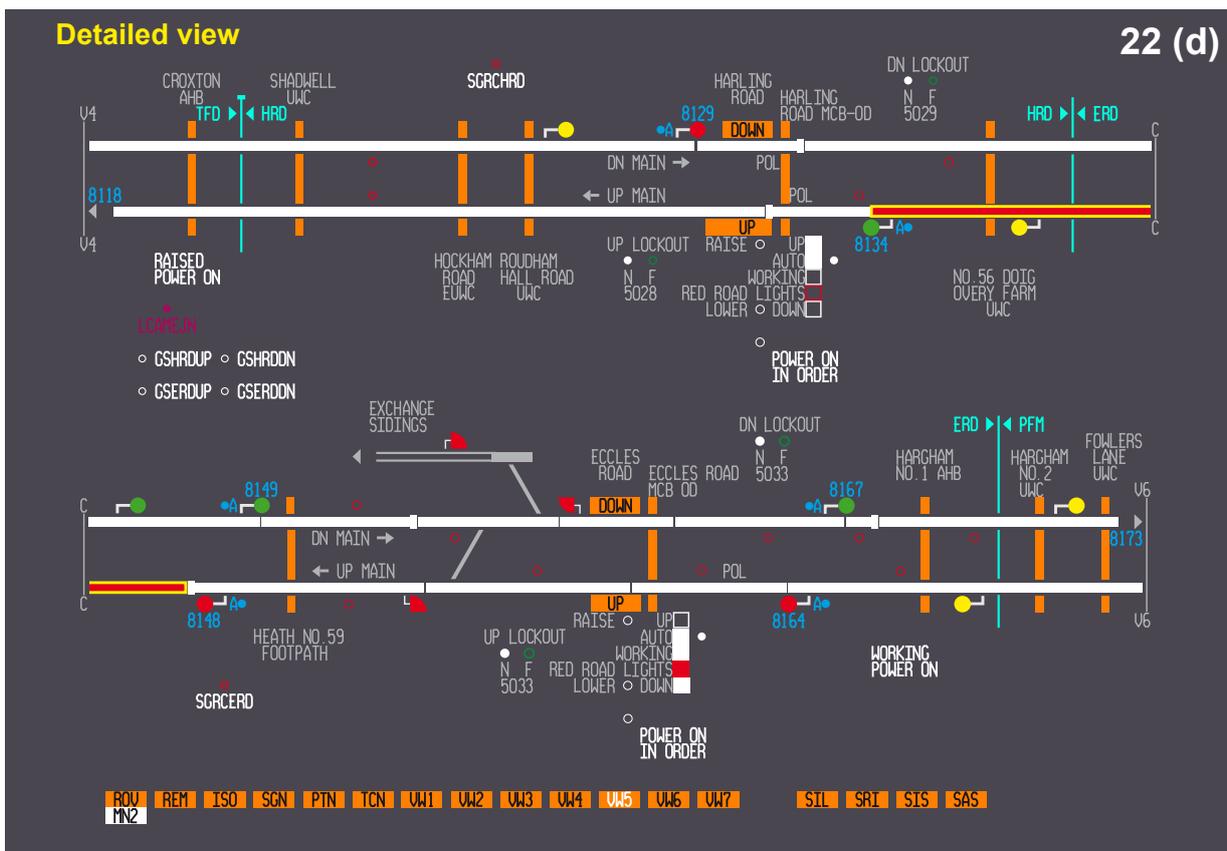
Figures 22 (c) and (d): overview and detailed views with train 1K77 travelling towards Harling Road MCB (OD) between 12:27:07 and 12:28:50 hrs. The signaller received the call from the user at Hockham Road UWC at 12:28:33 hrs. Note: train 1K77 was shown as plain red on the VDU display. Highlight (yellow border) added by RAIB.

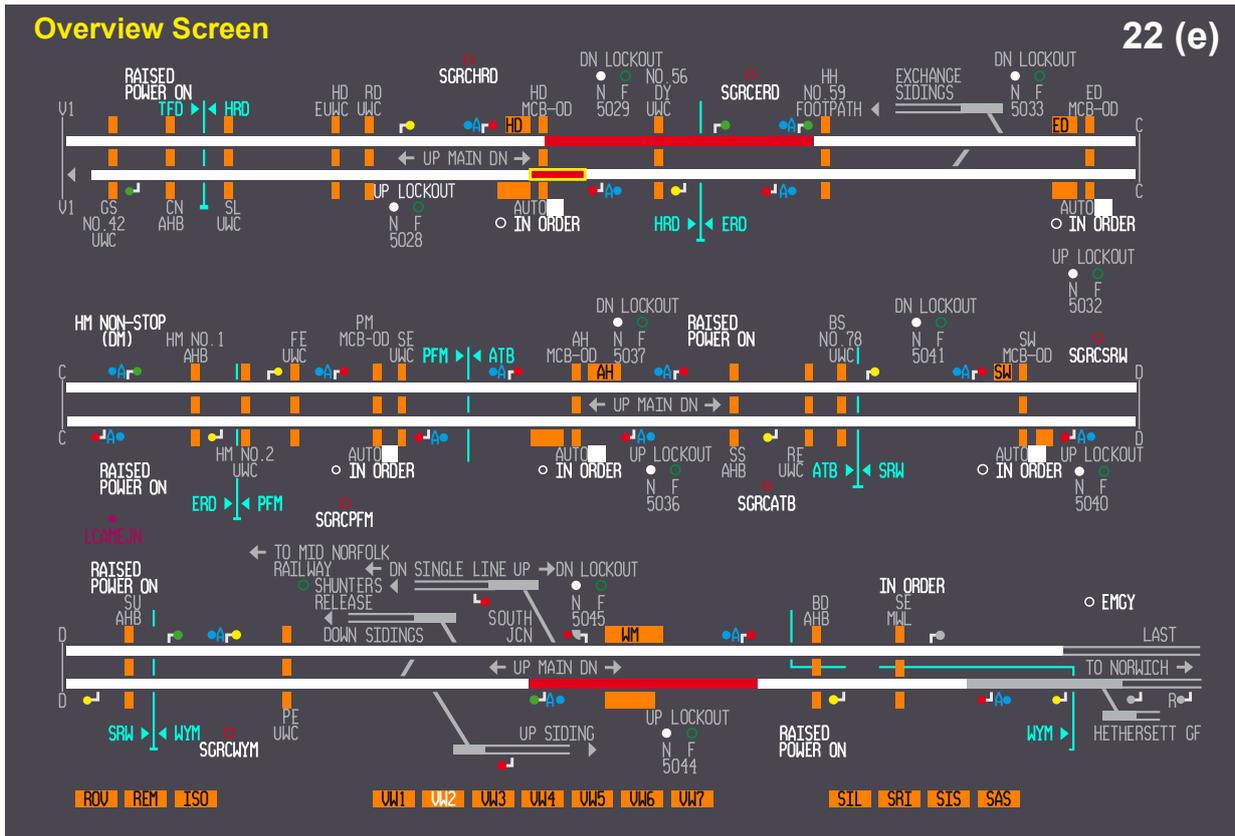
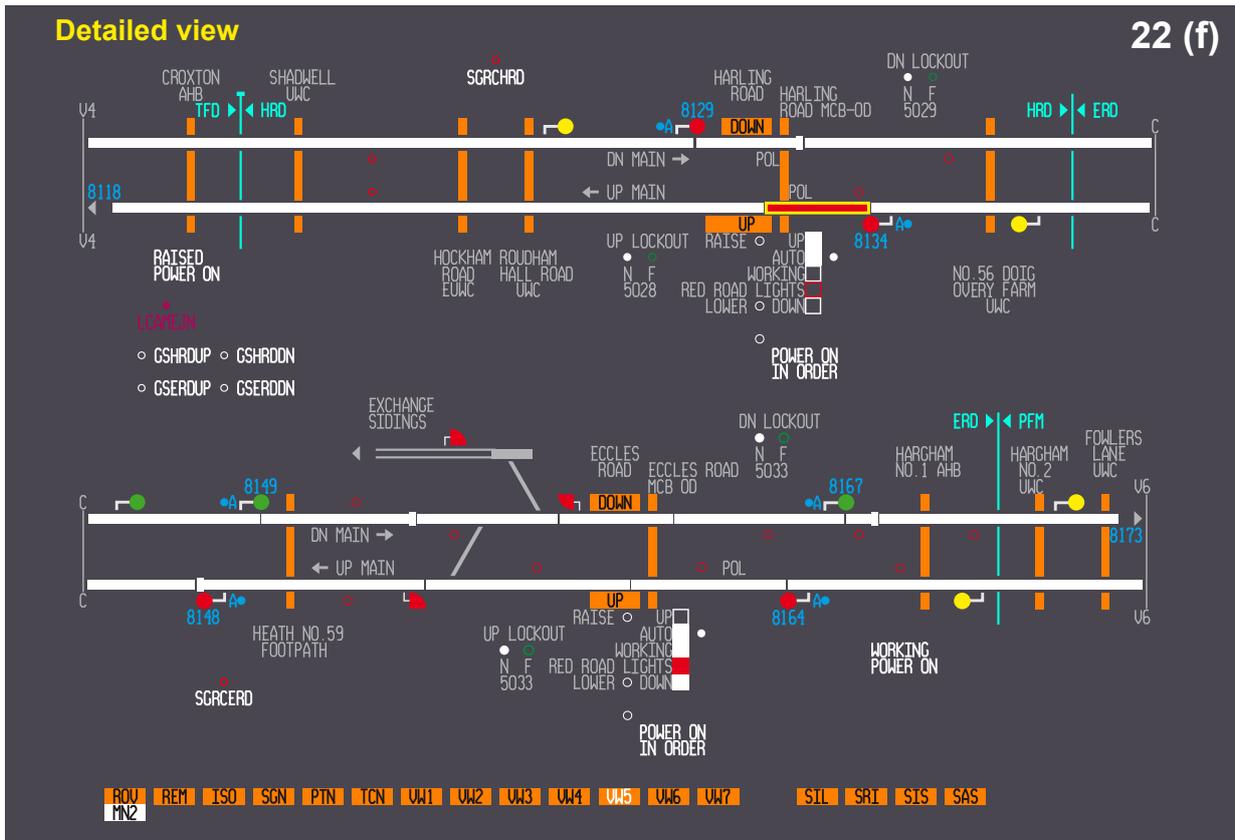
Figures 22 (e) and (f): overview and detailed views of train 1K77 travelling past Harling Road MCB (OD) between 12:28:50 and 12:28:59 hrs. The signaller terminated the call from the user at Hockham Road UWC at 12:29:00 hrs. Note: train 1K77 was shown as plain red on the VDU display. Highlight (yellow border) added by RAIB.

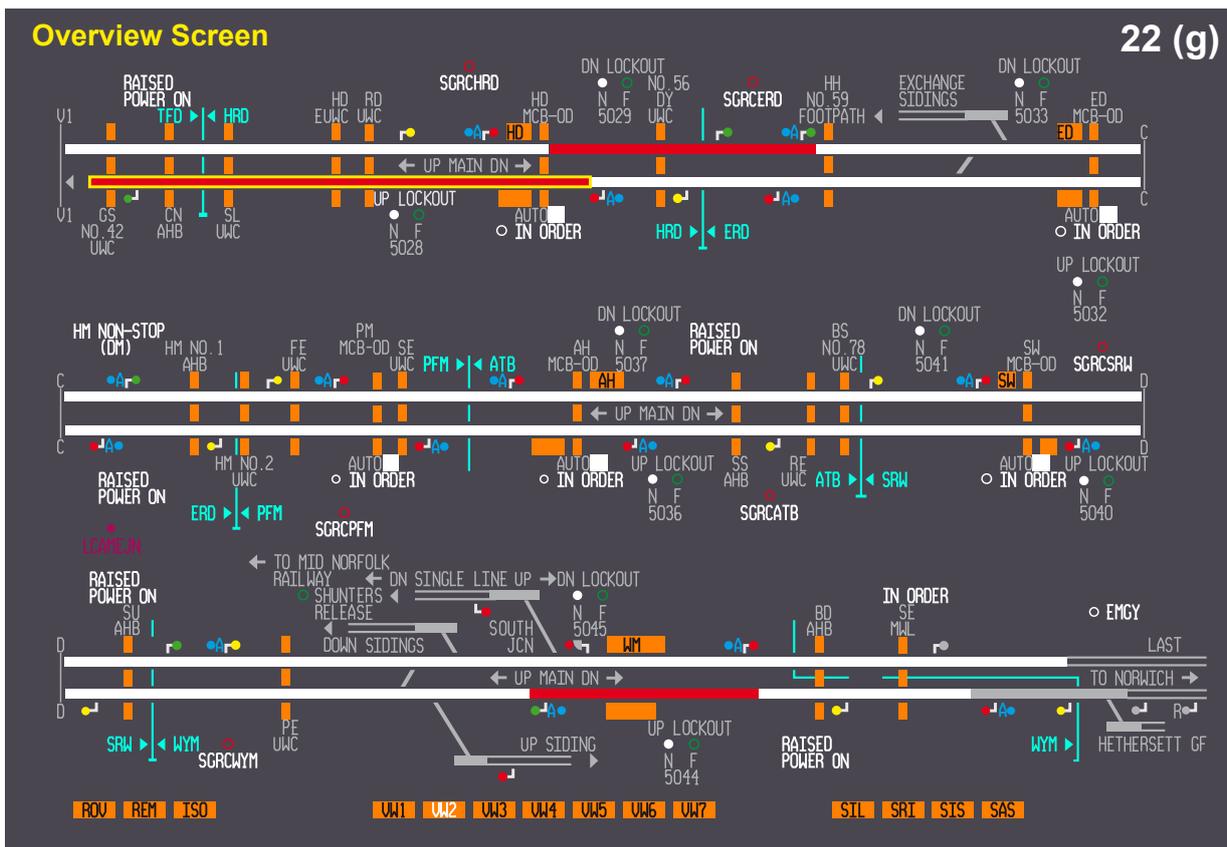
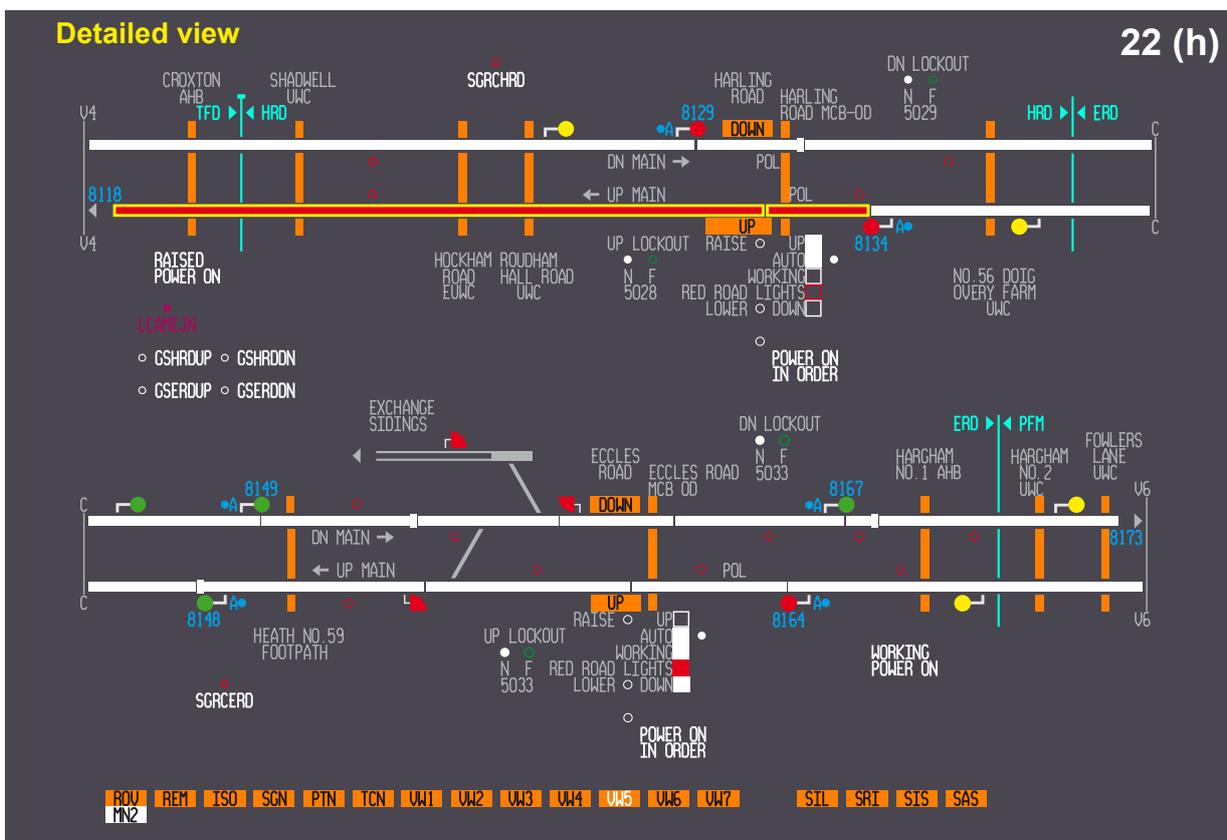
Figures 22 (g) and (h): overview and detailed views of train travelling towards Hockham Road UWC between 12:28:59 and 12:30:26 hrs (12:30:04 hrs probable time of collision). Note: train 1K77 was shown as plain red on the VDU display. Highlight (yellow border) added by RAIB.
