## ACCIDENT

<b>Aircraft Type and Registration:</b>	Socata TB20 Trinidad GT, G-SCIP	
<b>No &amp; Type of Engines:</b>	1 Lycoming IO-540-C4D5D piston engine	
<b>Year of Manufacture:</b>	2000 (Serial no: 2014)	
<b>Date &amp; Time (UTC):</b>	19 July 2016 at 1535 hrs	
<b>Location:</b>	Sleap Airfield, Shropshire	
<b>Type of Flight:</b>	Private	
<b>Persons on Board:</b>	Crew - 1	Passengers - None
<b>Injuries:</b>	Crew - None	Passengers - N/A
<b>Nature of Damage:</b>	Propeller blades damaged, nose underside abraded and engine presumed shock loaded	
<b>Commander's Licence:</b>	Private Pilot's Licence	
<b>Commander's Age:</b>	61 years	
<b>Commander's Flying Experience:</b>	2,642 hours (of which 1,651 were on type) Last 90 days - 26 hours Last 28 days - 13 hours	
<b>Information Source:</b>	AAIB Field Investigation

### Synopsis

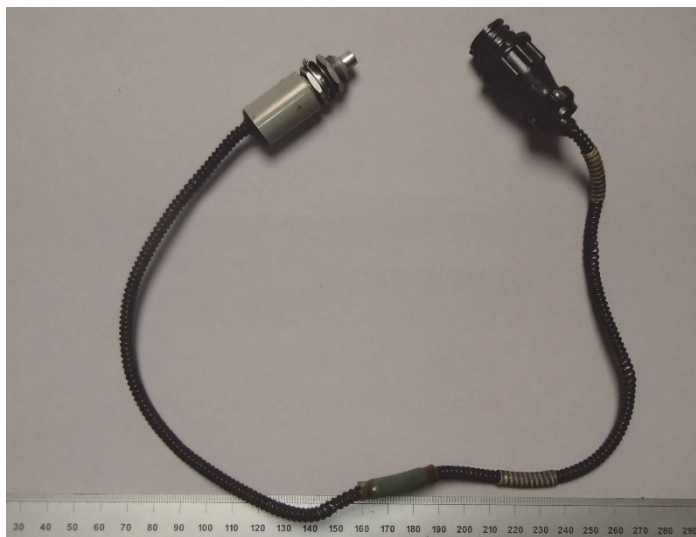
**Figure 1**

Following the second event, the nose gear downlock microswitch, Part Number TB2061032005, was removed from the aircraft and sent to the AAIB. Figure 1 shows the switch after removal.

Downlock microswitch and connector after removal from the aircraft

The component was initially tested by assessing the continuity between the pins on the connecting plug, with and without the switch plunger being pressed. The results were inconsistent and it was decided to send the switch for testing at the aircraft manufacturer's facility in France. This was supervised by the Bureau d'Enquêtes et d'Analyses (BEA), who are the French air safety investigation authority.

The test confirmed the AAIB results and additionally confirmed that the state of the microswitch changed randomly when lightly tapped with a finger. The unit was then X-rayed and subsequently disassembled by the BEA.

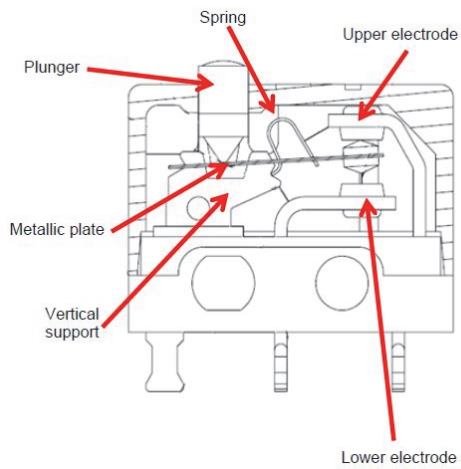
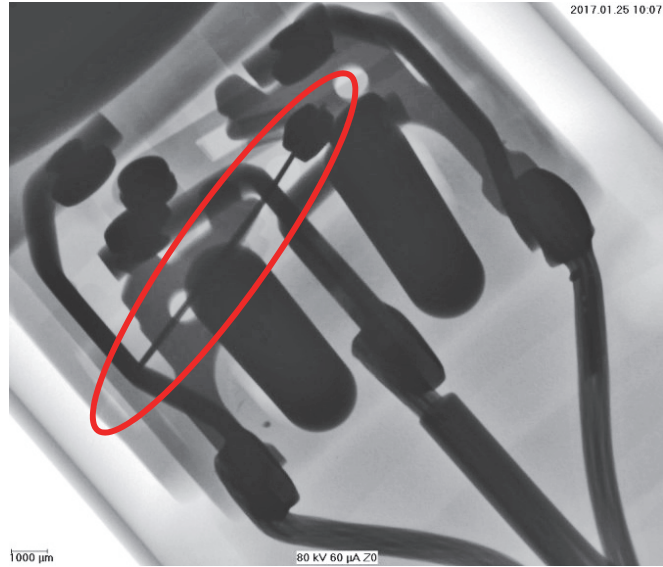
**Figure 2**

The switch assembly comprised a spring-loaded plunger acting on two (for redundancy) integral microswitches. These in turn contained a metal plate with a rounded contact, or electrode, at the end. Figure 2 shows a sketch of the cross section and one of the X-ray images.

It was found that moving or tapping the switch would cause the metal plates to move relative to the surrounding components. Cutting the switch assembly open confirmed that the components of one of the microswitches were loose. In the other, the spring had become jammed under the plate. The aircraft manufacturer stated that they had not received any reports of similar failures and, having checked their stock of switch assemblies, confirmed that all of them functioned correctly. The manufacturer additionally stated that they considered that a possible reason for the internal components being found in this condition was the switch may have been subjected to a severe impact.

Cross section of assembly and (right) a sample X-Ray image.  
The metal plate was loose

The aircraft manufacturer was unaware of any similar occurrences regarding the switch assembly and considered that the extent of disruption of the internal components may have been the result of a severe impact. It is possible that such an impact occurred in the earlier accident, although the switch had operated normally during the 25 flight hours leading up to this accident on 19 July 2016.
