ACCIDENT

Aircraft Type and Registration:	Ikarus C42 FB100, G-CDNR	
No & Type of Engines:	1 Rotax 912 ULS piston engine	
Year of Manufacture:	2005 (Serial no: 0507-6696)	
Date & Time (UTC):	20 March 2016 at 1600 hrs	
Location:	Stoke Airfield, near Burrows Lane, Middle Stoke, Kent	
Type of Flight:	Private	
Persons on Board:	Crew - 1	Passengers - None
Injuries:	Crew - 1 (Fatal)	Passengers - N/A
Nature of Damage:	Aircraft destroyed	
Commander's Licence:	National Private Pilot's Licence (Aeroplanes)	
Commander's Age:	61	
Commander's Flying Experience:	117 hours (of which 17 were on type) Last 90 days - 2.5 hours Last 28 days - 1.5 hours	
Information Source:	AAIB Field Investigation

Synopsis

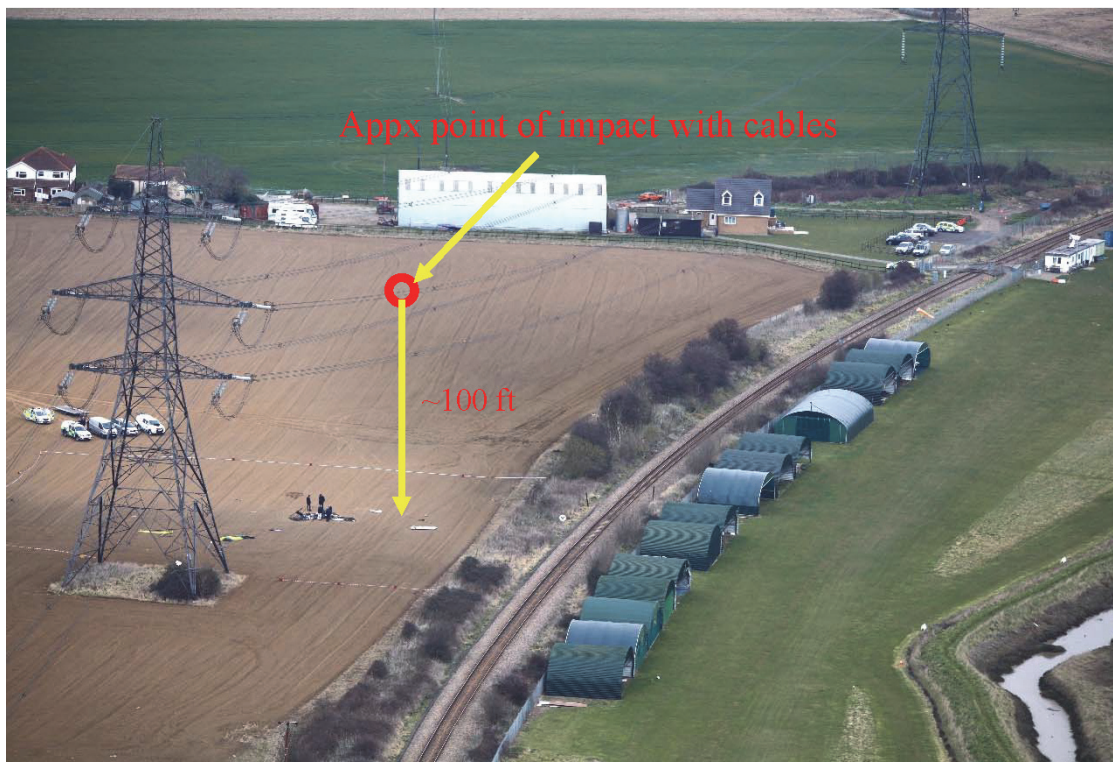
**Figure 1**

The aircraft had come to rest in a field adjacent to the northern edge of the airfield, beneath power cables carried on pylons running in a southwest-northeast direction (Figure 1).

View of accident site, looking along Runway 06

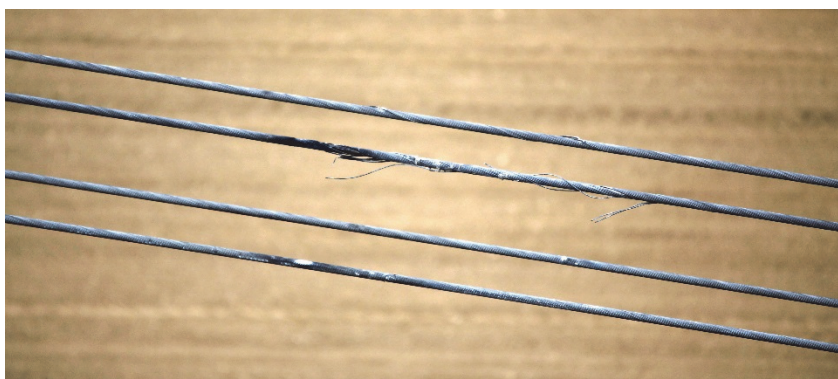
Figure 2

The aircraft had come to rest in an inverted attitude, with the nose pointing roughly parallel to the runway heading, ie 060°. The wreckage had burnt out, with the fire in the forward fuselage having been particularly intense. It was apparent that the right wing had separated close to the root as a result of striking the cable group mounted on the centre arm on the south side, approximately 100 ft above the ground. The right wing was found approximately 13 m from the main wreckage. The cables had not been severed, but had sustained damage in the form of broken cable strands (Figure 2).

Damage to power cables

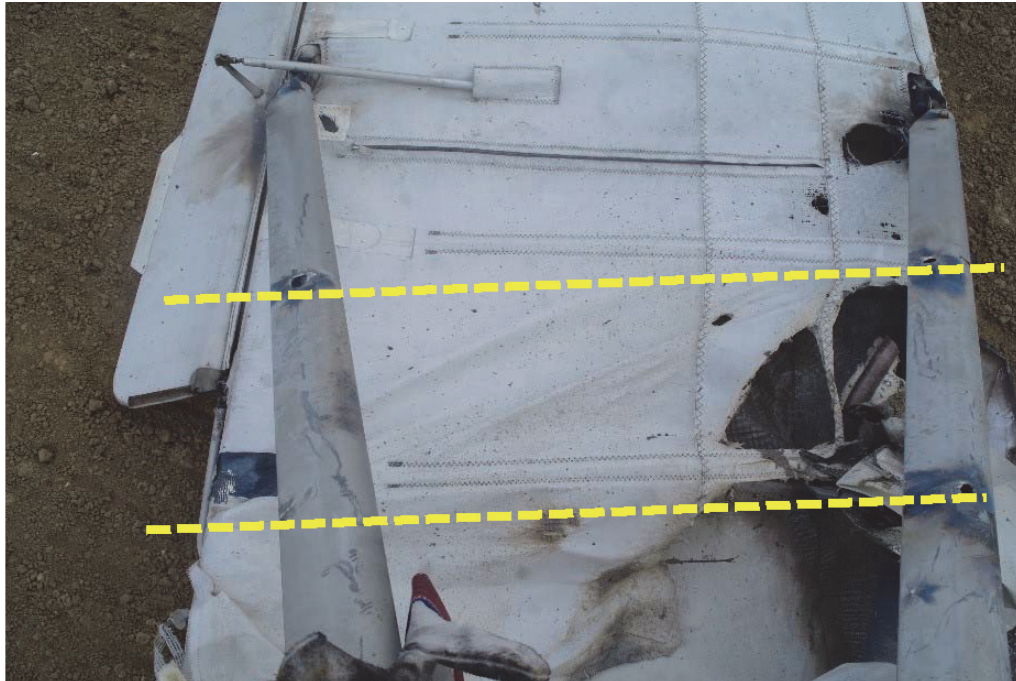
Figure 3

The cable group below the damaged ones exhibited some slight scuffing, possibly as a result of a brushing contact with the underside of the left wing; this showed evidence of light scuff marks on the wing struts, with several holes resulting from severe electrical discharges that had caused localised vaporising of the aluminium alloy. Similar features were observed on the structural members of both wings and on flying control components, with some of the flying control tubes having melted. The positions of the discharge damage on the wing struts was consistent with the spacing of the cables within the group (Figure 3).

Underside of right wing showing electrical discharge damage and possible cable contact positions

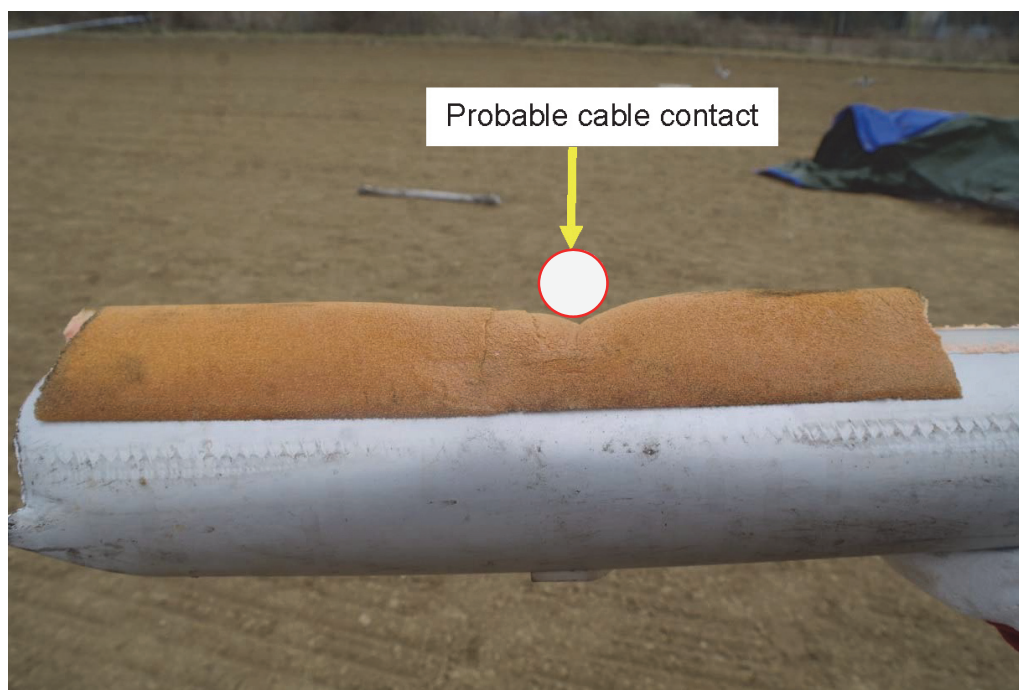
Figure 4

The right wing leading edge spar had been broken just inboard of its mid-span point, as a result of contacting the cables. A foam fillet had been bonded to the front face of the tube, giving an aerodynamic shape to the leading edge. An indentation was apparent in the foam, close to the spar fracture, which was consistent with being made by one of the cables (Figure 4). As can be seen, the cable would have been approximately vertical relative to the wing leading edge, suggesting the aircraft was in a near vertical nose-down attitude at the time.

Likely cable contact on the right wing leading edge spar

It was concluded, from the available evidence, that the right wing had struck the middle set of cables on the south side of the pylons whilst the aircraft was in a steep, probably vertical, nose-down attitude. It is likely that this caused a yaw to the right, bringing the left wing into light contact with the lowest set of cables, resulting in the phase-to-phase discharge that in turn produced the bright flash and explosion reported by witnesses.

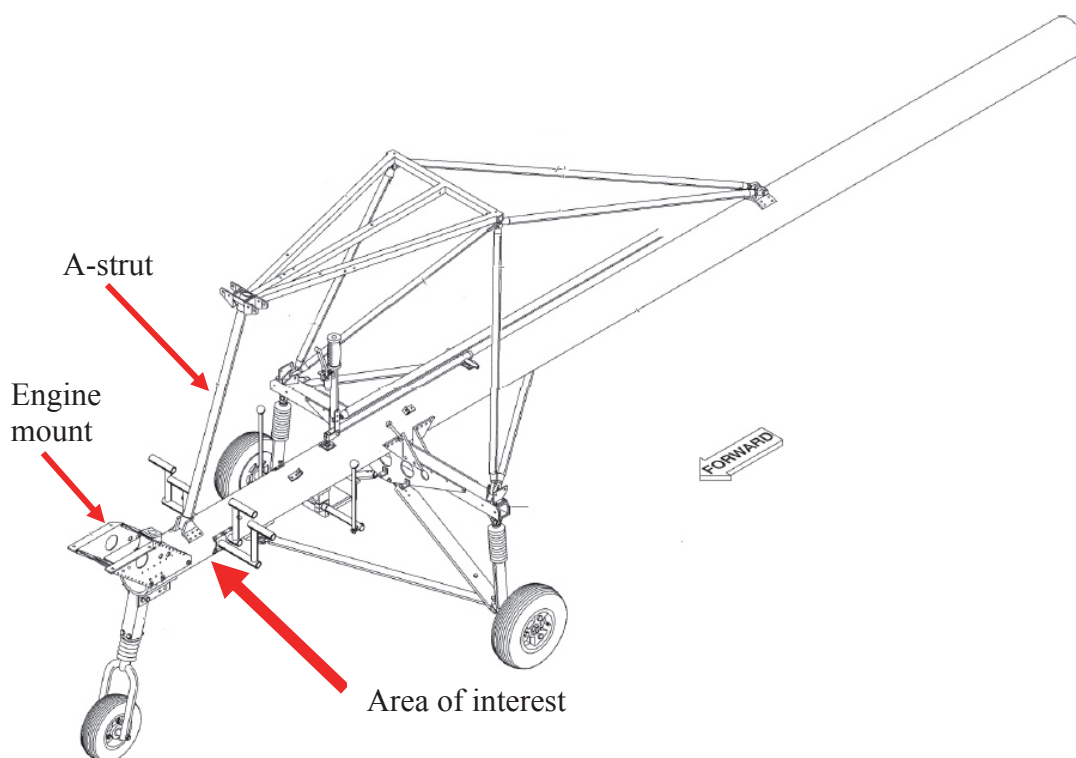
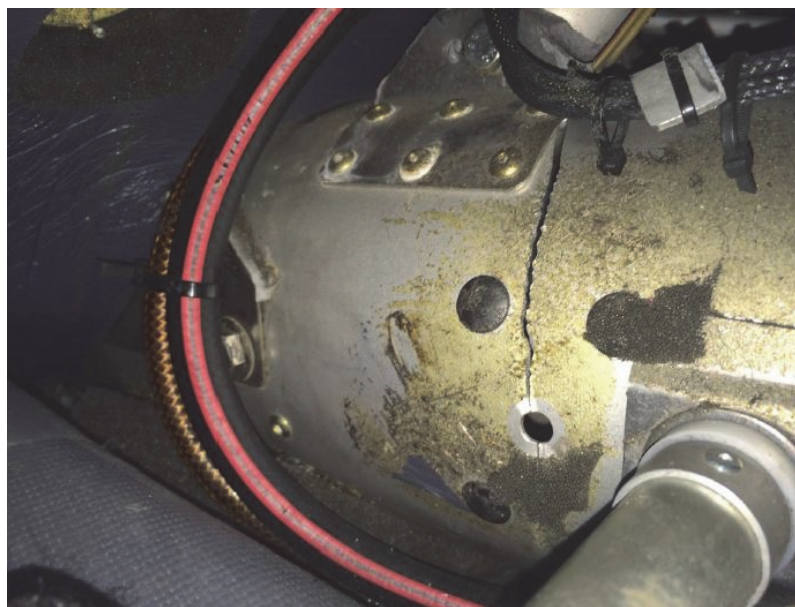
Cracks have been found emanating from the corners of the upper cut-outs which, if allowed to propagate, would compromise the structural integrity of the engine mountings, the nose landing gear leg and the A-strut. An extreme example is shown in Figure 5b. As far as is known, no crack has progressed to complete failure. The LAA covered the topic in an article in the August 2016 issue of their '*Light Aviation*' magazine.

Figure 5a
View of fuselage structure

Figure 5b
Example of crack emanating from rear cut-out, as shown in OSB 29

The cracking of the fuselage tube resulted in an Owner's Service Bulletin (OSB) 29, which was issued on 16 June 2016. The Bulletin became the subject of a Civil Aviation Authority (CAA) Emergency Mandatory Permit Directive (MPD), issued on 28 June 2016. It required an inspection for cracking of the front of the fuselage tube; the affected area is shown in Figure 5a. The engine is supported, via a pylon, on the front of the tube. In addition, there are two square cut-outs in the tube; the front one carries the nose landing gear and the rear forms the attachment of the A-strut.

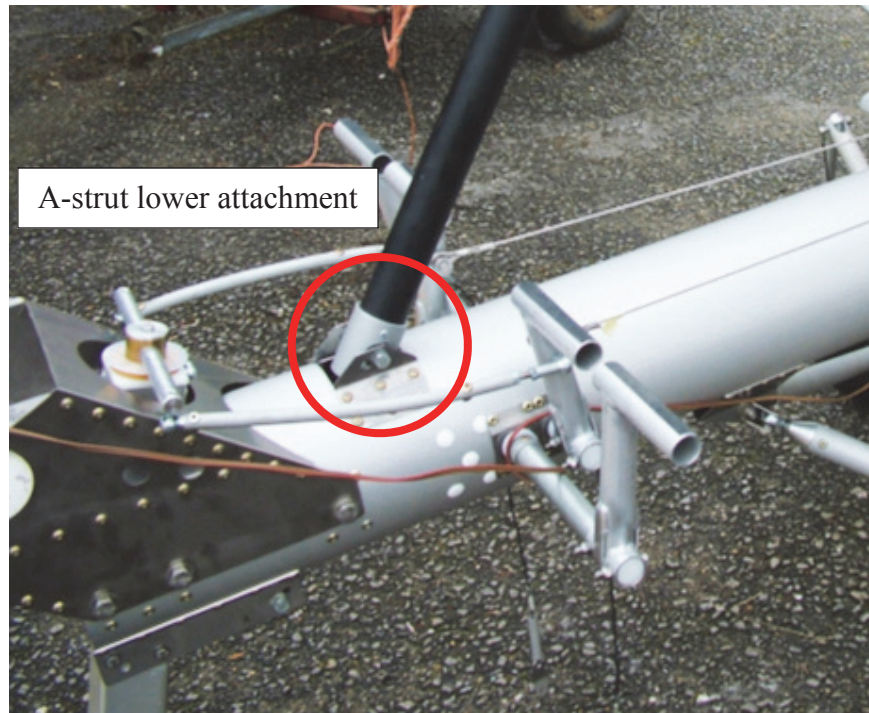
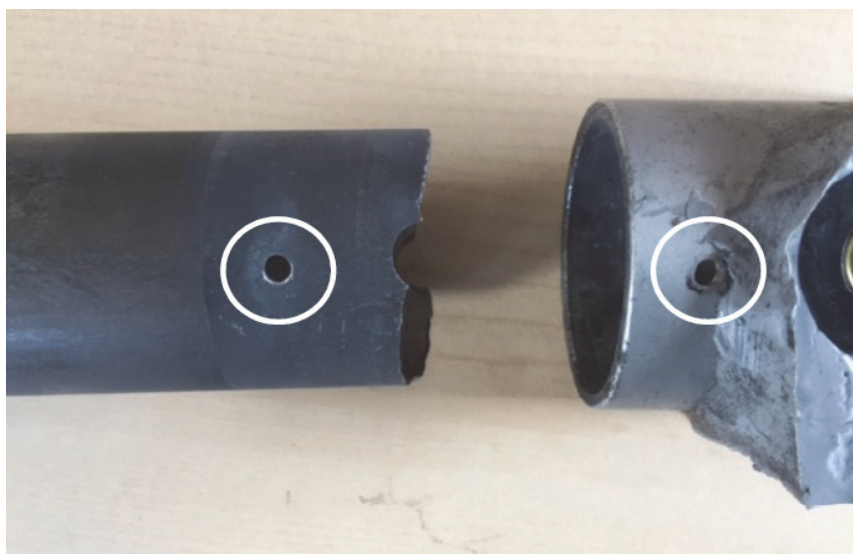
the outer collar at the connection between the strut and the upper surface of the main fuselage tube (Figures 6a and 6b). The failure was concealed by the collar and the upper part of the strut had been retained in position only by a single locating rivet (ie a manufacturing aid) that located the collar on the strut. The crack had emanated from the bolt hole in the strut.

A-strut attachment to forward fuselage tube

Failed A-strut after removal of collar, showing rivet hole

The UK agent for the aircraft, in conjunction with the German manufacturer, issued OSB 31 on 30 November 2016, applicable to all C42 A and B model aircraft, although later B models featuring a different design were exempted. The Bulletin stated that it was believed that the failure was the result of excessive loads placed on the A-strut due to near failure of the main fuselage tube. One other similar case was known to have occurred on an aircraft known to have sustained landing gear damage. However, it was also considered that the failure may have been related to fatigue due to flexing of the A-strut, thus introducing the requirement for an inspection of potentially vulnerable aircraft.

The OSB requires any aircraft which have previously suffered damage that could have affected the A-strut, such as nose gear or accident damage, to be inspected by means of a borescope inserted into the strut from its lower end. However there was no requirement to inspect aircraft with no history of damage and which had flown less than 2,000 hours. Aircraft with more than 2,000 flying hours were recommended to be inspected at the next Annual or 100-hour Inspection, whichever occurred first.

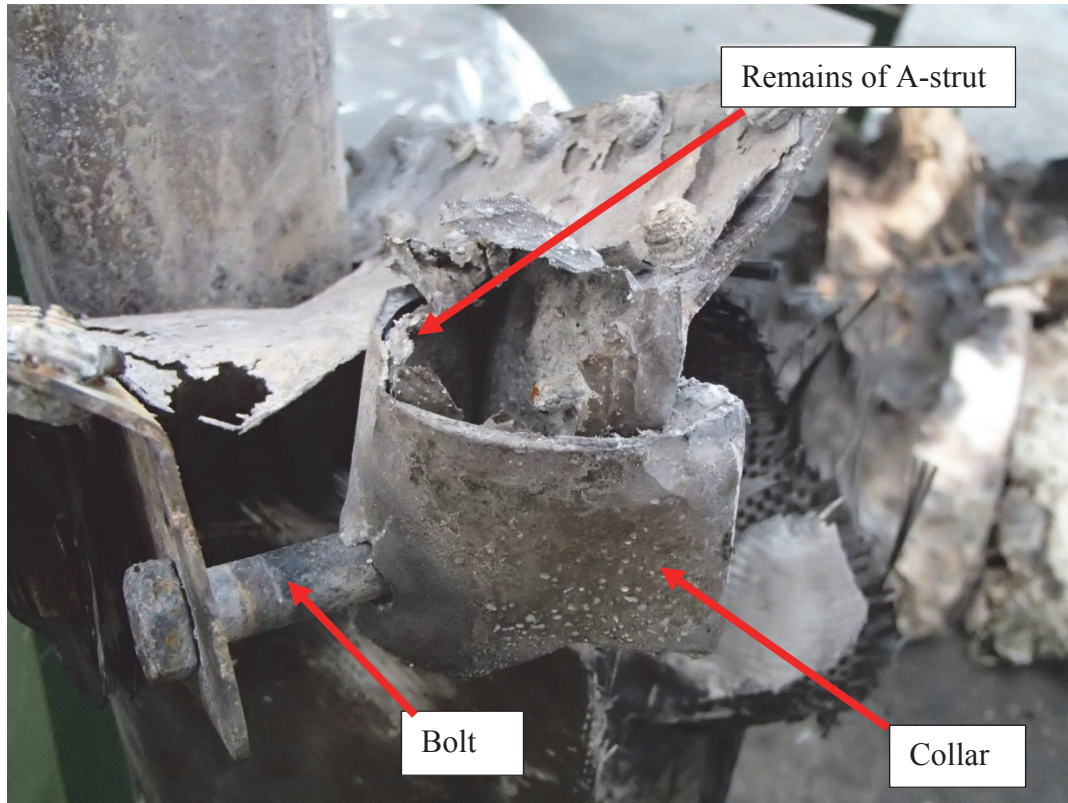
Figure 7
Lower attachment

The A-strut upper and lower attachments to the fuselage tube were made with steel brackets. These had survived the post-impact fire, whereas much of the surrounding aluminium material had not. Figures 7 and 8 show the remains of the lower and upper attachments. The lower attachment was similar to the upper in that both used collars and locating rivets (the rivet is not visible in the image of the lower attachment).

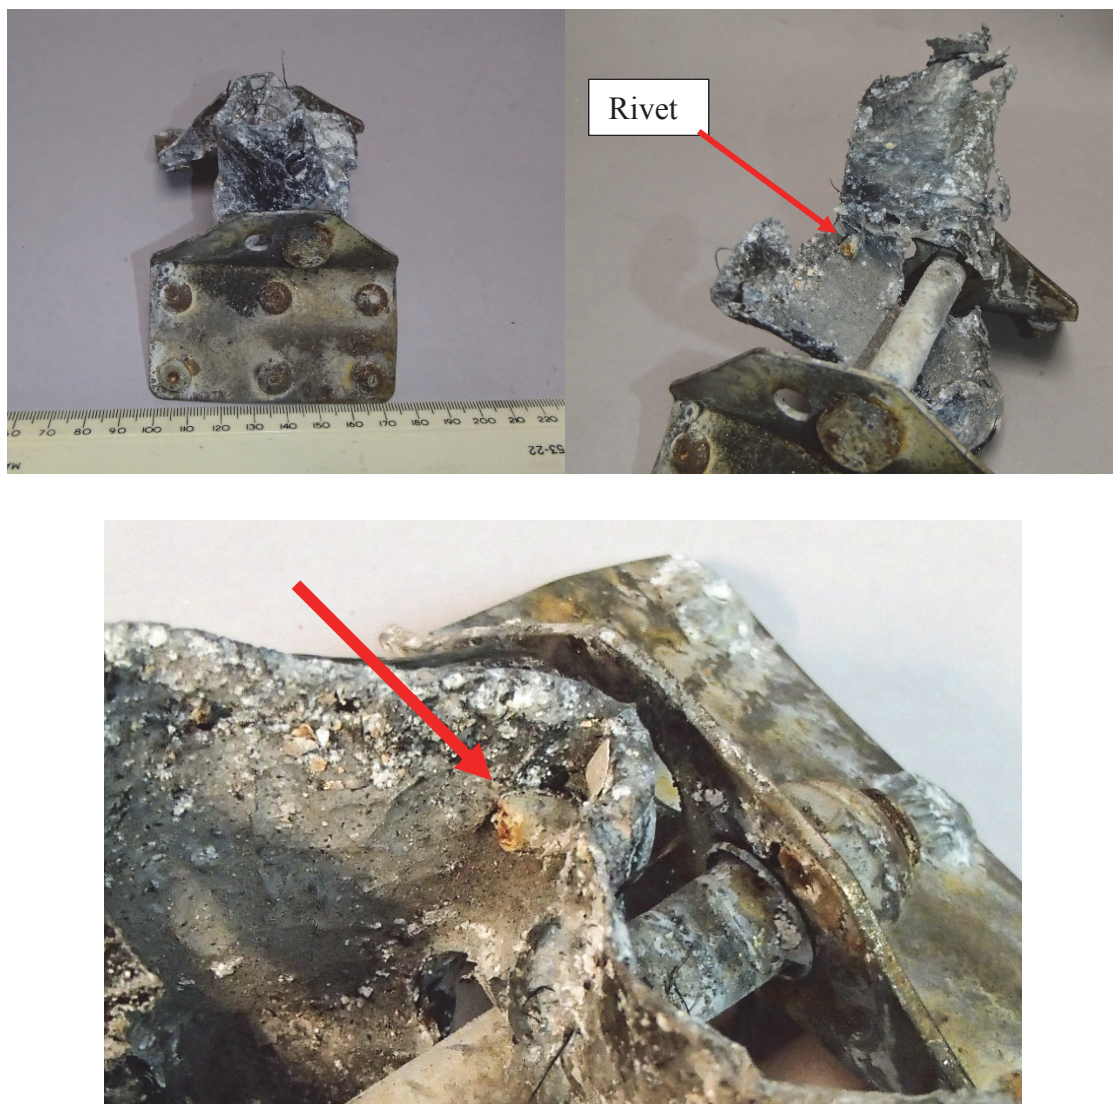
Figure 8

The remains of the collar on the upper attachment were fragile and part of it was peeled aside to reveal the locating rivet; this appeared intact. However there was no evidence of any part of the A-strut, unlike the lower attachment, where a section of the strut, together with the rivet was found positioned concentrically within the collar.

Remains of A-strut upper attachment and (lower view) rivet

Had a failure of the A-strut occurred, the upper section would have been held mostly by the locating rivet, which could have failed in shear under the action of flight loads. The rivet was found to be intact and undistorted, similar in appearance to the rivet in the lower attachment, which still retained the bottom of the A-strut. This suggested that there had not been an airborne failure, and this is supported by the statement from the manufacturer's design/certification engineer that the rivet would withstand flight loads of 2 to 3g. However, given the degree of damage sustained by the aircraft in the post-crash fire, the possibility of some other failure could not be discounted.

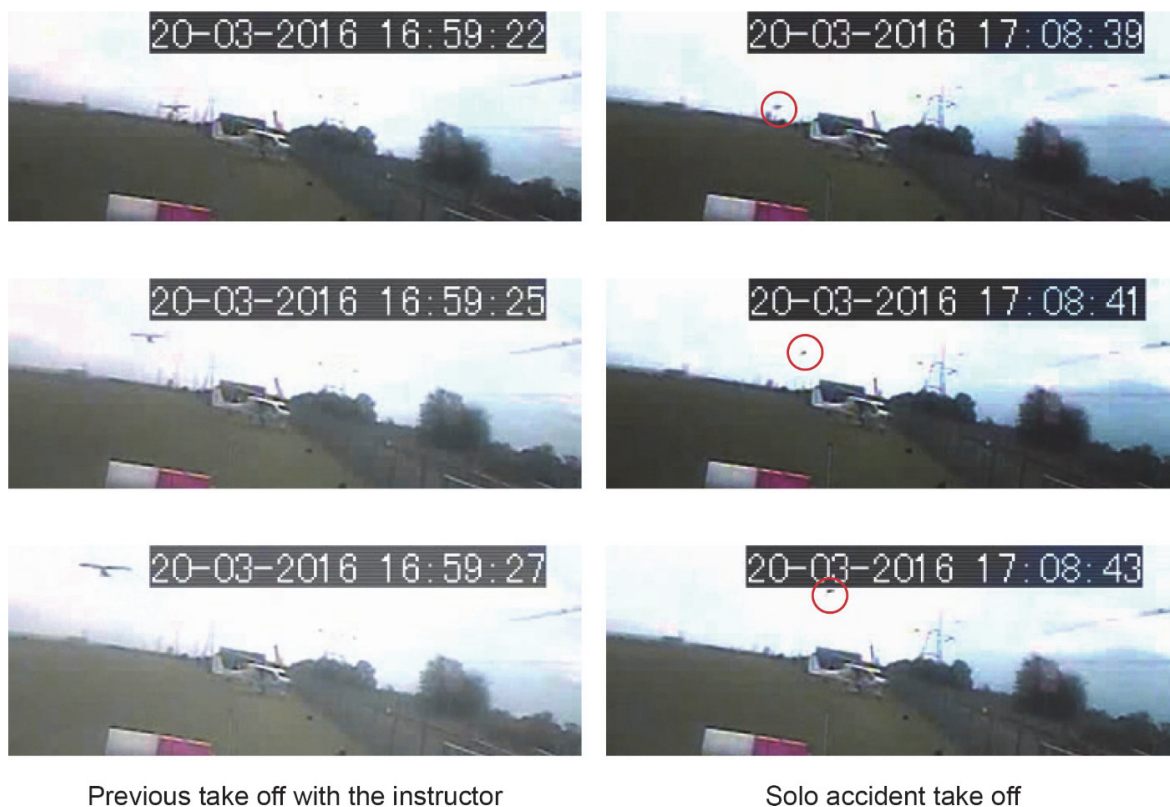
**Figure 9**

A video camera located on the clubhouse recorded both the takeoff with the instructor and the takeoff for the accident flight. Figure 9 shows three snapshots from each takeoff which illustrate differences in the respective flightpaths. The takeoff with the instructor was at a higher weight, but the aircraft tracked along the runway in a normal climb. On the accident takeoff the aircraft became airborne and climbed steeply, whilst drifting to the left (prior to dropping the left wing, descending and contacting the power lines).

Comparison of normal and accident takeoffs
