ACCIDENT

Aircraft Type and Registration:	Europa XS, G-BYSA	
No & Type of Engines:	1 Rotax 912 ULS piston engine	
Year of Manufacture:	2000 (Serial no: PFA 247-13199)	
Date & Time (UTC):	10 August 2016 at 1015 hrs	
Location:	Hollym Airfield, East Riding of Yorkshire	
Type of Flight:	Private	
Persons on Board:	Crew - 1	Passengers - None
Injuries:	Crew - 1 (Minor)	Passengers - N/A
Nature of Damage:	Aircraft destroyed	
Commander's Licence:	Private Pilot's Licence	
Commander's Age:	60 years	
Commander's Flying Experience:	918 hours (of which 438 were on type) Last 90 days - 49 hours Last 28 days - 11 hours	
Information Source:	Aircraft Accident Report Form submitted by the pilot

Synopsis

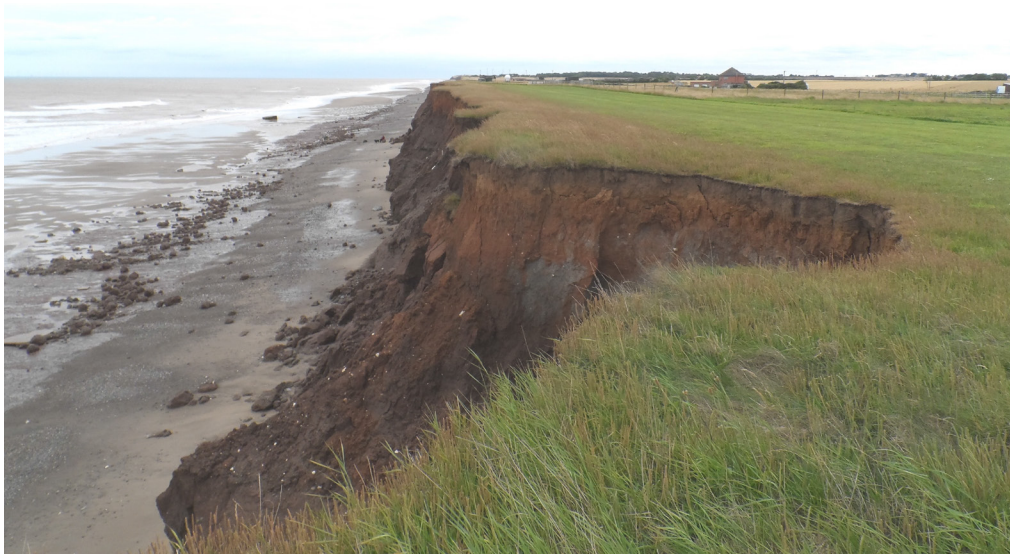
Figure 1

The pilot commented that the last time he had landed on Runway 32, the mown runway strip was bounded on both sides by significant fallow ground, providing some margin for error. Reviewing the airfield entry in commercially available flight guides had appeared to confirm to him that this remained the case. At the time of the accident the runway was reported as being 15 m in width, with a sketch diagram showing a clear area on each side. However, coastal erosion in the area is an average of two metres per year, with the cliff on the right of the runway being undermined by the sea and then collapsing in stages. This had resulted in the runway being moved to the left, until it abutted the fence, while the sea continued to erode the ground to the right of the runway, to its current width.

The pilot reported that, following the accident, he determined that the runway was approximately 14 m wide for this initial portion.

While landing on a cliff-top runway, the landing gear's right outrigger failed and the aircraft ran off the edge of the runway, over the cliff and into the sea. The failure of the aircraft's right outrigger was not explained. However, there was little margin for variation in landing track when using Runway 32, which was narrower than recommended by the CAA in CAP 793 because of coastal erosion (Figure 1).

Coastal erosion at Hollym Airfield

The airfield operator has informed the publishers of various flight guides that the runway width is now 10 m and requested that they include a warning to '*Beware cliffs on the east side of the airfield*'.

The airfield operator has informed publishers of various flight guides of the revised width of Runway 32 and warned about the cliffs on the east side of the airfield, for inclusion in their publications.
