ACCIDENT

Aircraft Type and Registration:	Reims Cessna F172N Skyhawk, G-DUVL	
No & Type of Engines:	1 Lycoming O-320-H2AD piston engine	
Year of Manufacture:	1978 (Serial no: 1723)	
Date & Time (UTC):	20 December 2016 at 16:04 hrs	
Location:	White Waltham Airfield, Berkshire	
Type of Flight:	Private	
Persons on Board:	Crew - 1	Passengers - 3
Injuries:	Crew - None	Passengers - None
Nature of Damage:	Right main landing gear failed, minor damage to the tailplane and elevator	
Commander's Licence:	Private Pilot's Licence	
Commander's Age:	61 years	
Commander's Flying Experience:	15,600 hours (of which 230 were on type) Last 90 days - 3 hours Last 28 days - 2 hours	
Information Source:	Aircraft Accident Report Form submitted by the pilot and AAIB enquires and examination of failed components

Synopsis

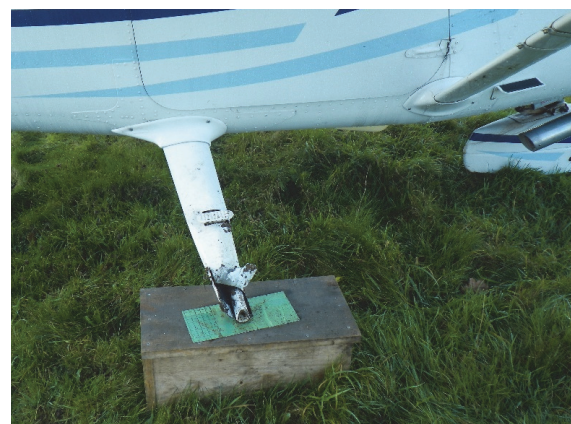
Figure 1

The pilot reported that the touchdown on the grass runway at White Waltham was smooth with little impact; however as the aircraft slowed to approximately 35 kt, there was a loud bang and the right side of the aircraft dropped. The aircraft turned to the right by approximately 120° before it came to a halt. On vacating the aircraft, the pilot noticed that the right main wheel assembly had detached from the landing gear leg (Figure 1).

Right main wheel assembly detached from its leg

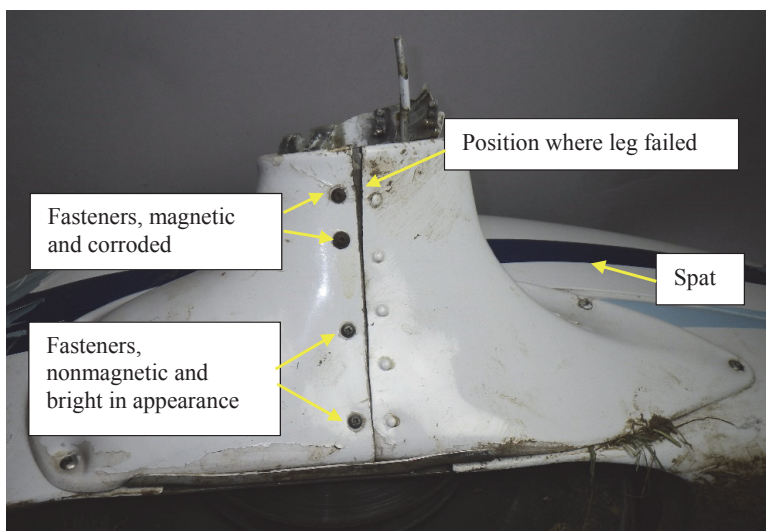
Figure 2

The right main landing gear leg failed adjacent to the top fastener in the aerodynamic fairing, which covers the lower part of the leg and is attached to the wheel spat (Figure 2). The screws in the fairing should all be identical; however the top two screws were found to be magnetic and heavily corroded, whereas the bottom two screws were non-magnetic and were bright in appearance. The screws were therefore made from different materials and varied in length by between 9 and 11 mm.

Fairing attached to right wheel spat

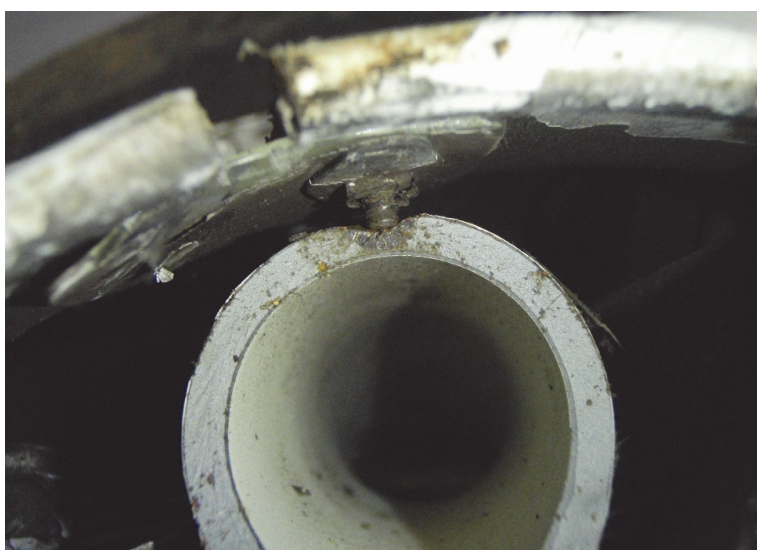
Figure 3

The top fastener had made contact with the leg and formed a dent approximately 6.8 mm in diameter and 1.6 mm deep (Figure 3). Spots of discoloration and surface damage indicated that the other three screws had also been in contact with the leg.

Top fastener in contact with the landing gear leg

The right landing gear leg failed as a result of a fatigue crack that initiated from damage caused by the end of a screw in contact with the leg. The condition of the fracture surface indicated that the fatigue crack was present for a period of time. The cyclic loads in the leg during the landing and taxiing would have caused the fatigue crack to grow until the leg eventually failed in overload during a ground roll.

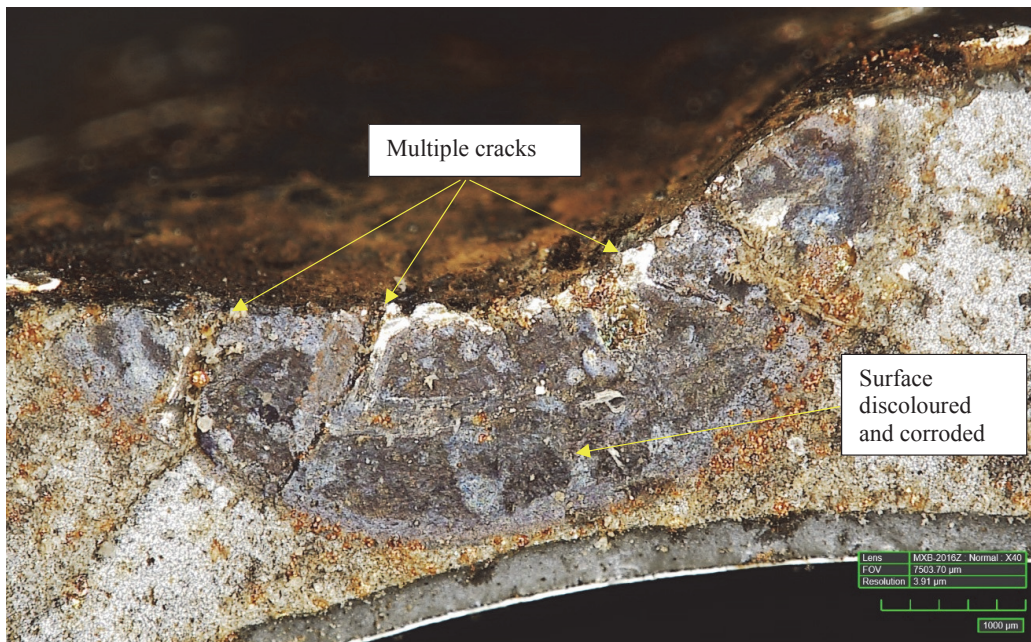
Figure 4

Examination of the fracture surface under a microscope revealed multiple cracks emanating from the dent, which had been caused by contact with the screw. The surface in the area of the dent was discoloured and corroded, and beachmarks extended from the centre of the dent to approximately 0.5 mm from the inner surface of the landing gear leg (Figure 4). The beachmarks were evidence of fatigue cracking and the corrosion and discolouration showed that the crack had grown over a period of time before it failed in overload. Due to the nature of the failure it was not possible to estimate the time period over which this occurred.

Multiple cracks and corroded surface
