Fatal man overboard from the fishing vessel *Pauline Mary* east of Hartlepool on 2 September 2016

SUMMARY

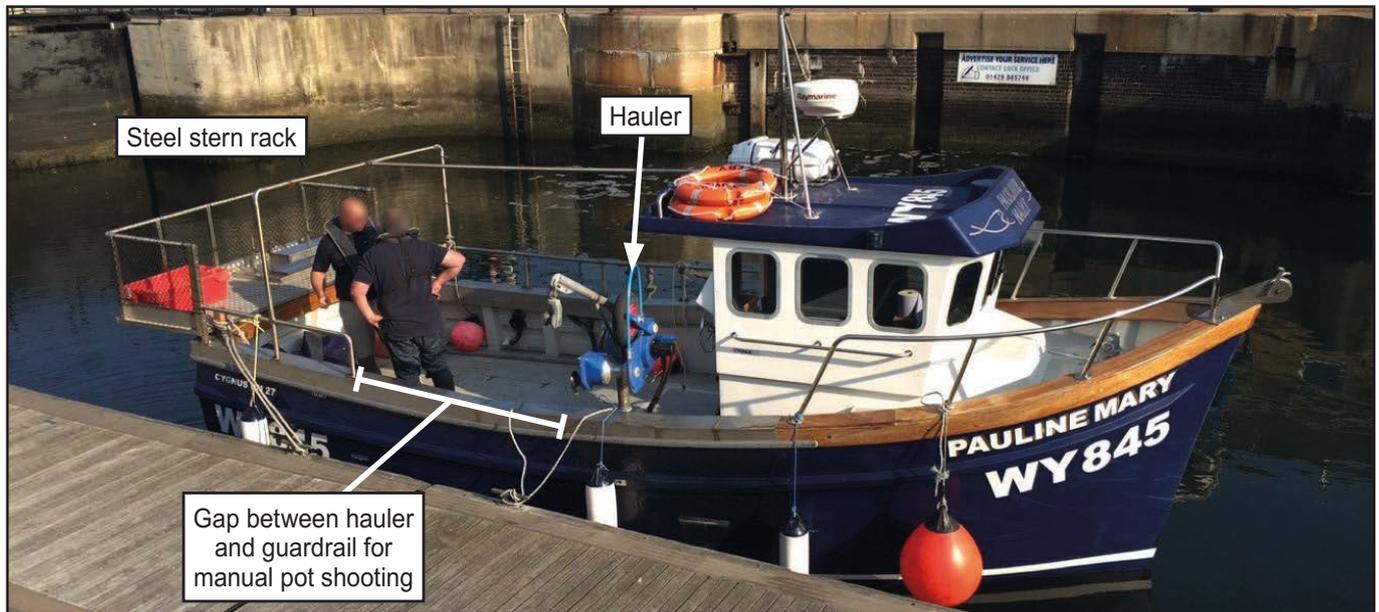
Figure 1: *Pauline Mary* showing deck layout and equipment

During the vessel's conversion, the owner fitted a hydraulic pot and net hauler on the starboard forward side of the working deck and installed steel guardrails on top of the gunwales. He also fitted a steel rack over the stern to store loose fishing gear (**Figure 1**). After registering *Pauline Mary* as a UK fishing vessel, the owner recruited a local fisherman to act as skipper and operate it.

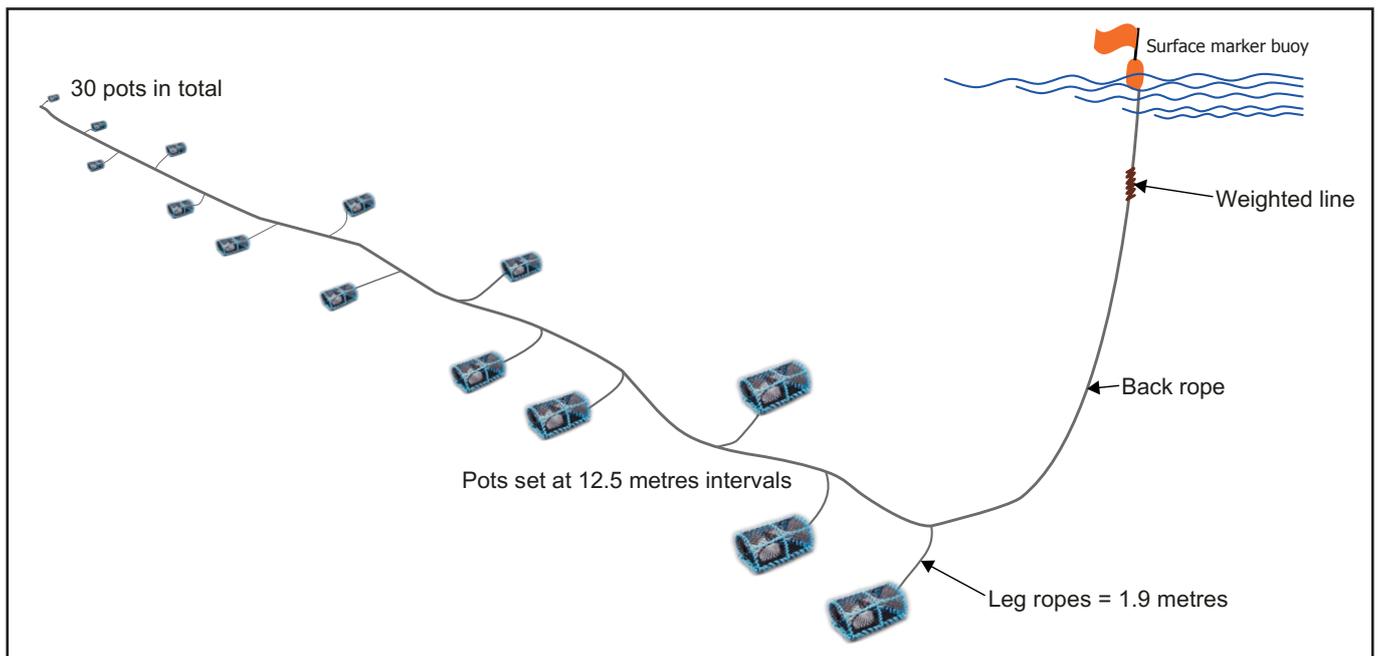
With the assistance of a crewman, *Pauline Mary's* skipper planned to work seven strings of pots in fishing grounds about 1 nautical mile east of Hartlepool harbour (**Figure 2**). Each string had a weighted marker buoy and 30 steel framed pots. Each pot was attached to a 12mm diameter polyethylene back rope by 1.9m long leg ropes at intervals of about 12.5m (**Figure 3**).

To shoot the potting gear, the crewman released the back rope's weighted marker buoy and then manually threw one pot at a time over the starboard side in the gap between the guardrail and the hauler (**Figure 1**). The skipper controlled the vessel's course and speed from the wheelhouse. The skipper intended to employ his brother, Lee Renney, as his regular crewman.

Figure 3: Arrangement of *Pauline Mary*'s potting gear

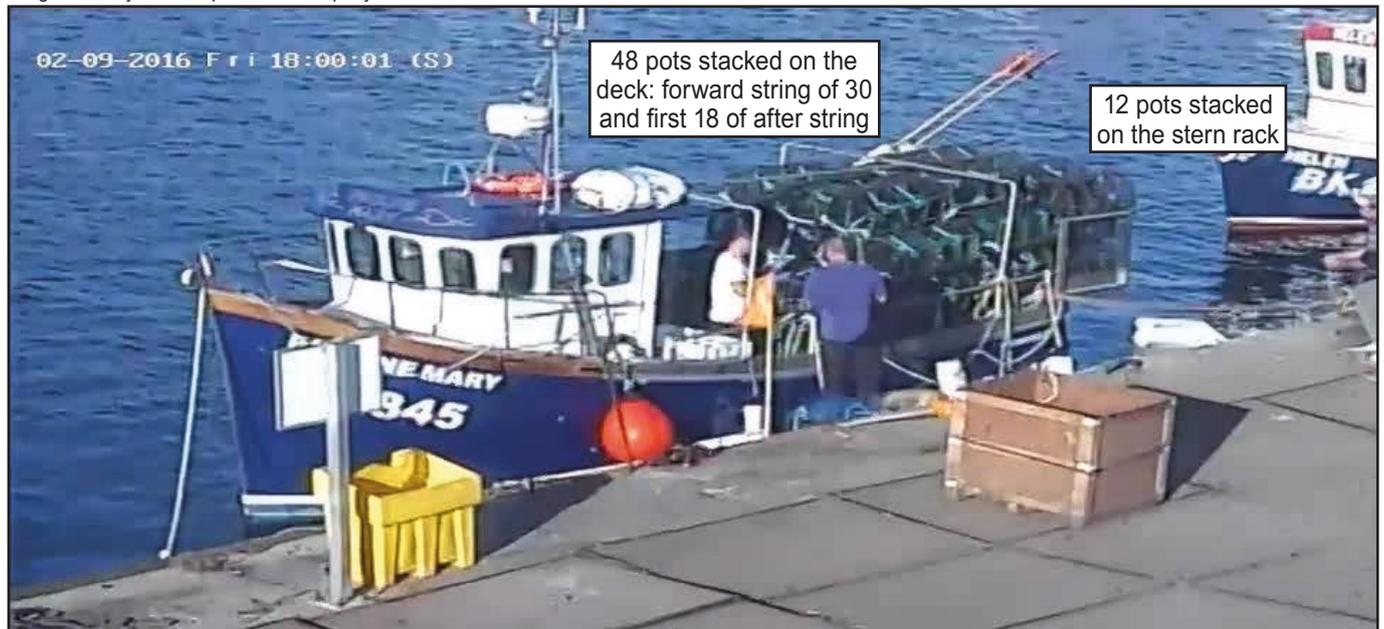
with one string of pots stacked on the forward end of the working deck and the other stacked behind. Eighteen pots from the after string were stacked on deck and 12 were stacked on the stern rack (**Figure 4**).

Figure 4: *Pauline Mary* at Hartlepool Fish Quay fully loaded prior to departure

The skipper and his brother were in the process of laying their gear for the first time when the accident happened. In order to do this, they loaded two strings of pots on the deck at a time. This required the pots to be stacked high and left very little room on deck, which made the task of shooting the pots even more dangerous. The temptation to heavily load a potting vessel when initially laying gear or when shifting grounds might be high as it saves time and therefore money; however, it significantly increases the levels of danger to the crew. In this case, the fishing grounds were very close to the harbour and therefore the financial benefits were low. Had the skipper carefully considered the risks, he might have planned to make seven trips to lay the gear, instead of four.

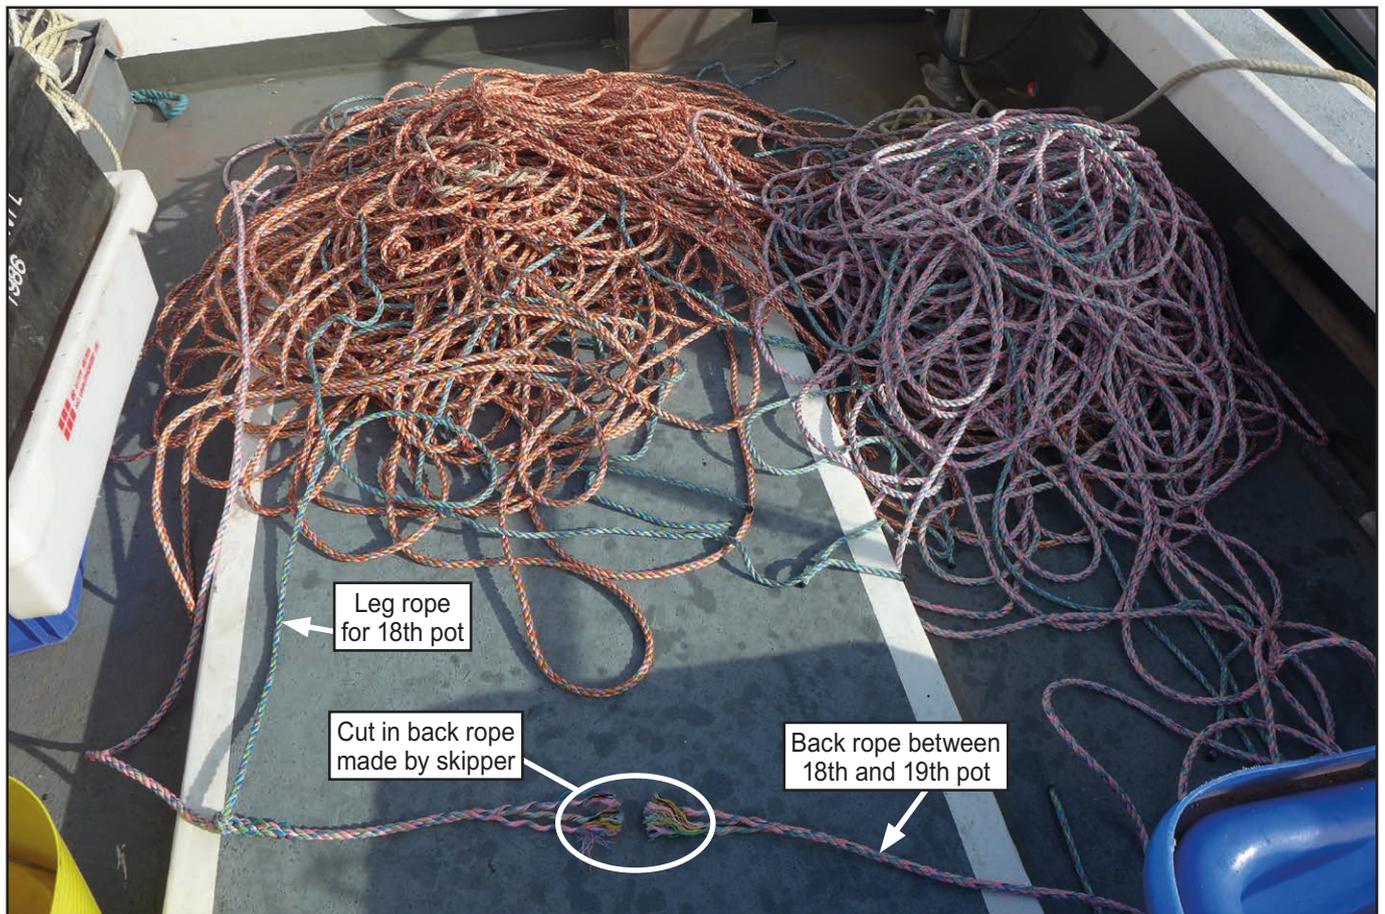
Post-accident examination of the gear identified that the skipper cut the back rope between the 18th and 19th pots on the string (**Figure 6**). Each pot weighed 21kg (dry) and 13kg when in seawater and the depth of water in the accident location was 23m. As Lee was tangled close to a pot and the distance between each pot was 12.5m, there would have been the weight of 2 pots (26kg) pulling him underwater after the back rope was cut.

Figure 6: Post-accident examination of the fishing gear showing the cut in the back rope close to the 18th pot in the string

When the skipper cut the back rope, Lee was released from the hauler and pulled back under water by the pots' weight for a second time. As the back rope was cut between pots 18 and 19 on the string (**Figure 6**), it is likely that Lee had become entangled in the back rope between pots 17 and 18, or the leg rope for the 18th pot. The 18th pot in the string would have been the last one stored on the deck, and to pick it up Lee would have had to avoid the remaining 150m of back rope (from pots 19 to 30) that would have been on the deck (**Figure 7**). With the remaining pots stacked high on the stern rack this would have been the most dangerous part of the task.

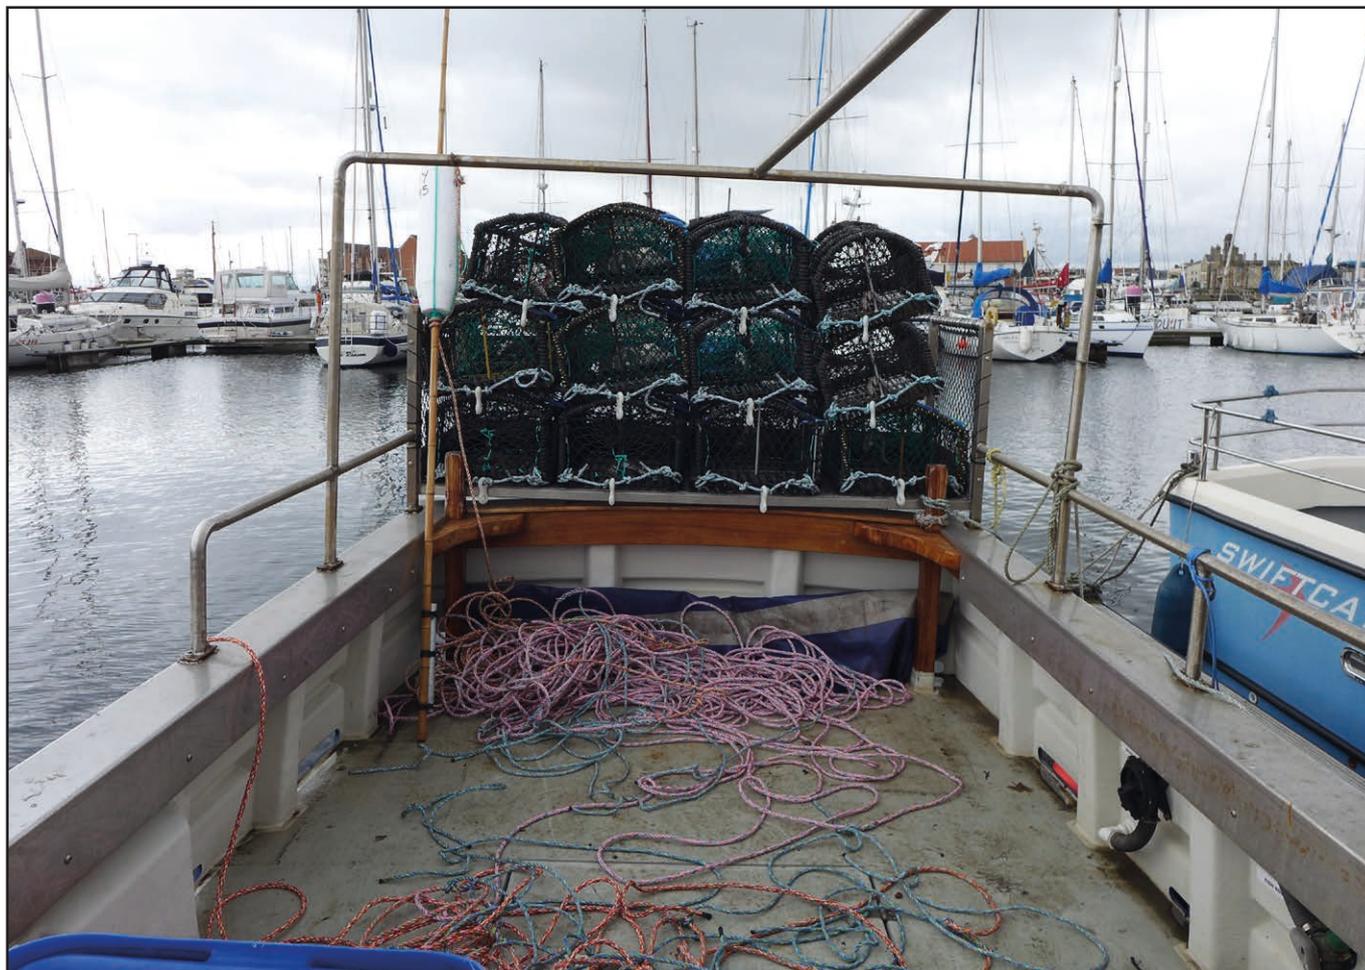
Lee's entanglement was not witnessed by the skipper or the female adult passenger, and therefore his position on deck when his leg was snagged could not be determined. Initially, Lee was pinned against the bulwark by the back rope, but he was unable to resist the increasing weight of the trailing pots so was soon pulled overboard into the sea.

Figure 7: Illustration showing the final 12 pots on the stern rack, and the potential hazard associated with loose ropes on the deck

Potting is a particularly hazardous occupation and being carried overboard by the gear is one of the most common causes of potting vessel fatalities. This was reflected in fishing industry guidance, which clearly warned of the potentially fatal hazards on the deck of potting vessels, in particular the risk of entanglement where there is no physical separation between the crew and the ropes.

In order to minimise the risk, safe methods for working the pots need to be developed and followed. In particular, every effort should be made to separate the crew from the gear. This is often achieved by designing vessels that allow self-shooting or by installing barriers between the crew and the ropes. As *Pauline Mary* was designed for manual shooting and had an open deck, the avoidance of entanglement was entirely reliant on the tidy stacking of pots and crew vigilance.
