Report on the investigation into  
carbon monoxide poisoning  
on board the motor cruiser

***Love for Lydia***

on Wroxham Broad, United Kingdom

between 7 and 9 June 2016

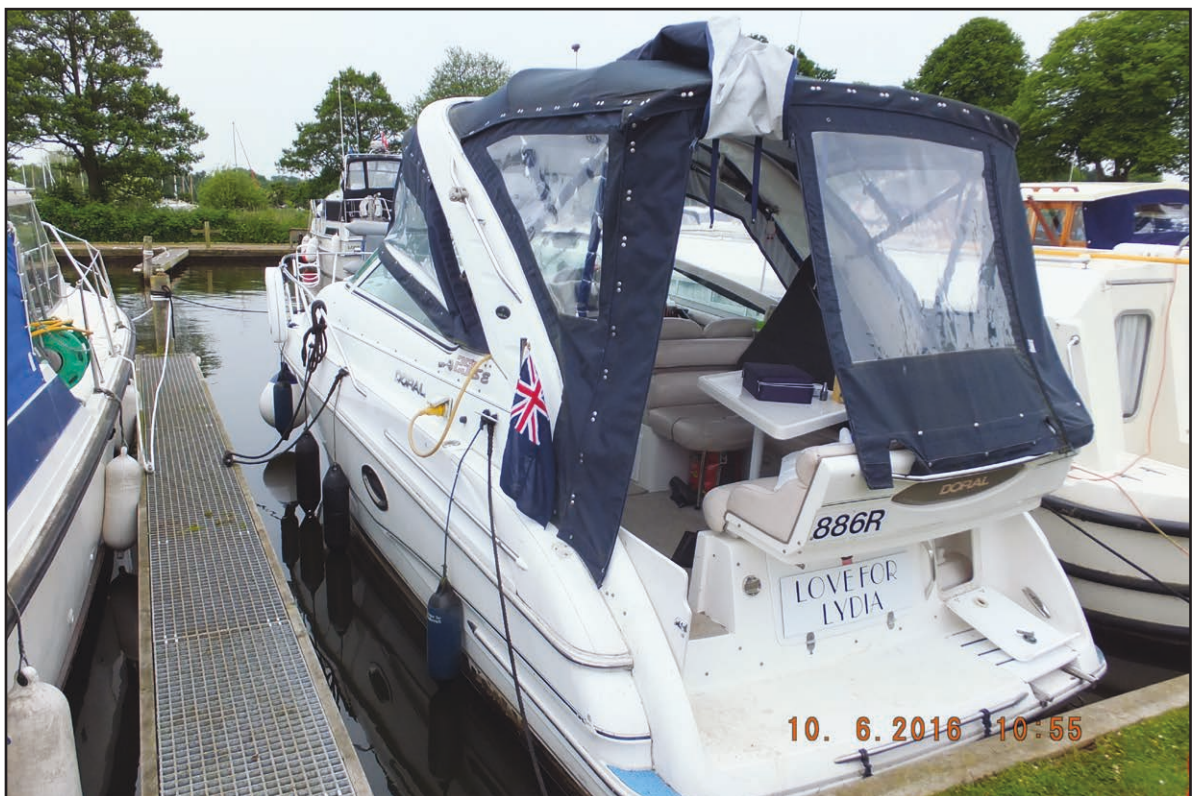
Figure 3: Configuration of *Love for Lydia*'s canvas canopy

The first responder unfastened the poppers securing the canopy at *Love for Lydia*'s stern. The FRS then tested the atmosphere on board the vessel and no carbon monoxide (CO) was detected. At 1653, the ambulance crew examined the boat's occupants, Alan Frost and his partner Tina Wilkins, and confirmed that they were

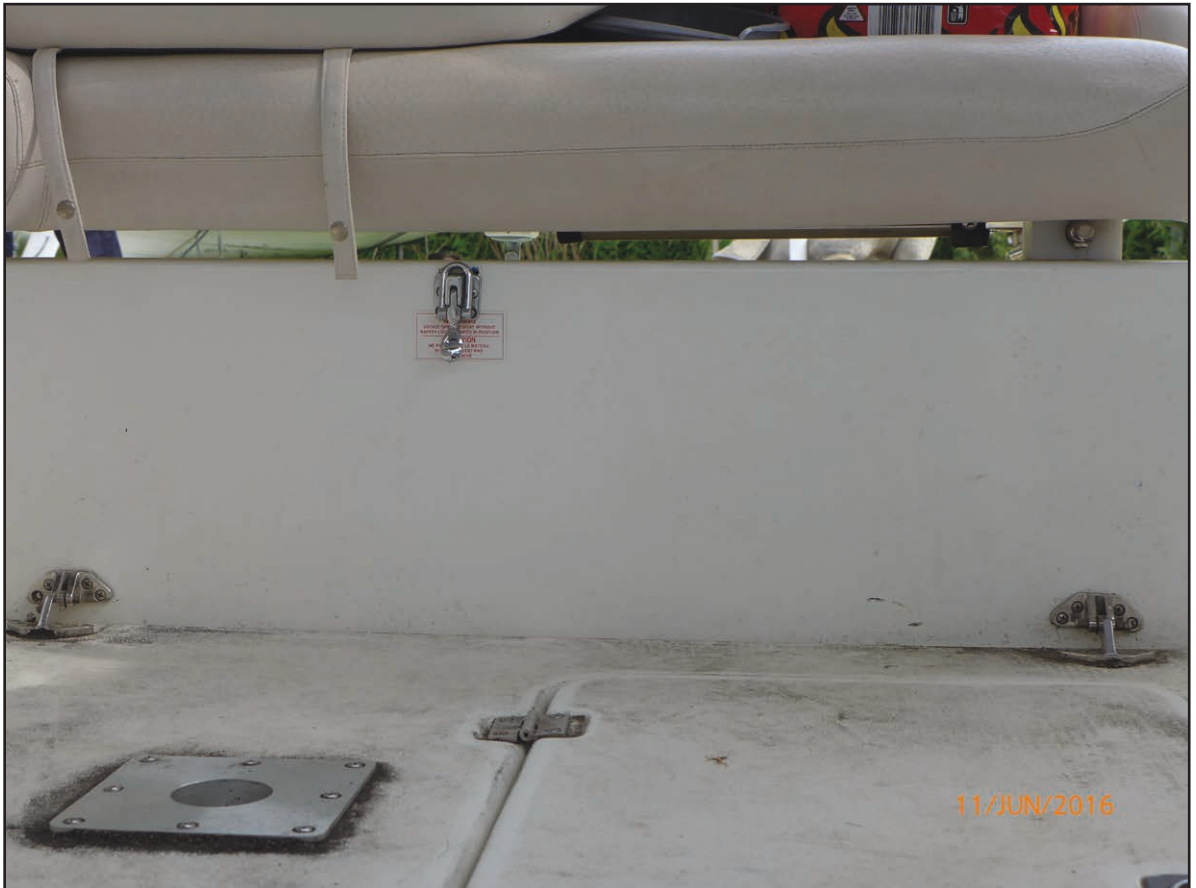
**Figure 7:** Gap under aft bench seat

The aft deck and helm area, which was above the engine bay and aft cabin, was fitted with seating and a table (**Figure 6**). A movable bench seat was fitted at the aft end of the deck. The gap between the underneath of the seat and the top of the transom was approximately 5cm (**Figure 7**). In common with many sports motor cruisers, the aft deck and helm area was fitted with a canvas canopy (**Figure 3**) that was attached to the superstructure with press studs. The canopy's configuration was adjusted by zips and twist lock fastenings. The canopy was last replaced in 2011 by a Broads-based supplier at a cost of £2200. No warnings on the dangers of CO poisoning accompanied the canopy.

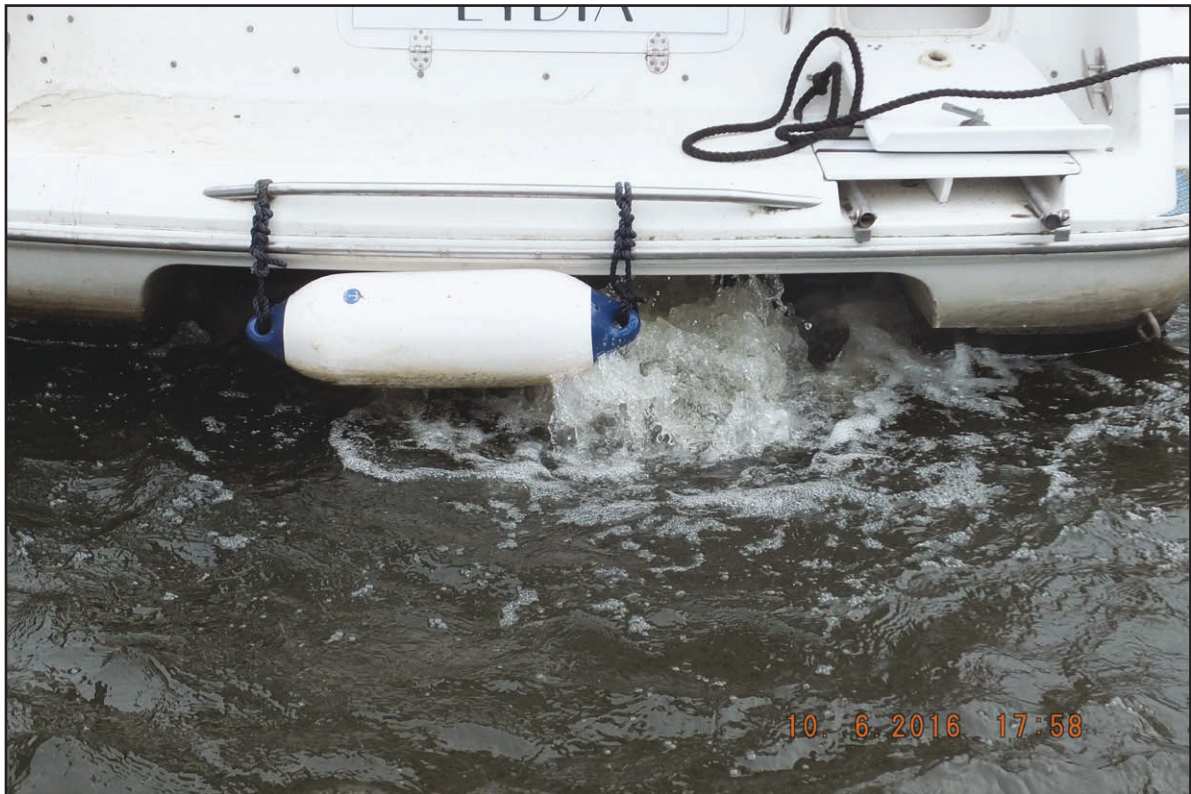
**Figure 8:** 'Wet' exhaust

*Love for Lydia*'s propulsion was supplied by a naturally aspirated, 5.7 litre, eight-cylinder (V8) Mercury Mercruiser inboard engine. The engine had an output of up to 300hp through a steerable outdrive and could drive the boat at cruising speeds of 20-25 knots and a top speed of 40 knots. The engine incorporated a 'wet' exhaust system that vented non-catalysed<sup>2</sup> exhaust gases and cooling water through the outdrive under the water on the stern transom (**Figure 8**).

Data from tests on similar engines, conducted by the manufacturer in 2002, showed that the concentration of CO in the engines' emissions with the engines idling was between 44099ppm and 48206ppm (**Table 1**).

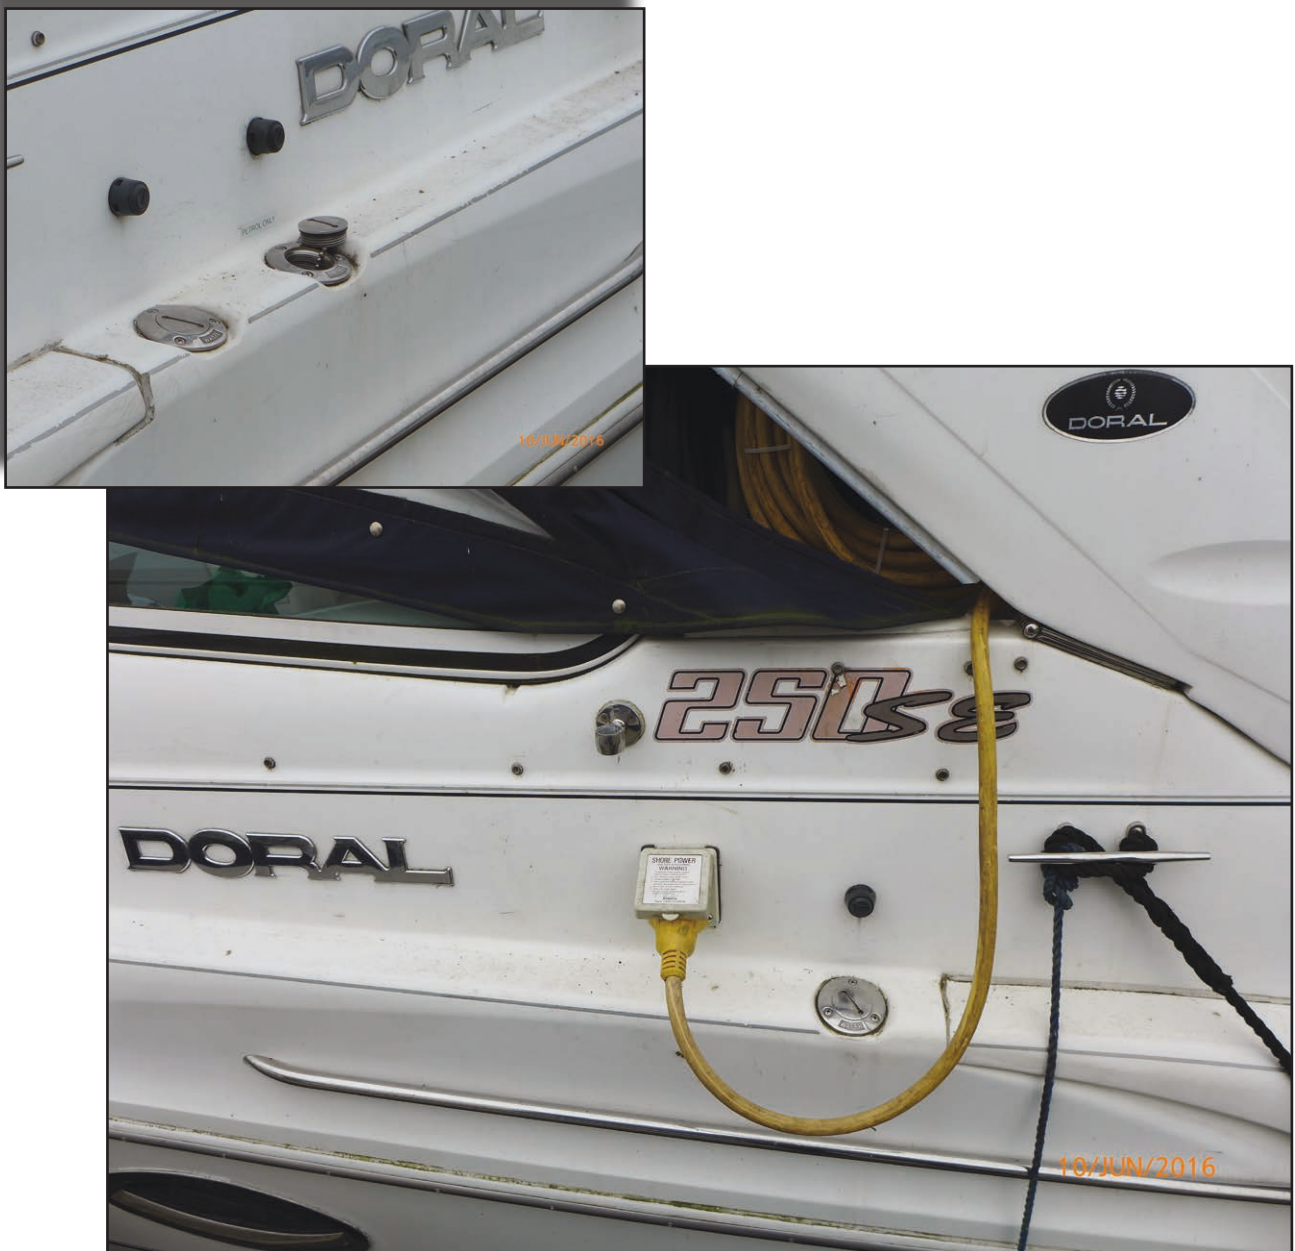
**Figure 10:** Shore cable and fuel tank cap

- The fuel filler cap located on the starboard side had been unscrewed (**Figure 10**).
- A 'shore power' lead was coiled on the port side of the aft seating area. The 'inboard' end of the lead was plugged into the boat's supply socket (**Figure 10**).
- The switches on the electrical distribution panel in the galley for the fridge, internal lights and domestic water pressure pump were in the 'on' position (**Figure 11**).
- The boat's batteries were in a discharged condition.
- There were no carbon monoxide alarms on board.

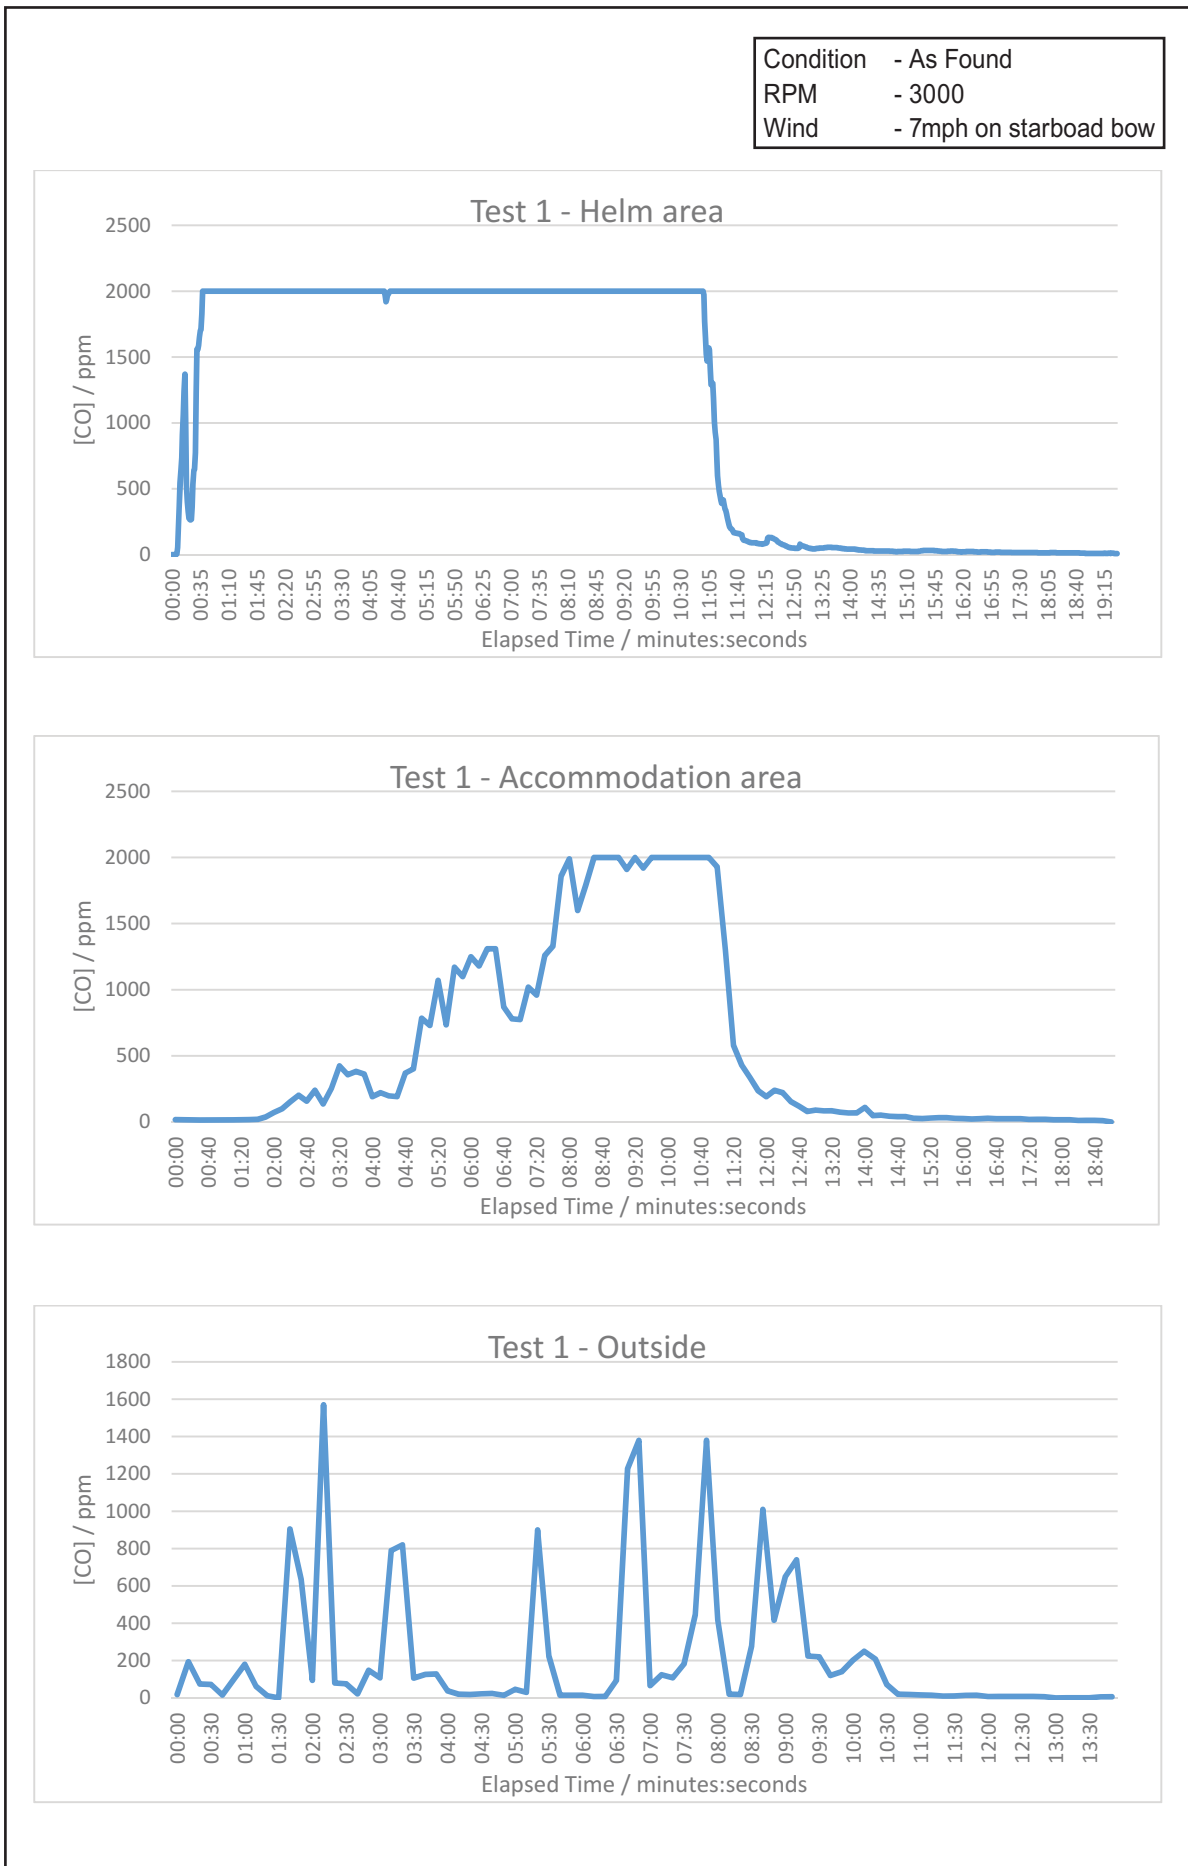
**Figure 13: Test result – Test 1**

- In the 'as found' condition with an engine speed of 3000, the concentration of CO in the helm position reached over 2000ppm within 39 seconds. Similar levels were recorded in the forepeak cabin within 8 minutes (**Figures 13**). At 600rpm, the concentration of CO reached 600ppm within 50 seconds in the helm area and 450ppm in the forepeak cabin within 10 minutes.

Condition - Hatch and side vents open  
 Canopy - On  
 Wind - 5mph fine on port bow

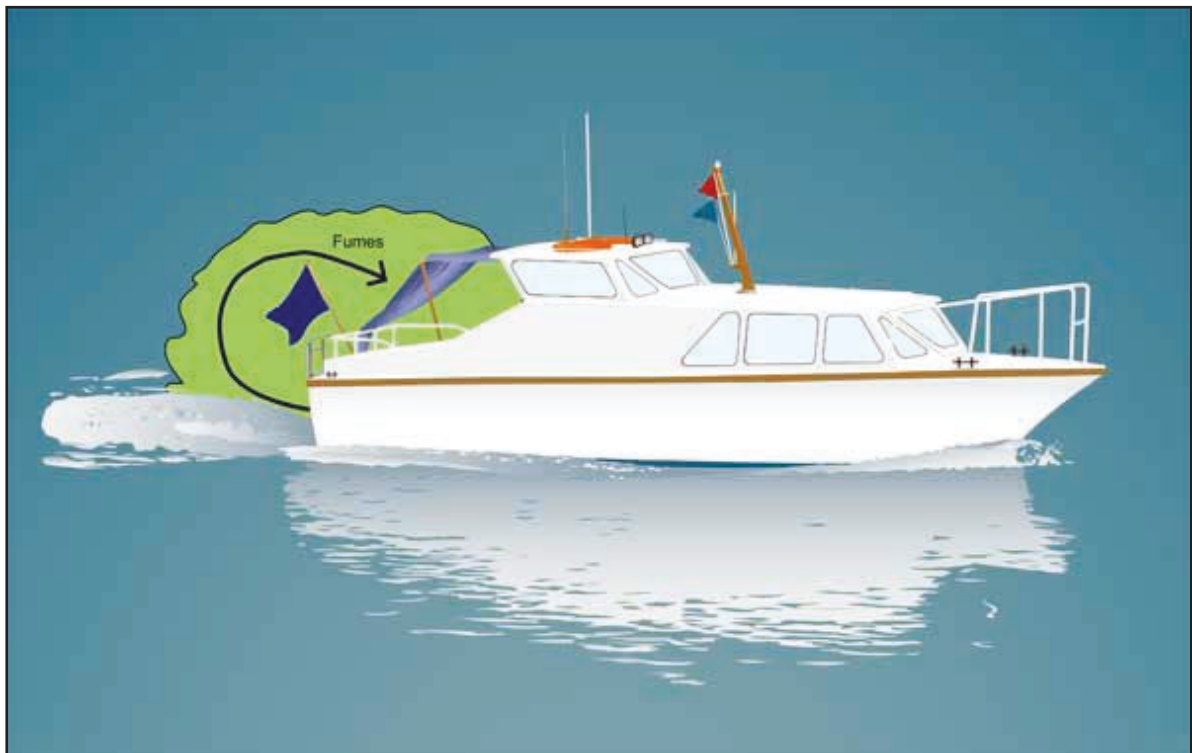
**Figure 16:** Diagram showing 'station wagon effect'

'Station wagon effect' is a phenomenon in which emissions from a boat's exhaust accumulate behind the boat or travel back into the boat due to pressure differential, usually when the boat is underway (**Figure 16**). As a result, CO spreads into habitable spaces.
