Report on the investigation of  
the collision between

***Osprey and Osprey II***

resulting in serious injuries to one passenger

19 July 2016

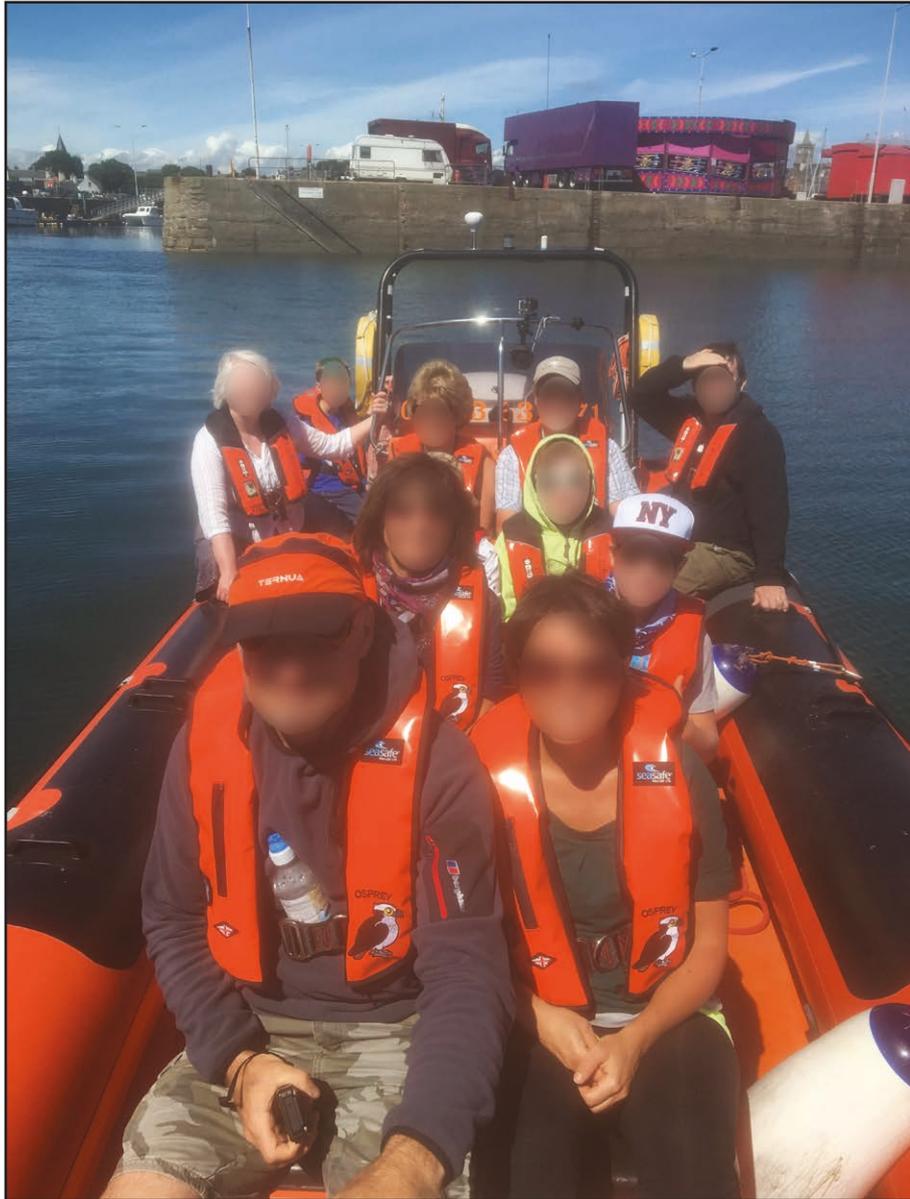
**Figure 2:** *Osprey II* passengers shortly after departing Anstruther, showing two passengers and the skipper's son seated on the tubes

On the day of the accident the additional passengers on *Osprey II* were directed to sit on the tubes in a position aft of the two designated positions. This allowed them a handhold on the tube, and a handhold on the stainless steel frame around the helm console (**Figure 8 inset**).

The operating company, Isle of May Boat Trips Ltd, has since banned similar manoeuvres in future and has prohibited crew and passengers from sitting on the RIB inflatable tubes.

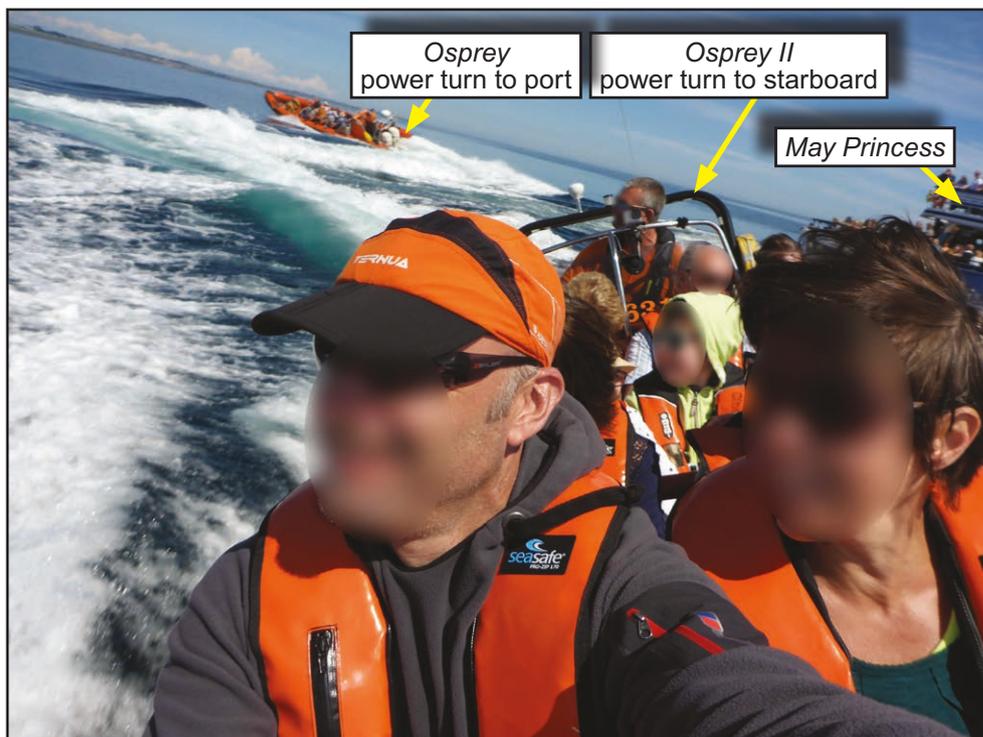
Figure 4: Both RIBs commencing power turn

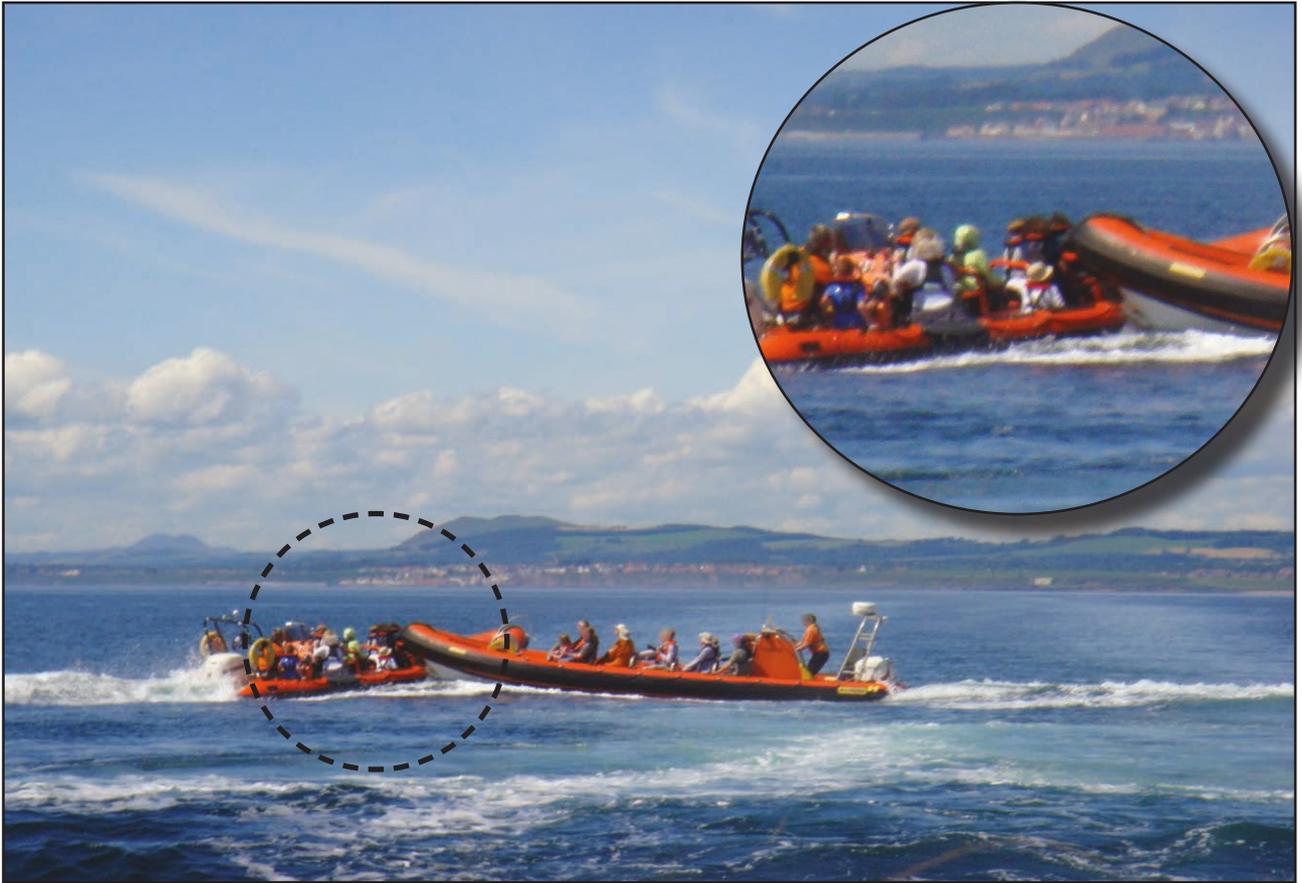
As the RIBs turned towards each other, it became apparent to both skippers that the RIBs were in danger of colliding. *Osprey II*'s skipper tried to avoid collision by turning to port, reducing engine speed and engaging astern gear as soon as the engine would allow. As the RIB rapidly slowed down, a child who was sitting on one of the bench seats slid off her seat and onto the floor. *Osprey*'s skipper also tried to avoid collision by turning to starboard and then to port and by engaging astern gear on both engines, which rapidly slowed the RIB (**Figure 5**).

At 1252, the passenger sitting on *Osprey II*'s starboard inflatable tube turned away from *Osprey*'s approaching bow, which then pinned her to *Osprey II*'s helm console. The starboard aft section of *Osprey II*'s inflatable tube was punctured and rapidly deflated.

**Figure 5:** *Osprey* about to collide with *Osprey II*

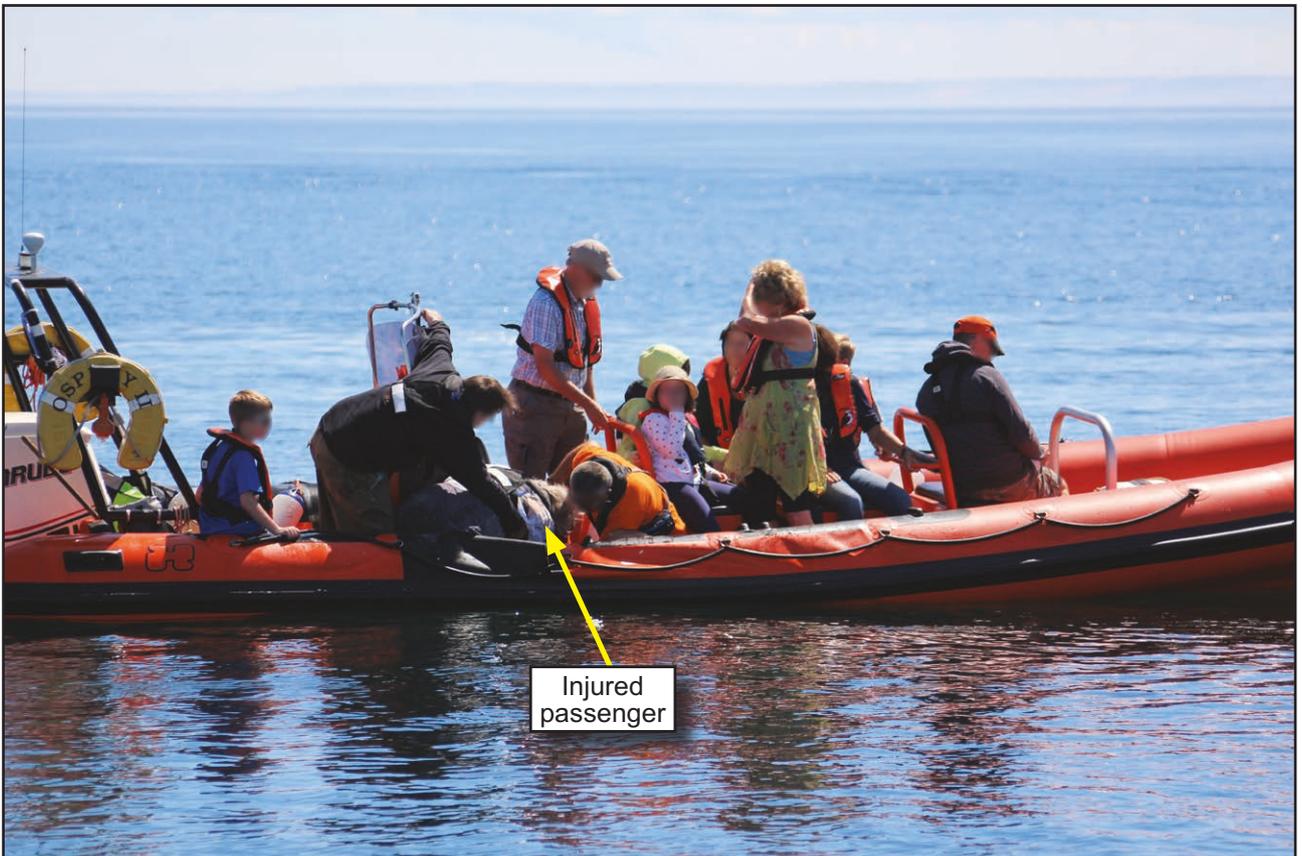
*Osprey II*'s skipper, realising that the passenger was injured, pushed *Osprey*'s bow away, freeing her. The skipper then made an initial assessment of the injured passenger, who was in obvious pain but able to communicate. He tried to relocate her onto one of the bench seats, but she was in too much pain to move (**Figure 6**).

**Figure 6:** Injured passenger in slumped position following accident

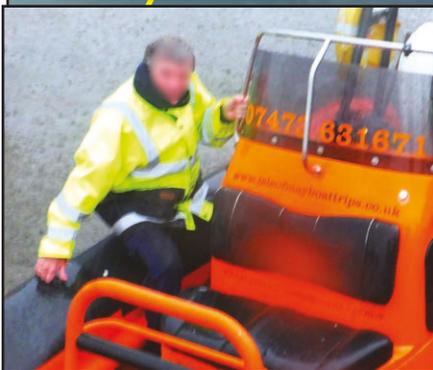
Figure 8 inset: actual seating position on tube of *Osprey II*

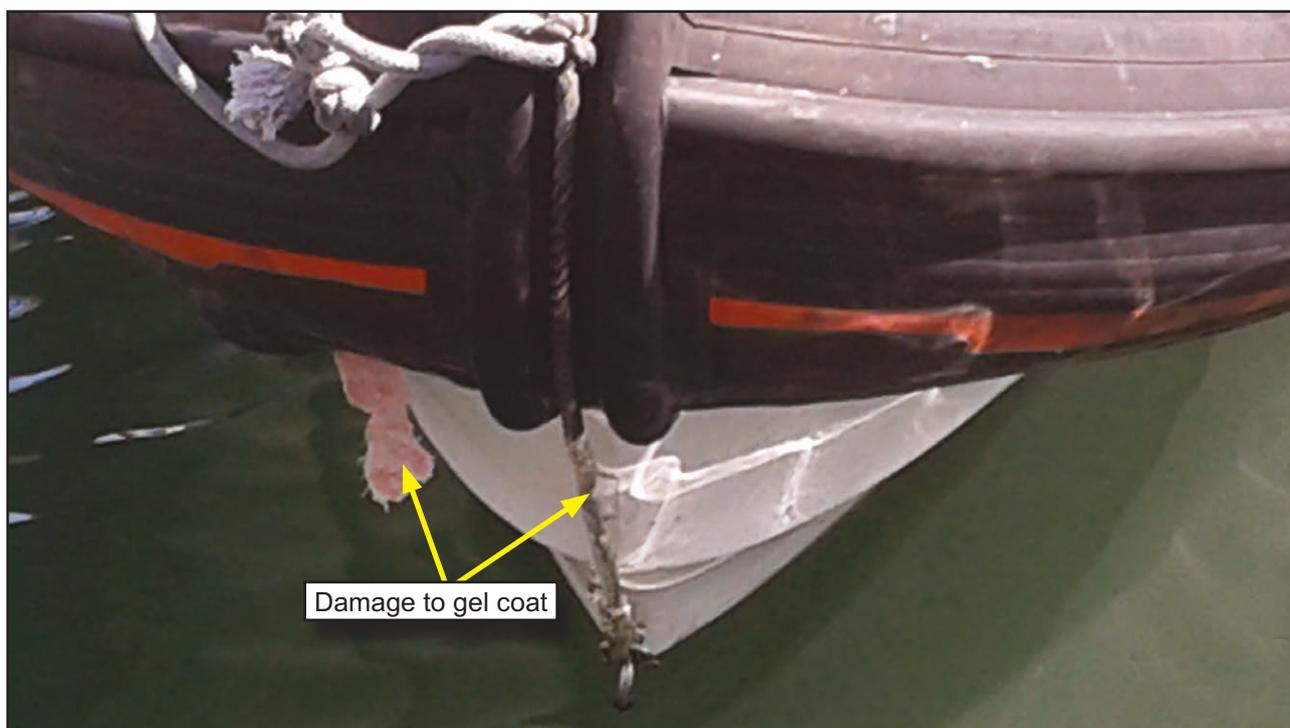
**Figure 9:** *Osprey*

*Osprey* sustained minor damage to the gel coat on its bow (**Figure 9**).

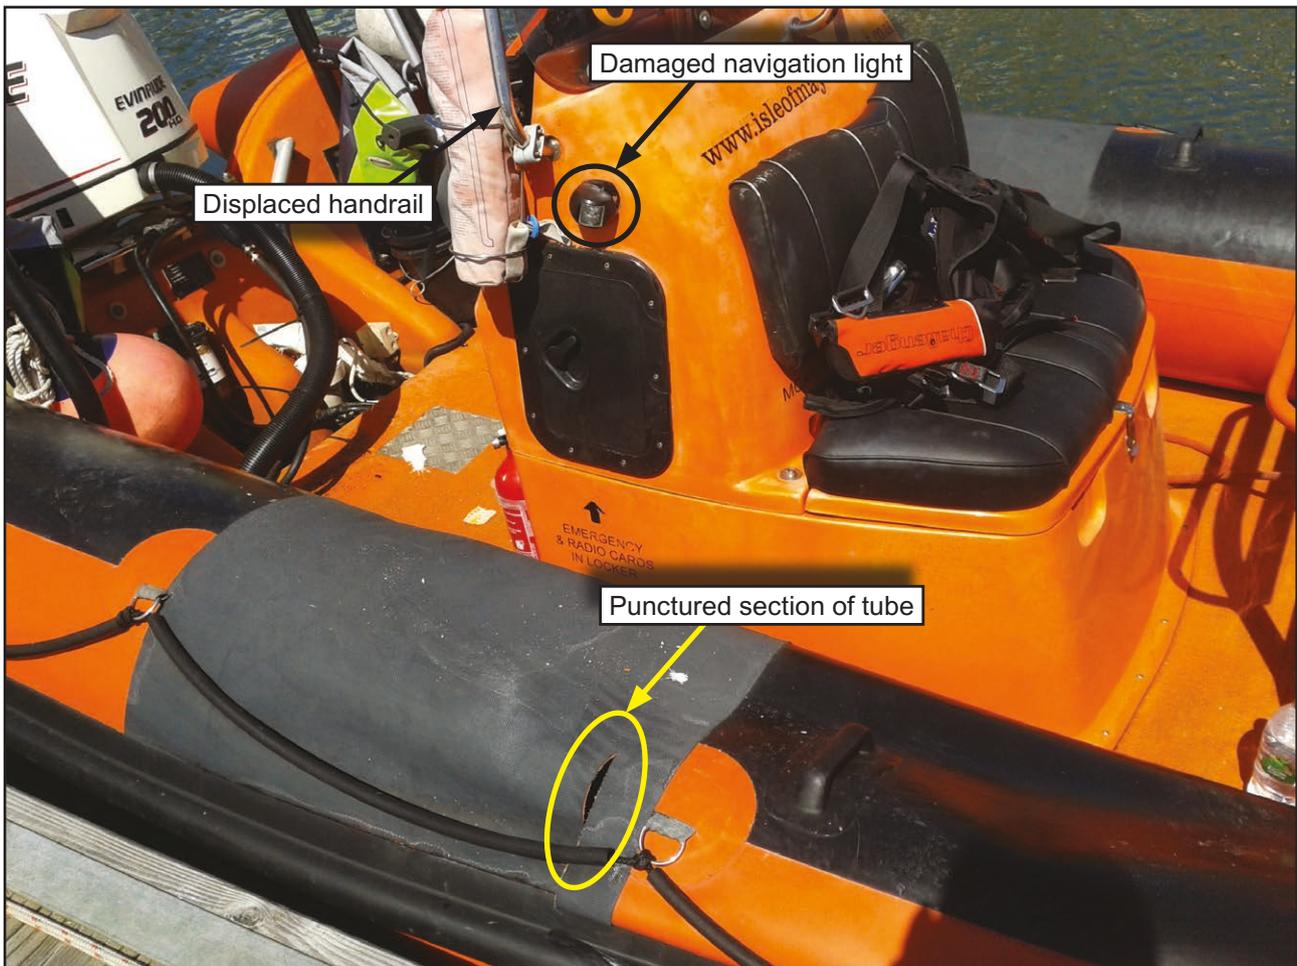
In addition to *Osprey II* sustaining a puncture and tear to the aft starboard section of its inflatable tube, there was damage to the helm console, starboard navigation light and stainless steel grab rail (**Figure 10**).

Figure 10: Damage to *Osprey II*

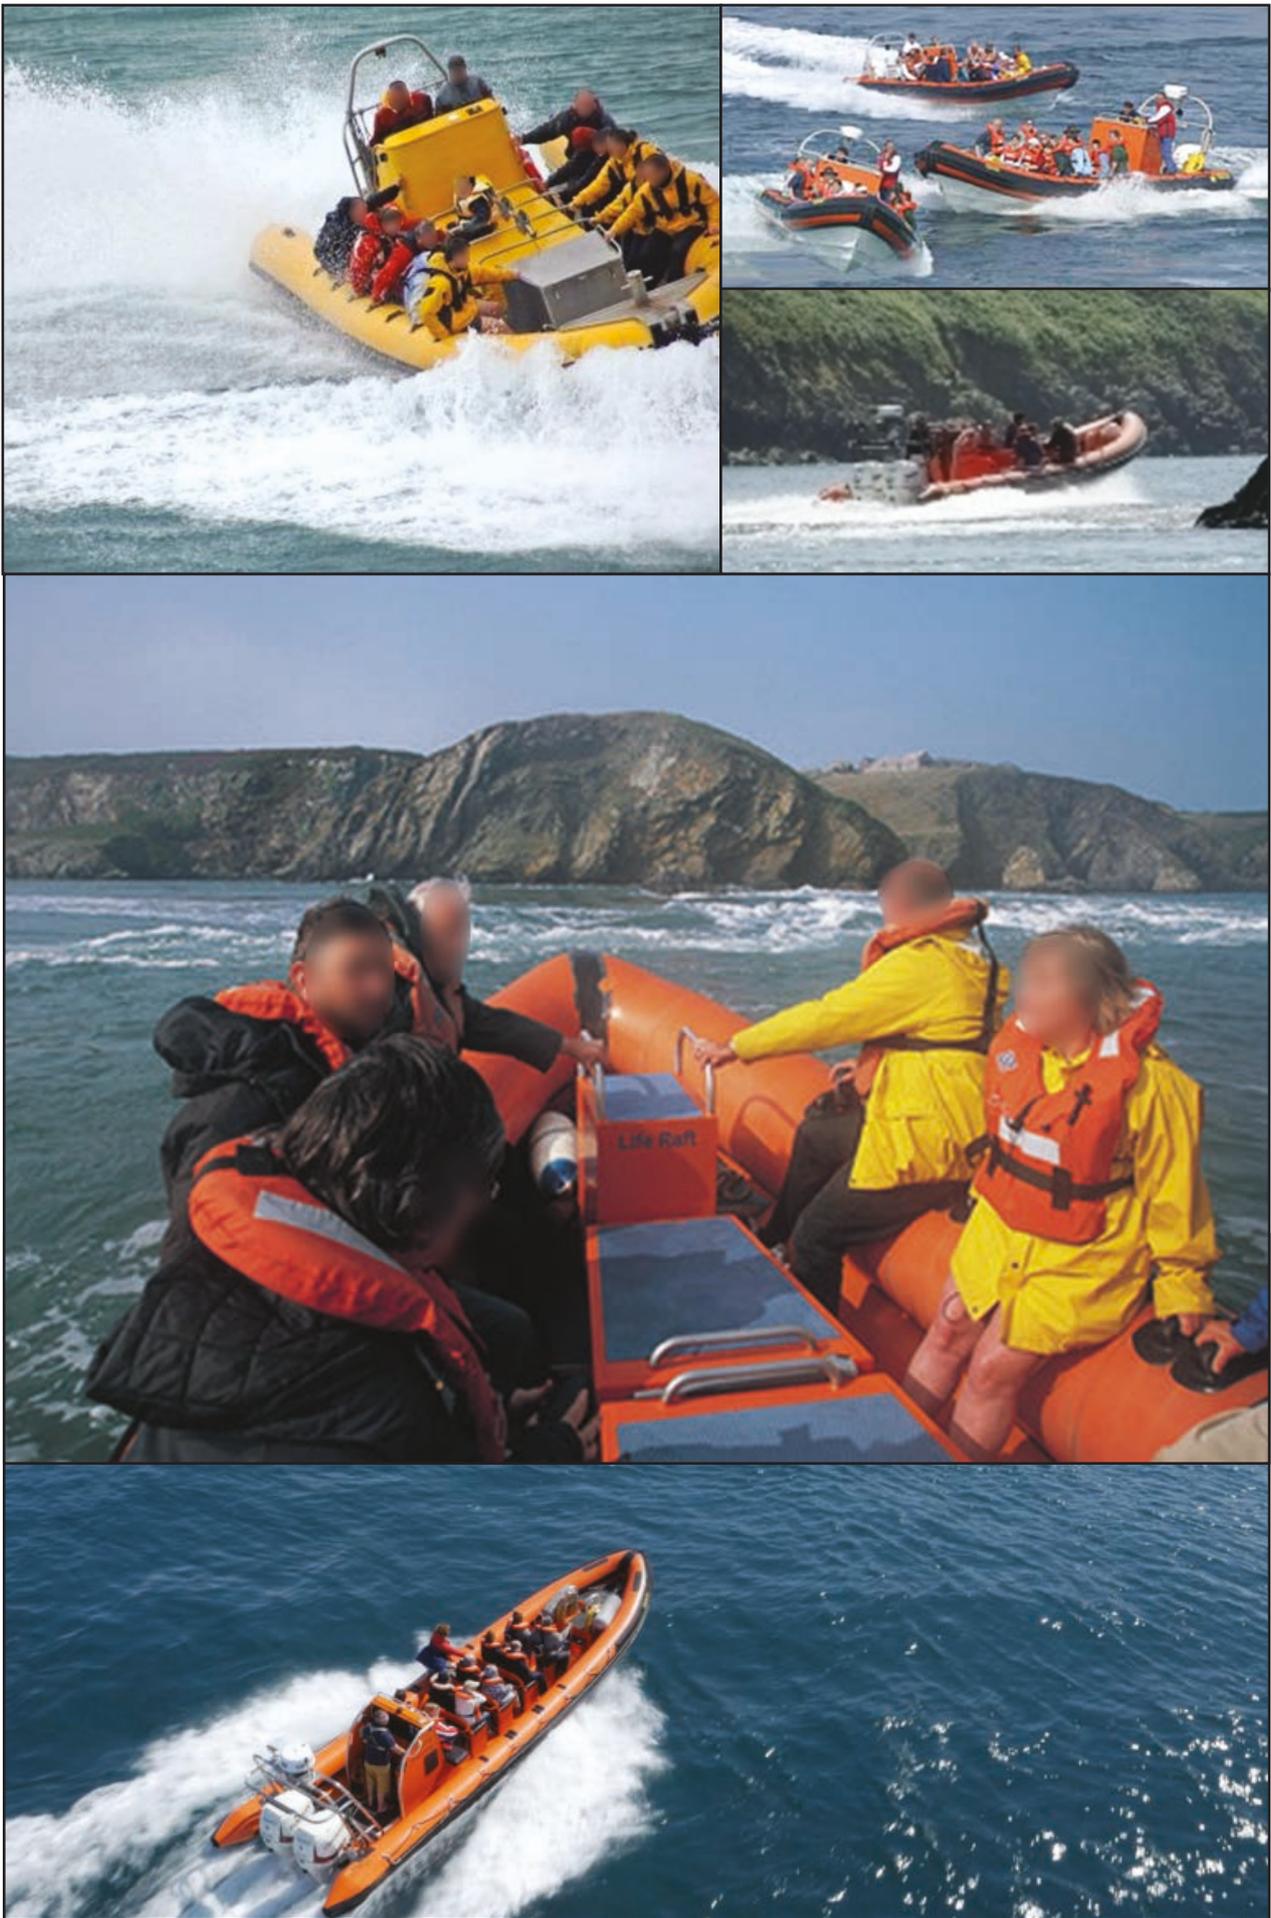
From the findings of this investigation and the MAIB reports listed in section 1.12, it is evident that sole reliance on an operator's risk assessment to determine suitable passenger seating for a particular activity is resulting in widespread unsafe practices. Of particular concern is the absence of a common understanding between operators, the MCA, CAs, passengers and port authorities as to when seating on a RIB's inflatable tubes is considered to be unsuitable.

**Figure 12:** Examples of inappropriate seating on RIBs operating around the UK

- 2017/115** Include in its forthcoming Recreational Craft Code with respect to commercially operated passenger carrying RIBs:
- A requirement for the certificated maximum number of passengers to be limited to the number of suitable seats designated for passengers.
  - Guidance on its interpretation of "suitable" with respect to passenger seating.
  - A requirement for passengers not to be seated on a RIB's inflatable tubes unless otherwise authorised by the Certifying Authority and endorsed on the RIB's compliance certificate with specified conditions to be met for a particular activity.

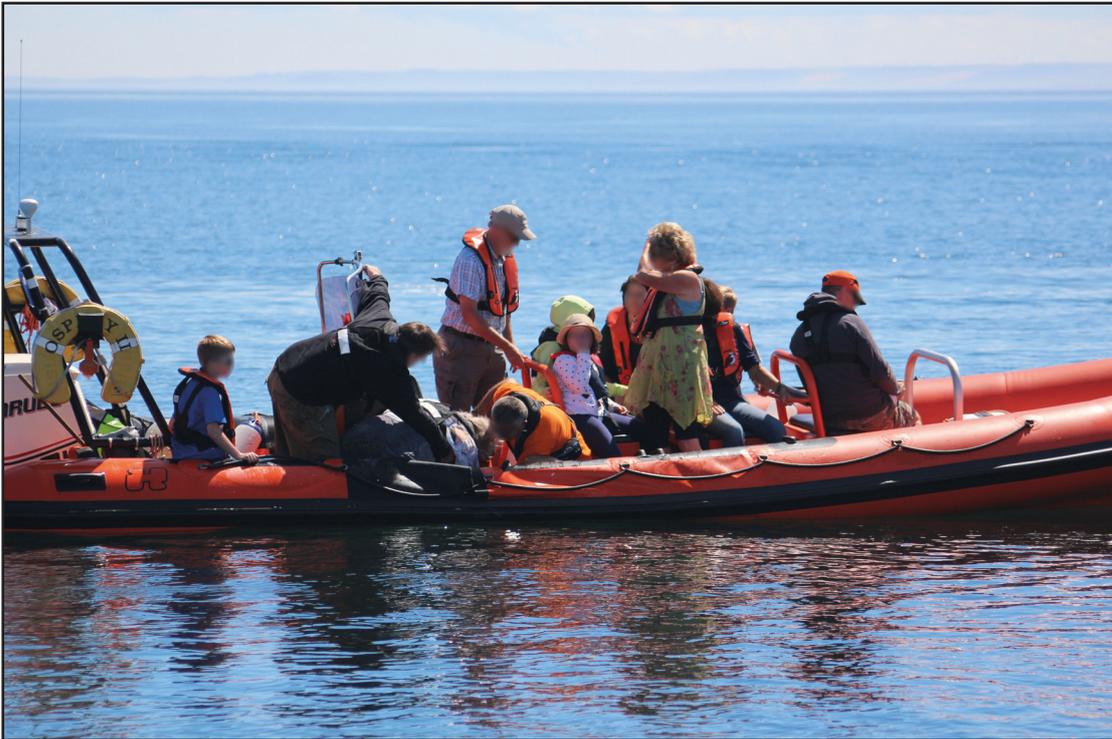
**Figure 2:** Injured passenger in slumped position following accident
