ACCIDENT

Aircraft Type and Registration:	Westland Wasp HAS1, G-KAXT	
No & Type of Engines:	1 Rolls-Royce Nimbus MK 10301 turboshaft engine	
Year of Manufacture:	1967 (Serial no: F9669)	
Date & Time (UTC):	23 September 2016 at 0845 hrs	
Location:	Bishopstone, Salisbury, Wiltshire	
Type of Flight:	Private	
Persons on Board:	Crew - 1	Passengers - 1
Injuries:	Crew - None	Passengers - None
Nature of Damage:	Broken universal joint and collective pitch control rod, damaged tail rotor and driveshaft, structural damage	
Commander's Licence:	Private Pilot's Licence	
Commander's Age:	63 years	
Commander's Flying Experience:	984 hours (of which 379 were on type) Last 90 days - 21 hours Last 28 days - 8 hours	
Information Source:	AAIB Field Investigation

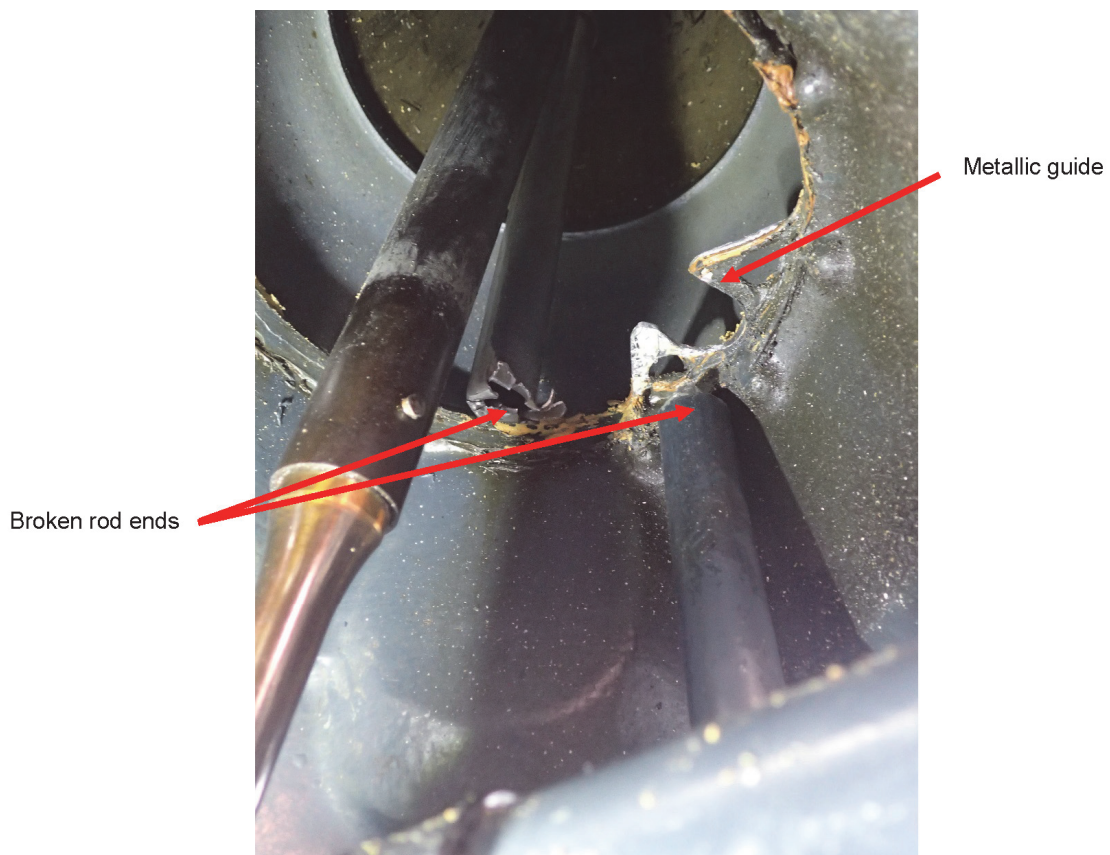
Figure 2

Examination, under the supervision of the AAIB, identified that the collective pitch control rod in the main rotor gearbox had broken. The failure occurred in an area where the rod passes through an aperture in a metallic 'guide' (Figure 2). By design, the rod should not touch the guide.

Broken collective pitch control rod

The circumferential fracture faces had been damaged by repeatedly impacting the surrounding structure and it was not possible to establish the initiating failure mechanism. Nevertheless, axial cracks extended approximately 30 mm away from the failure and the metallurgist identified features that were indicative of fatigue.

The vibration caused accelerated wear and cracking in both bushes in the pitch rod upper attachment fitting. The excess wear allowed lateral movement of the control rod and, therefore, contact with the metal guide. Repeated contact with the guide eventually resulted in the rod failing due to fatigue.

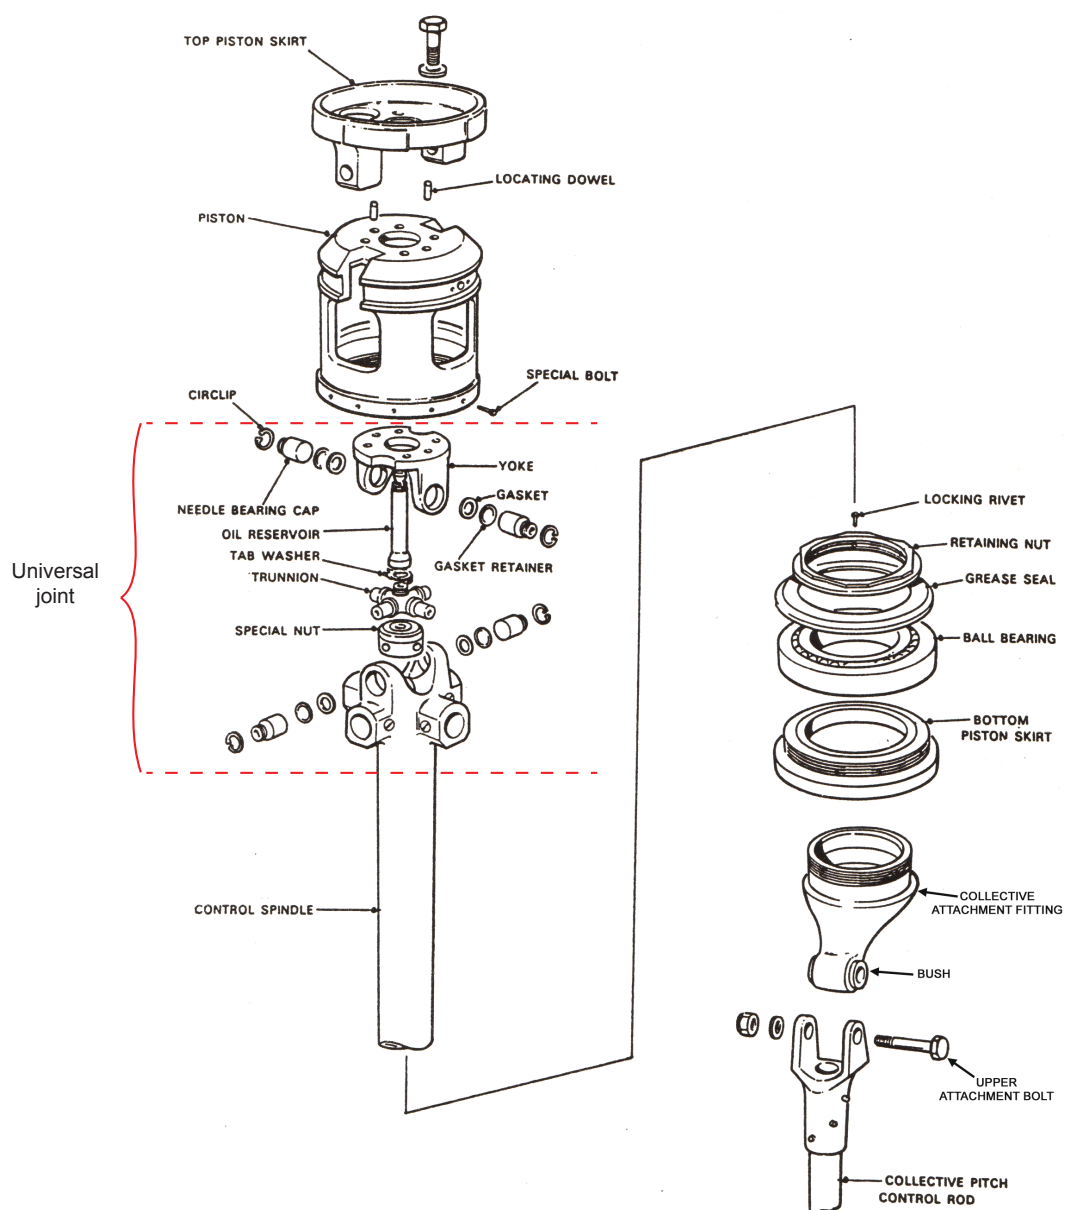
Figure 3
Control hub assembly

The main rotor gearbox was removed and disassembled to access the control hub assembly and the upper section of the broken collective pitch control rod (Figure 3). All four spider arms showed evidence of unexpected wear due to repeated contact with the vertical slots in the main rotor drive shaft, which exhibited corresponding wear.

The joint between the collective pitch control rod and the collective attachment fitting exhibited excessive play. The bolt and bushes (both of which were cracked) were found to be outside the allowable wear limits. The excess play would allow lateral movement of the control rod resulting in contact with the metal guide.

Further examination of the control hub assembly identified corrosion on the universal joint and one of the 'ears' of the cyclic control spindle had broken, allowing the universal joint trunnion to become partially free. A cylindrical component found loose within the gearbox was identified to be the oil reservoir and an indentation on it had been made by contact with the adjacent piston skirt.

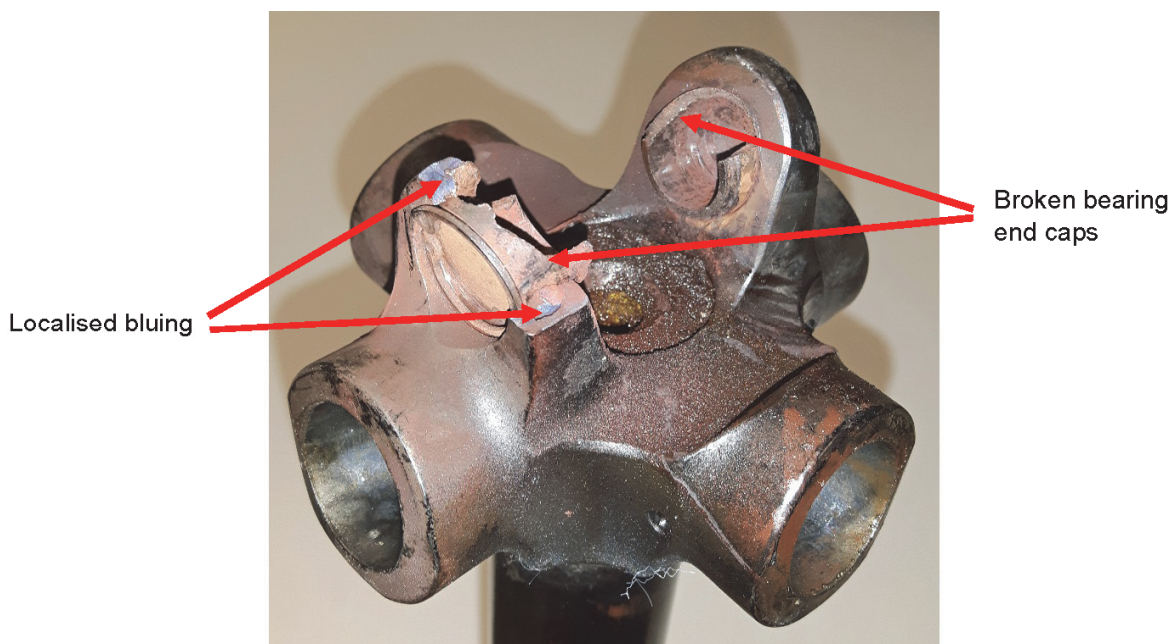
Figure 4

Corrosion deposits on the fracture faces of the broken control spindle ear indicated that the failure was not recent (Figure 4). Localised bluing of the material was indicative of an overheated condition. Both bearing caps were corroded and sections of their outer walls were missing; only four needles from the two needle bearing assemblies were identified.

Control spindle showing corrosion, broken ear and damaged end caps

The EMPD requires operators to perform a visual check of the condition of the universal joint and conduct periodic lubrication of the joint.

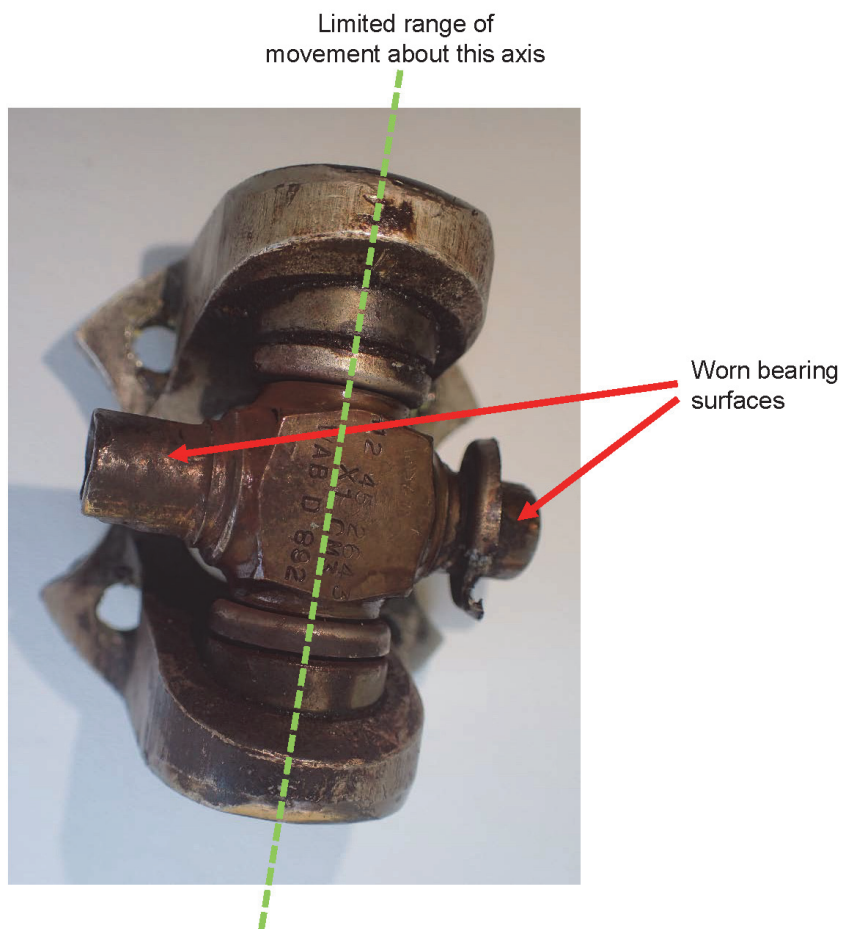
Figure 5

The exposed bearing surfaces of the trunnion showed extensive corrosion and wear (Figure 5). Attempts to move the trunnion about the axis that remained intact required undue force and the range of movement was restricted to approximately 10°. The evidence indicated that the universal joint had been operating with insufficient lubrication for a considerable period of time.

Corroded universal joint trunnion and worn bearing surfaces

The mechanical damage indicated that the universal joint had been operating without lubrication for an extended period of time. The manufacturer considered that vibration would have been expected and the pilot advised that vibration had been identified in the months preceding the accident. The cause had not been established and an experienced Scout pilot who had flown in G-KAXT had expressed concern over the severity of the vibration. Irrespective of this, however, the helicopter had successfully completed an air test four days prior to the accident.
