ACCIDENT

Aircraft Type and Registration:	Breezer B600E, D-ETDK	
No & Type of Engines:	1 Rotax 912 ULS	
Year of Manufacture:	2014	
Date & Time (UTC):	2 August 2016 at 0933 hrs	
Location:	2.5 nm NW of Oban Airport, Argyll	
Type of Flight:	Private	
Persons on Board:	Crew - 1	Passengers - 1
Injuries:	Crew - 1 (Serious)	Passengers - 1 (Serious)
Nature of Damage:	Aircraft destroyed	
Commander's Licence:	Light Aircraft Pilot's Licence	
Commander's Age:	63	
Commander's Flying Experience:	2,500 hours (of which 1,200 hours were on type) Last 90 days - 30 hours Last 28 days - 15 hours	
Information Source:	AAIB Field Investigation

Synopsis

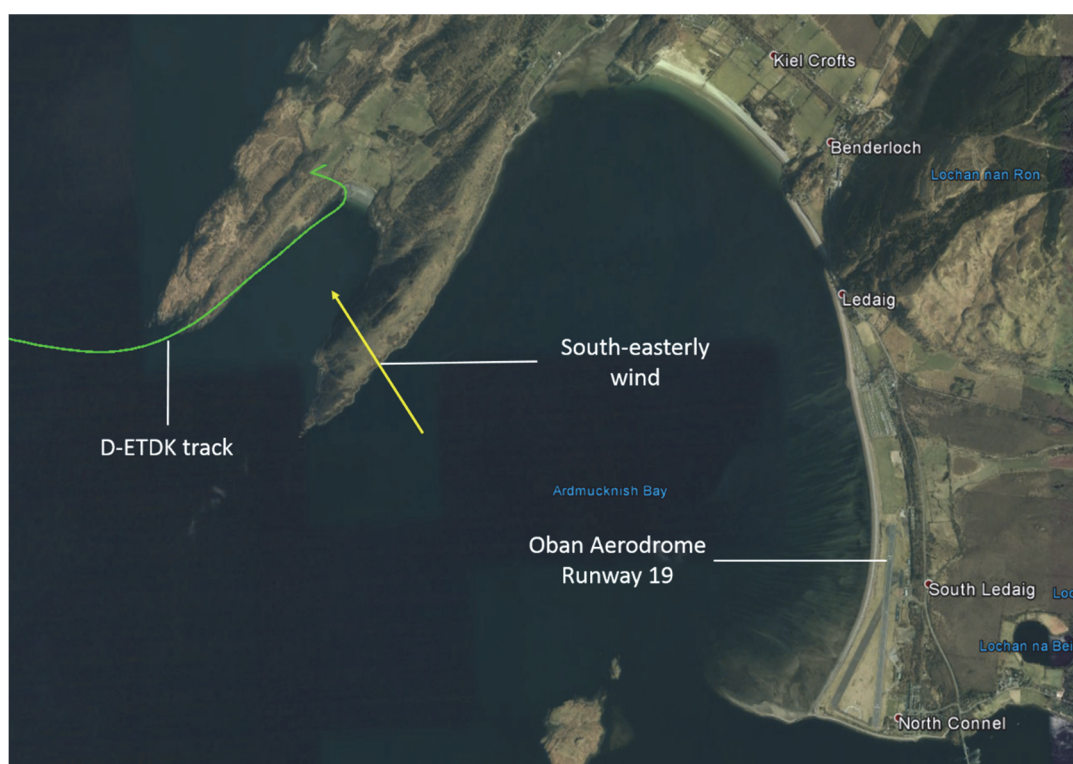
Figure 2

The pilot of D-ETDK saw some of the aircraft ahead begin to fly “unusual” ground tracks to increase the separation between them before landing. The aircraft immediately ahead of his flew a 360° turn for spacing and the pilot of D-ETDK turned to track approximately 050°M and slowed his aircraft to create his own spacing from the rest of the formation (Figure 2). He flew along the north-western edge of a small inlet, parallel to a ridge which lay upwind to the southeast of him, and, as he reached the end of the inlet, he encountered turbulence and lost control of the aircraft. Aware that his aircraft was descending rapidly at low level, the pilot activated the aircraft’s BRS at what he estimated to be between 600 and 700 ft amsl and the aircraft struck the ground shortly afterwards. The pilot and passenger were seriously injured.

Final portion of the D-ETDK recorded track

D-ETDK struck the ground in an area of grassland adjacent to woods, on the headland to the northeast of Ardmucknish Bay, opposite Oban Airport (Figure 2). The initial impact created ground marks and removed sections of grass. A second large ground mark, preceded by several ‘slash’ marks, contained sections of broken propeller blades and parts of the engine cowl. Further sections of propeller blade were found some 20 m away. A wreckage trail of small structural items then extended on a bearing of approximately 324° toward the wreckage of the fuselage. The grass along the wreckage trail had been flattened and further ground marks where the grass had been removed were visible at various points. The fuselage was resting inverted, with the nose of the aircraft pointing back along the wreckage trail, but offset by some 40°. The ballistic recovery parachute was still attached to the aircraft and extended out in a direction of approximately 285°.
