ACCIDENT

Aircraft Type and Registration:	UAS Schiebel Camcopter S-100 (unregistered)	
No & Type of Engines:	1 Austro Engine Wankel R-1	
Year of Manufacture:	2008 (Serial no: 232)	
Date & Time (UTC):	18 October 2016 at 0926 hrs	
Location:	Ship stationed off the coast of Benbecula, Outer Hebrides	
Type of Flight:	Aerial Work	
Persons on Board:	Crew - N/A	Passengers - N/A
Injuries:	Crew - N/A	Passengers - N/A
Nature of Damage:	Destroyed on impact with, and immersion in, water	
Commander's Licence:	N/A	
Commander's Age:	31 years	
Commander's Flying Experience:	999 hours (of which 999 were on type) Last 90 days - 8 hours Last 28 days - 6 hours	
Information Source:	Aircraft Accident Report Form submitted by the pilot, and manufacturer's investigation report

Synopsis

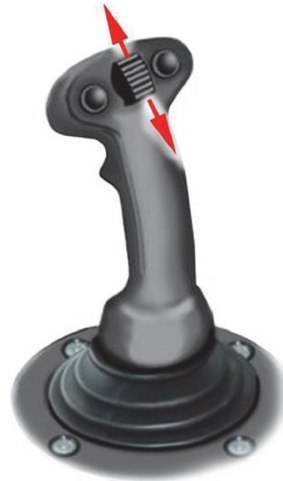
Figure 2

Operator joystick showing climb-rate thumb rocker control

An investigation was carried out by the manufacturer which, in summary, determined that for all three takeoffs, the operator's climb-rate inputs were below the 55% minimum required for shipboard operations. For the accident flight this started at 37%, reducing to 7% over 1.3 seconds; however, this was in addition to a rear cyclic command not present on the first two takeoffs until the UA was higher off the helideck. As the UA moved backwards without climbing, the operator selected 100% climb rate but continued to command more rear cyclic, increasing rearward acceleration. The investigation also noted that the ship's upward heave at the time also contributed to the UA's failure to climb away from the ship.

The manufacturer has implemented a software change to reduce operator workload during takeoff. If the UA is on the ground and the trim mode has been selected:

- Operator thumb rocker climb-rate inputs between -50% and +50% produce an automatic climb rate command of +50% until the trim becomes active, and
- All cyclic joystick inputs are ignored until the trim becomes active.
