Rail Accident Investigation Branch

Rail Accident Report

Fatal accident involving a train passenger near Balham 7 August 2016

Report 09/2017
May 2017

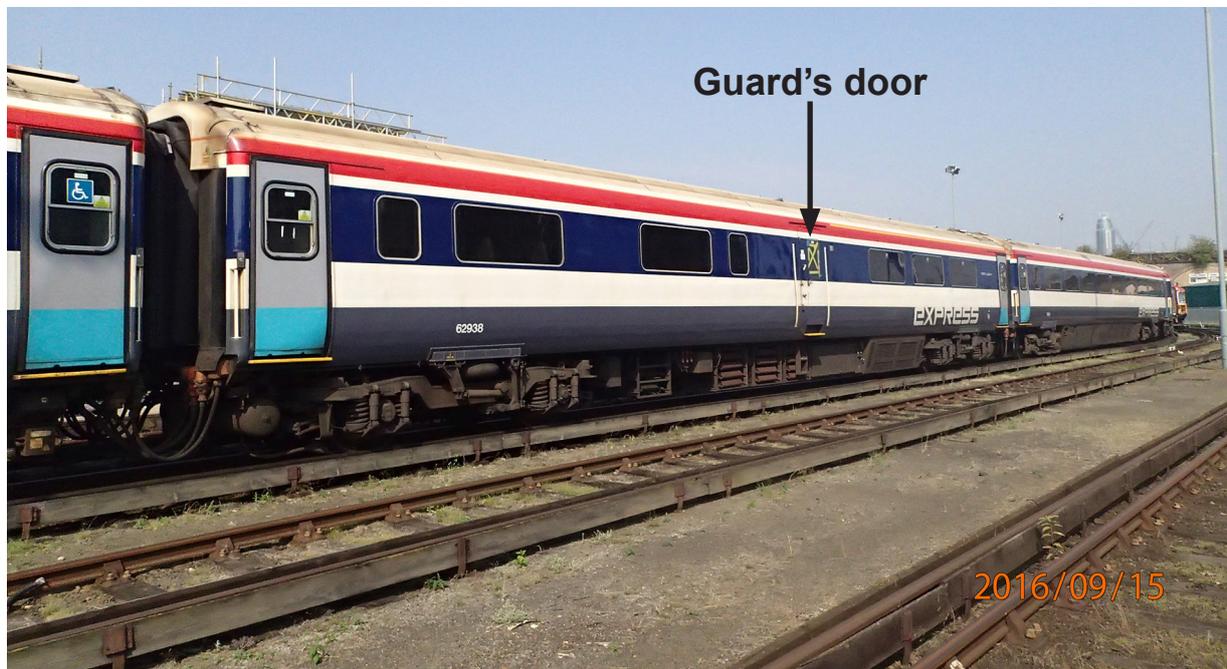
Figure 4: Middle carriage of a Class 442 unit showing guard's door (NB: the yellow tape on this door reflects a post-accident modification intended to discourage passenger use of the droplight window; see paragraph 111).

- Each passenger door has an opening *droplight* window which is usually locked with a carriage key, but can be opened to a limited extent by train crew for emergency ventilation during hot weather. The doors adjacent to the guard's compartment have fully opening droplight windows which are not lockable, so that the guard may use them during train dispatch.

- 111 After the accident, GTR implemented an interim measure of marking the corridor droplight window with yellow hazard tape, in order to deter its use by passengers (figure 11). The company then consulted with its health and safety representatives and, after agreeing that there was no requirement for guards to lean out of the window for train dispatch purposes, fitted window bars to its remaining Class 442 units (figure 12). This was completed by mid-December 2016.

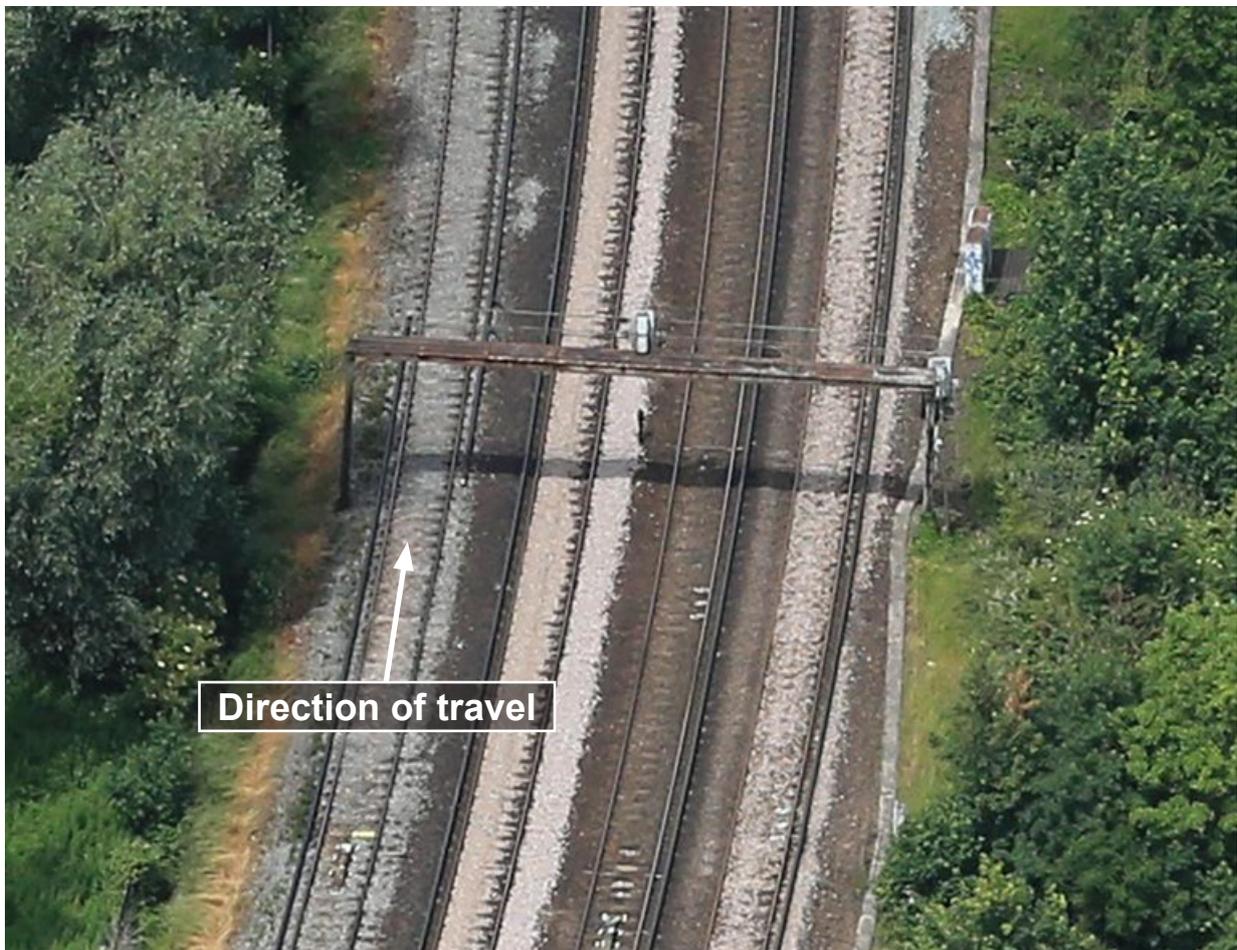
- The signal gantry is a *portal* structure spanning all four tracks of the railway (figure 5). It carries signals VC641 and VC643, which are for trains running in the down direction. The column on the up (west) side stands on the crest of a low embankment which is about 4 metres high and rises at an angle of approximately 30 degrees.
- Evidence indicates that the gantry was installed in 1952, but no records relating to its design or installation are available.

Figure 5: Overhead view of the signal gantry (courtesy of Network Rail)

- 68 The RAIB's site inspection found that the gantry column on the up side of the track leans inwards (towards the track) by two degrees. This results in a further reduction in clearance of about 105 mm at the top of the window.

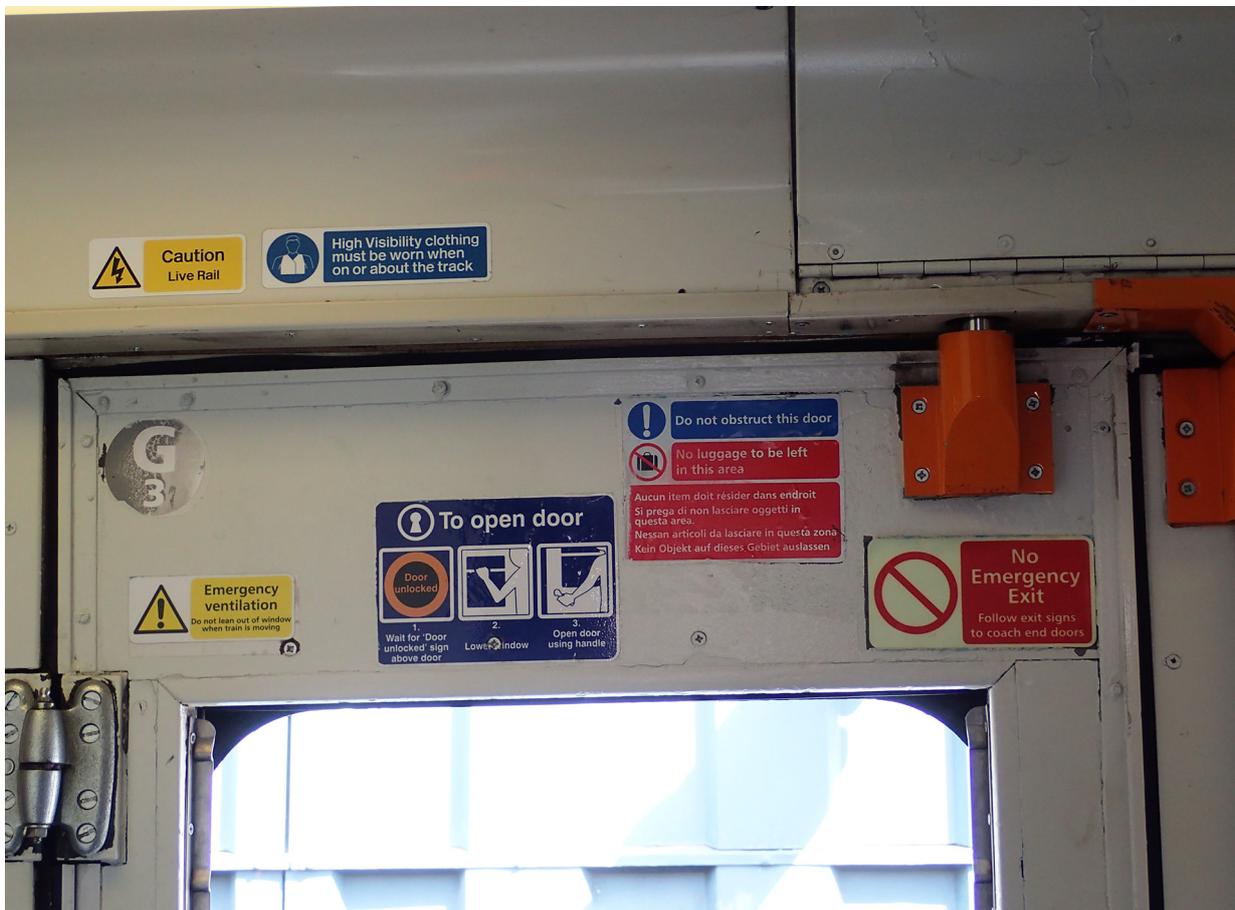
- 49 There is a yellow warning sticker on the door above the window stating, 'Emergency ventilation. Do not lean out of window when train is moving' (figure 6). The RAIB observed that the warning about leaning out of the window was secondary to the wording about emergency ventilation; moreover, this sticker exists in a cluttered environment of other warning and information signs. One of these signs, which is more prominent than the warning sticker, provides instructions on opening the door (including lowering the window to access the exterior door handle), despite the fact that this door is not intended for passenger use. Although there is a notice on the outside of the carriage that this door is 'not for passenger use', there is no such notice on the inside. It is not possible to say whether the lack of conspicuity of the warning notice was a factor in the accident at Balham, although the passenger was an experienced railway employee (paragraph 20), who was accustomed to trains with windows of this type.

Figure 6: Warning signage above the window

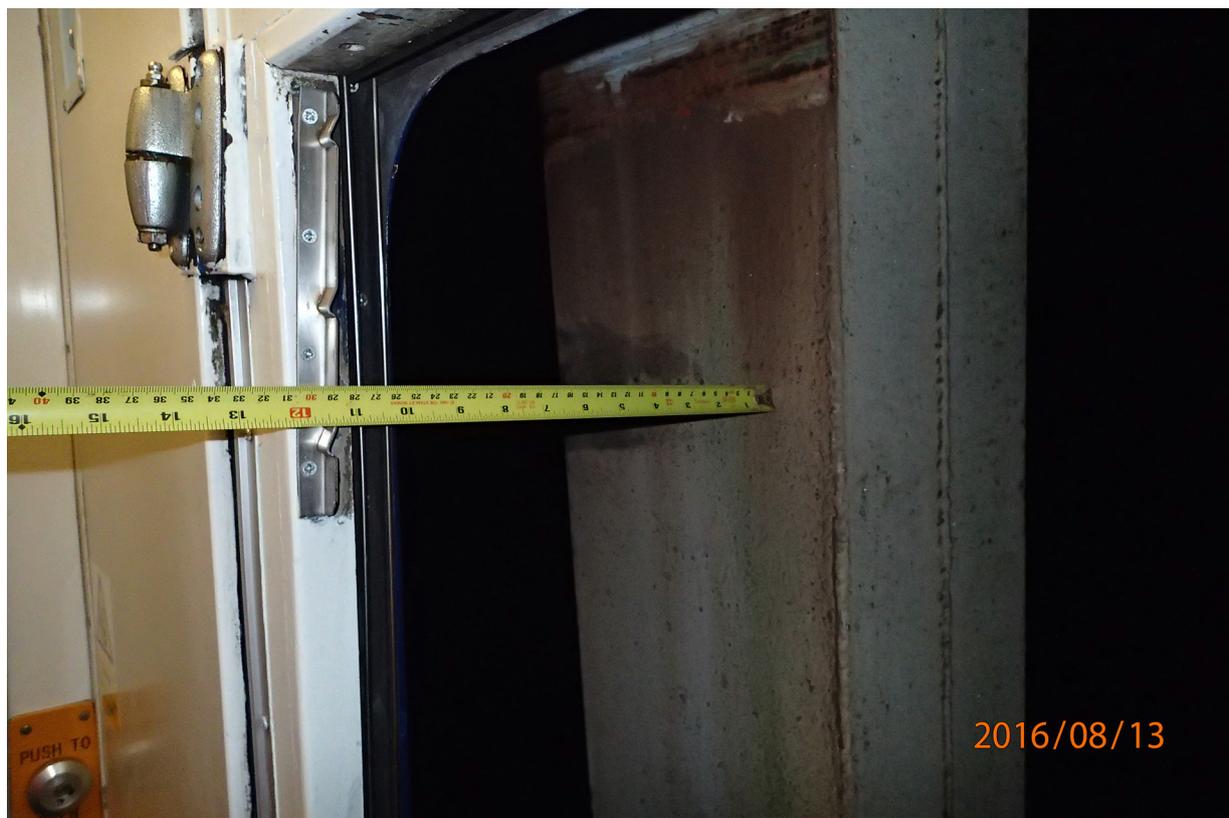
59 Prior to the accident on 7 August 2016, the most recent survey of the gantry by the structure gauging train was on 15 May 2015. Taking into account the full swept envelope of a Class 442 unit, this survey found that the smallest dynamic clearance from the window (measured at the top of the window) was 68 mm, while the static clearance was 209 mm. After the accident, the RAIB measured the static clearance at the impact point (which was about one-third of the way down the window) to be 260 mm (figure 7). Given the differences in measurement points and statistical variation in gauging surveys, these values are broadly consistent with each other.

Figure 7: Static clearance to the gantry from the droplight window

- 60 The oldest figure that Network Rail has for the dynamic clearance to the gantry at the upper end of train window level was recorded in January 2001, when there was a positive clearance of 160 mm at the top of the window, which is in the 'normal' band. Later surveys by the structure gauging train in December 2008, February 2011 and January 2015 found that clearance to the gantry was in the 'anomaly' band, with negative values of -38 mm, -90 mm and -55 mm respectively. Despite these negative values, there is no evidence that passenger trains were making contact with the structure. Track work carried out on 3 February 2015 restored the clearance to the positive value reported above (paragraph 59).

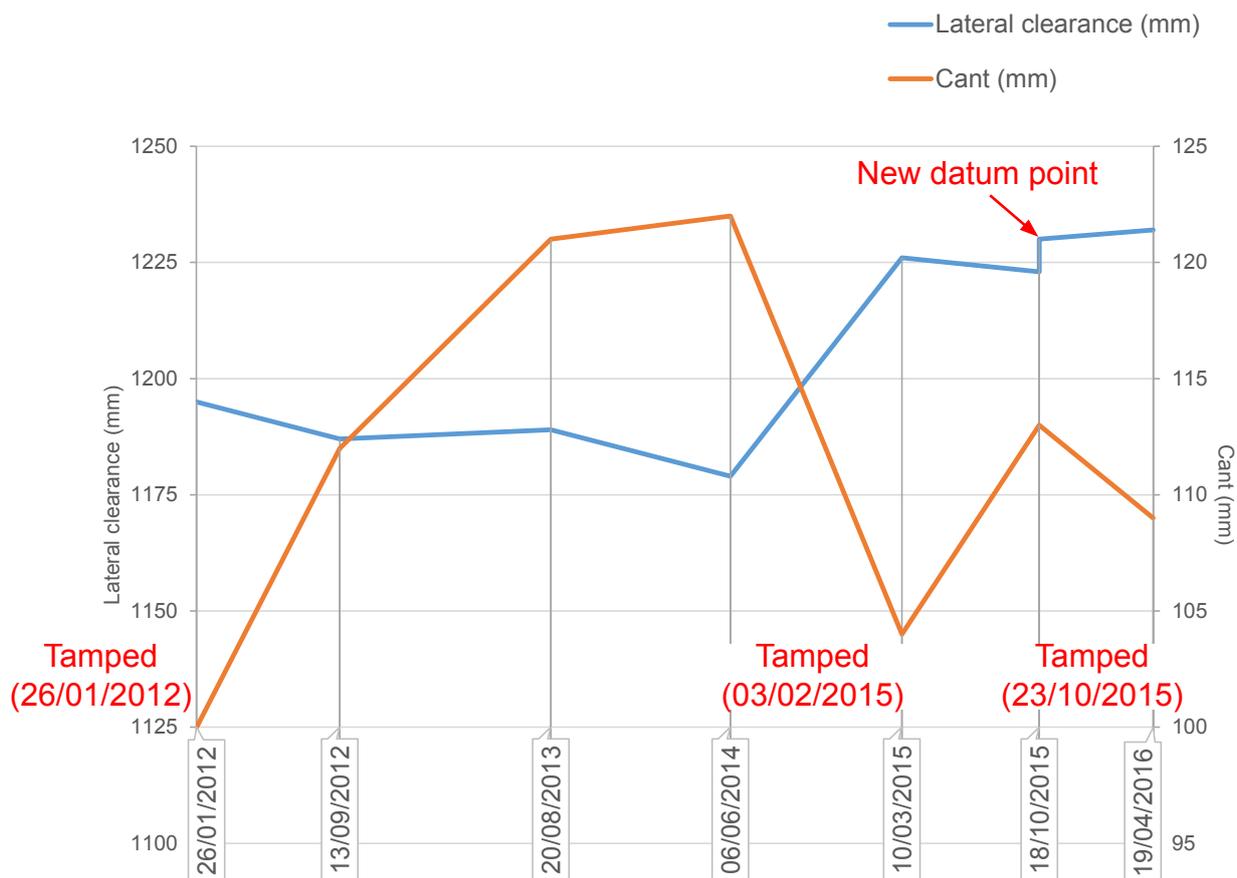
- 65 As well as lateral distance, the manual measurements also record track *cant*. These data show that, as well as the changes in lateral distance described above (paragraphs 62 and 63), track cant at this location also increases over time¹⁵ (figure 8). The minimum value of cant, recorded on 26 January 2012 following the tamping work, was 100 mm; the maximum value (on 6 June 2014) was 122 mm, which was followed by tamping work (paragraph 63). The tamping work aimed to restore cant to a target value of 105 mm.

¹⁵ This may be due to the track gradually slipping down the embankment (paragraph 16). Although Network Rail reported that there are no known earthworks problems in the area, many of the tamping records refer to problems with retaining the ballast on the track.

Figure 8: Graph of the lateral clearance and cant measurements since 2012

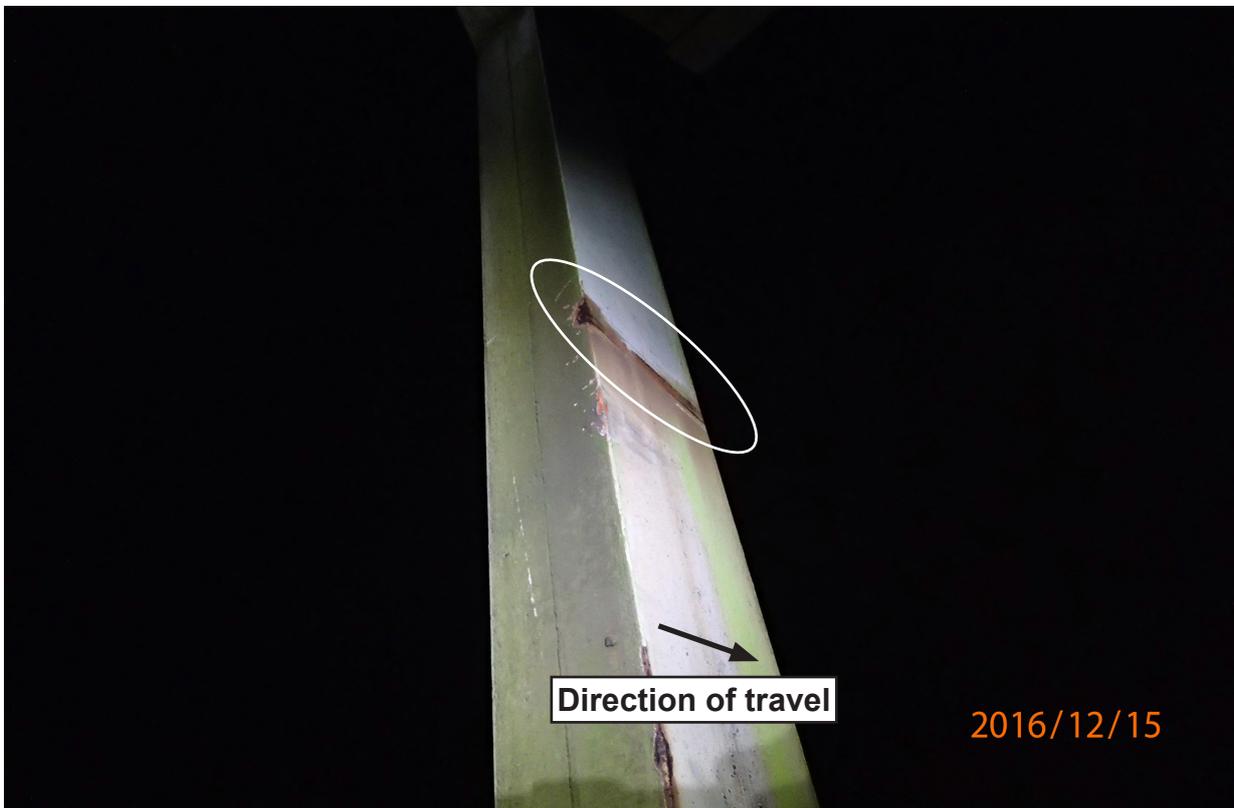
- 71 Network Rail stated that its risk management at this gantry was partly based on the assertion that there had been no vehicle impacts with the structure, despite surveys indicating negative clearance values for several years (paragraph 60). However, the RAIB observed witness marks on the structure indicative of a previous impact with the column (figure 9). Photographic records from Network Rail's structure examinations suggest that this impact occurred between April 2011 and April 2013, a period during which the surveyed clearance to the gantry was at its smallest and when track maintenance work took place to restore the clearance (paragraphs 60 and 63). However, there is no record of a vehicle striking the gantry, and so the RAIB cannot be certain about what caused the marks.

Figure 9: Witness marks (highlighted) on the gantry indicative of an earlier vehicle impact

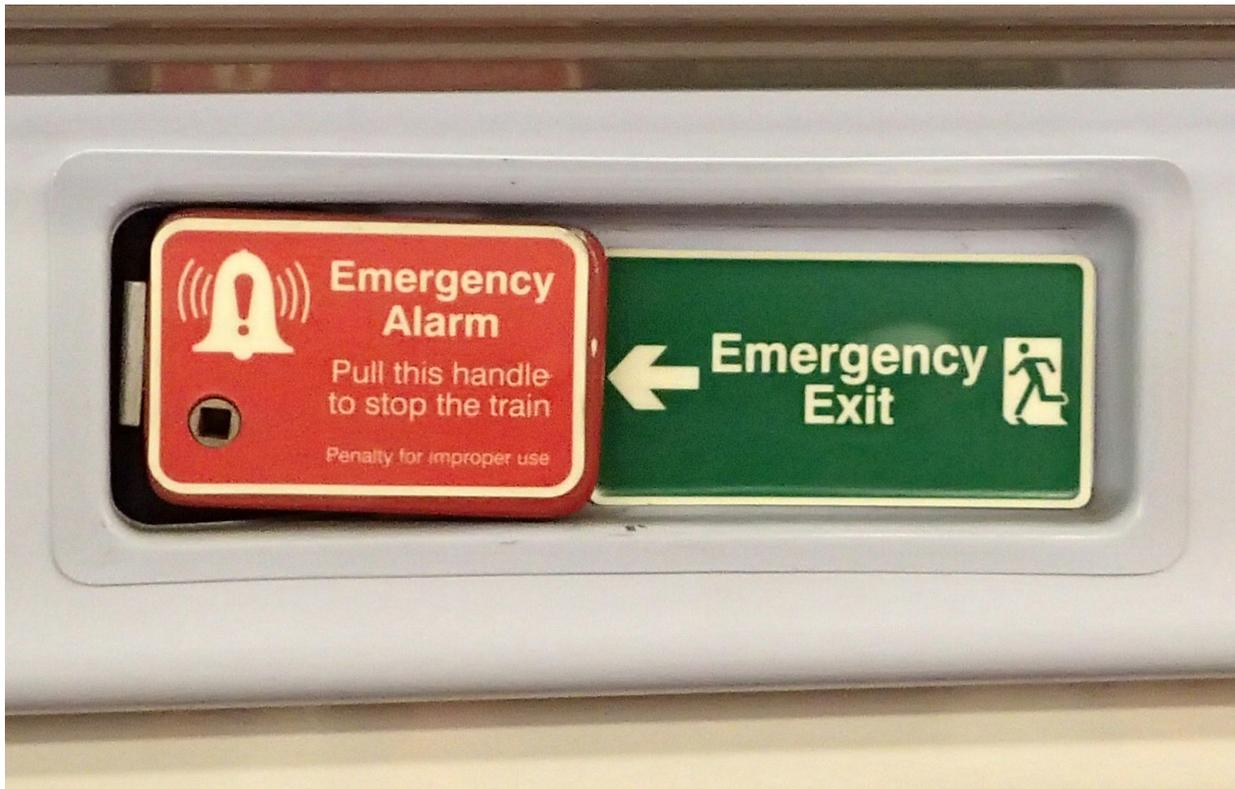
Figure 10: Emergency alarm on the Class 442 unit
