Fire on board fishing vessel *Ardent II* (INS 127) while alongside in Port Henry Basin, Peterhead 16 August 2016

SUMMARY

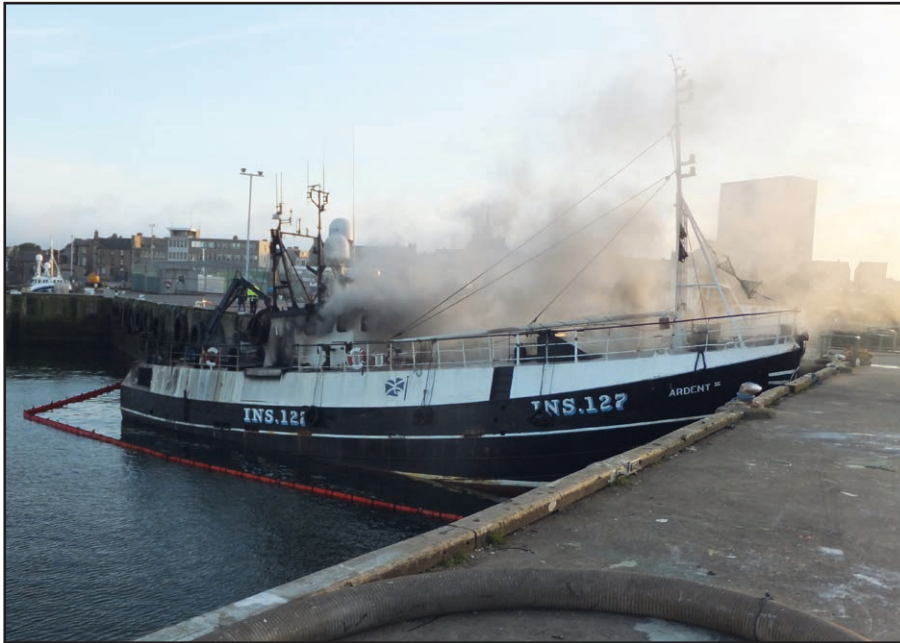
By 1209, the fire on *Ardent II* was believed to be extinguished. However, flames were later seen in the accommodation and further fire-fighting was necessary (**Figure 1**). The fire service continued damping down until the following afternoon, at which time there were no further hot spots or signs of smoke.

Figure 1: *Ardent II* on fire on 16 August 2016

Although still afloat, *Ardent II* was extensively damaged by the fire and was later declared a constructive total loss.

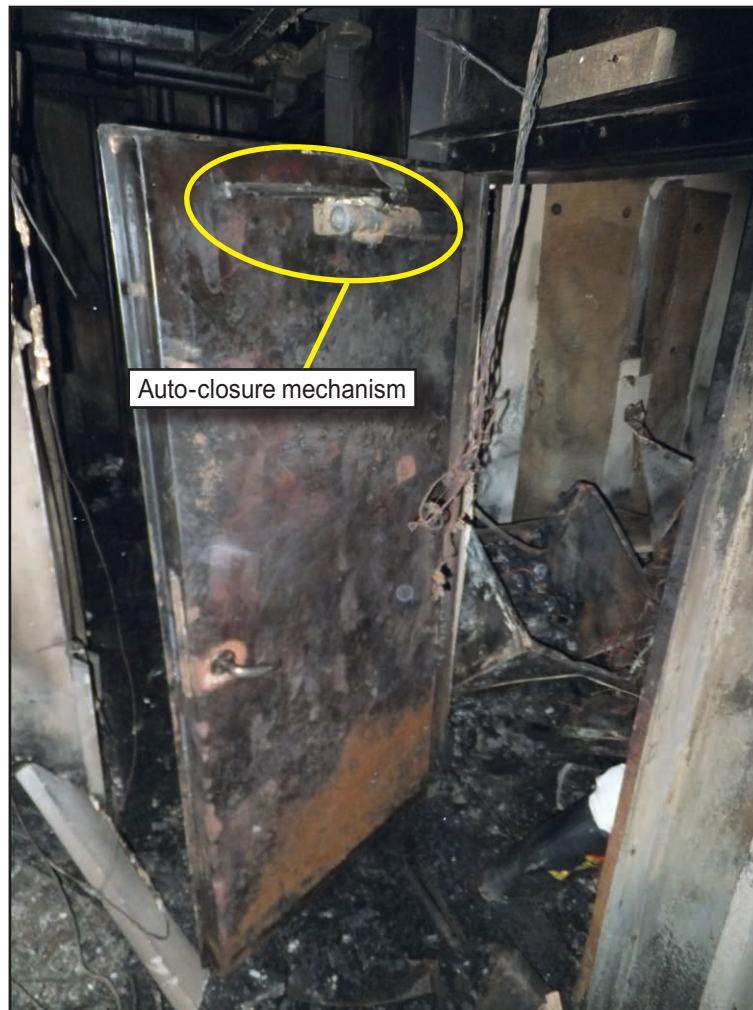
Fire protection fitted to *Ardent II* was limited to the galley boundary. The galley was separated from the crew mess room by a fire door, but this was normally secured open, its auto-closure having been disconnected previously (**Figure 3**).

Figure 3: Galley fire door with auto-closure disconnected

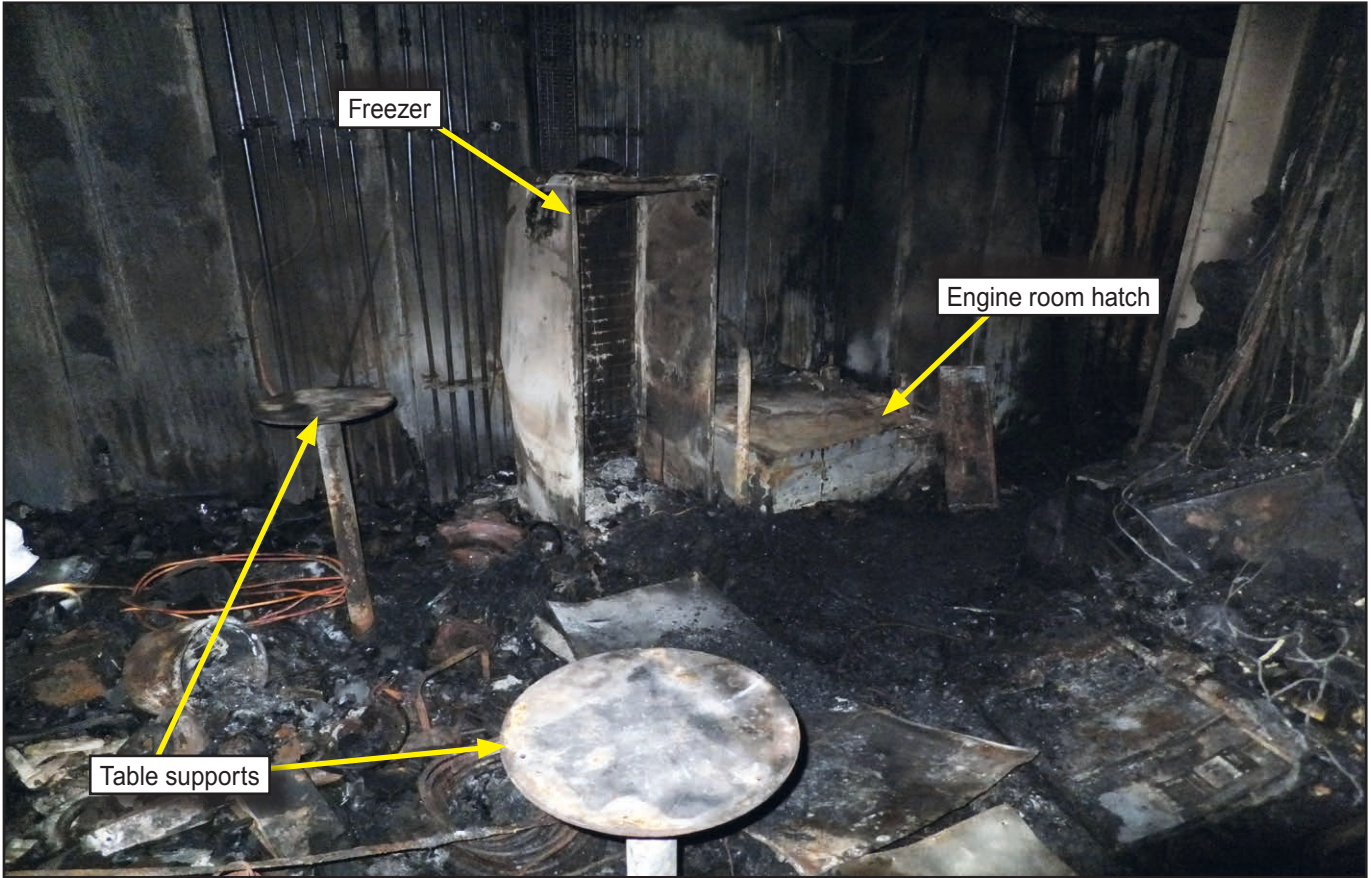
A detailed examination of the fire damage was undertaken to try to establish the source of the fire. The fire patterns and other evidence indicated the likely source of the fire was in the crew mess room. This ruled out it being a potential consequence of welding work carried out the day before the accident. Although the galley area was heavily damaged, the extent to which items had survived in this compartment also eliminated the possibility of the fire having originated there.

Figure 4: Fire damage to crew mess room

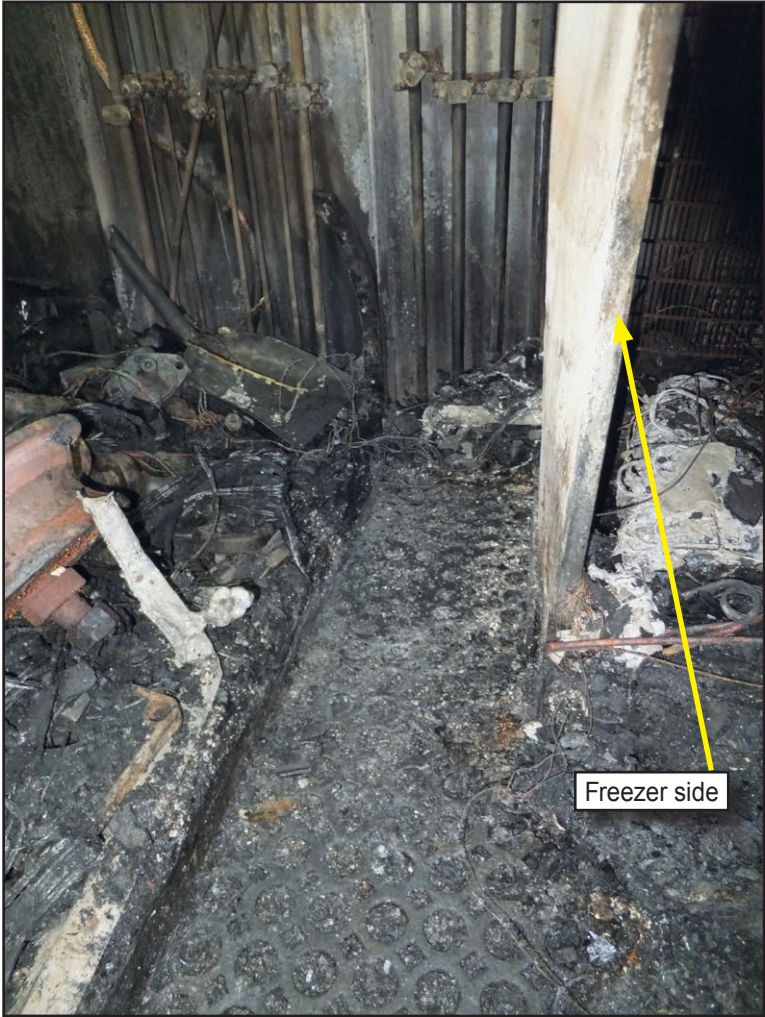
On excavation of the fire scene (**Figure 4**), it was apparent that the seat of the fire was at deck level in the gap between the freezer and the seating in the crew mess room (**Figure 5**). An aluminium plinth edging in this area had melted, there was heavy charring of the wood structure, and remnants of the multi-socket adapter (**Figure 6**), with the freezer plugged in, were found in the debris. A section of the fridge compressor electric cable was found intact, suggesting that the freezer itself was not the source of the fire. In light of this evidence, it is concluded that an electrical fault or failure of the multi-socket adapter was the most likely cause of the fire.

Figure 5: Location of source of fire

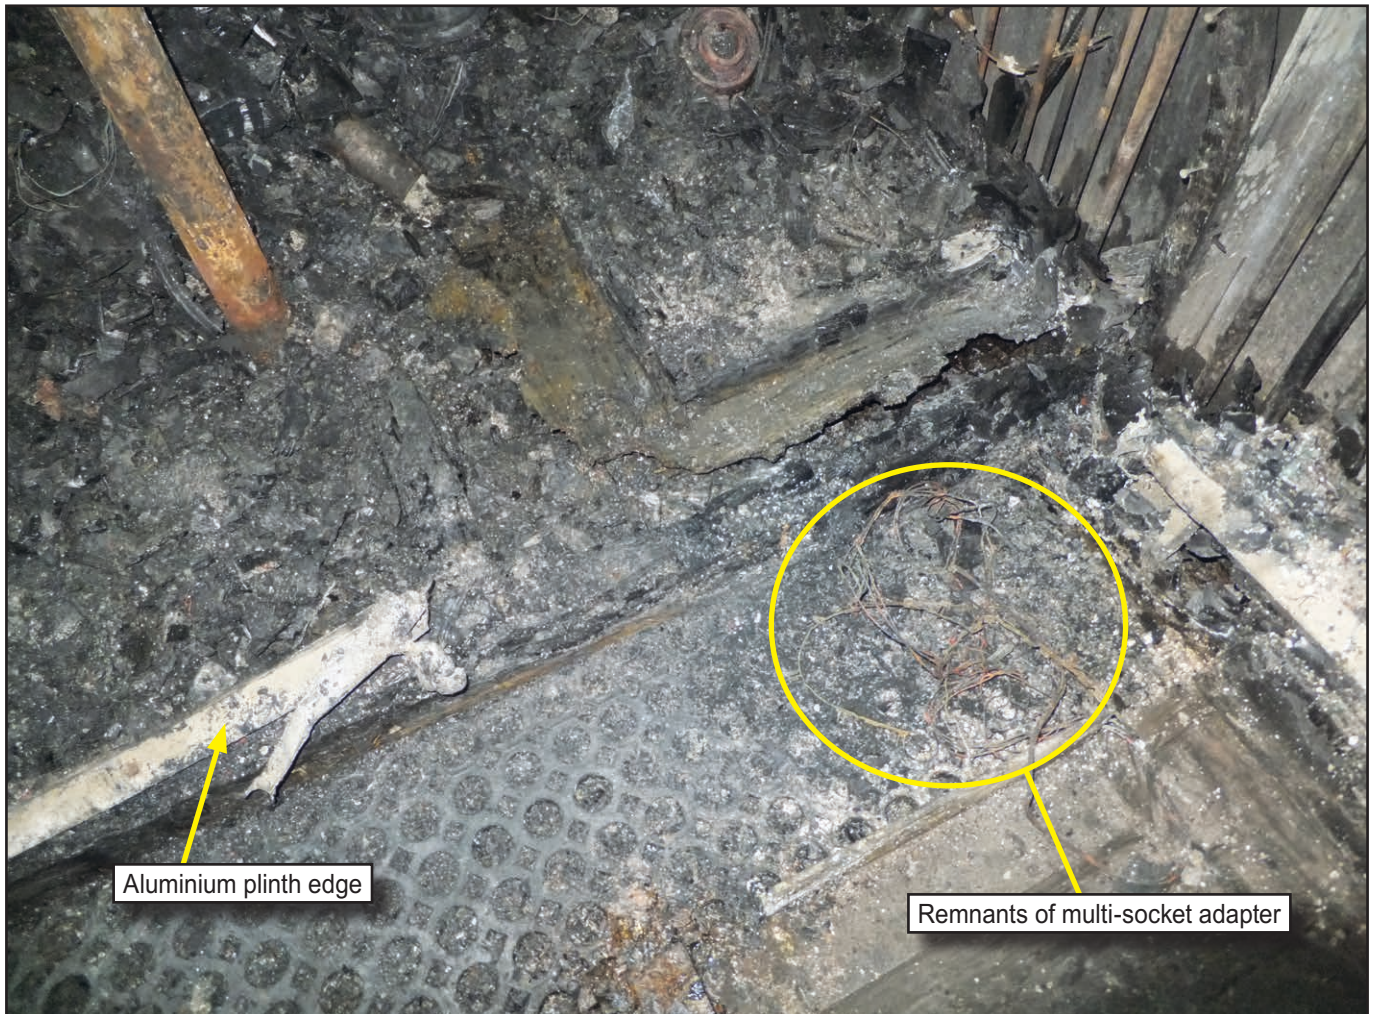
Figure 6: Remnants of multi-socket adapter

- An electrical fault or failure of a multi-socket adapter in the crew mess room was the most likely cause of the fire.
- There was no smoke detector fitted in the crew mess room and it was fortunate that one of the crew awoke and discovered the fire at an early stage. It enabled the crew to be alerted to the fire and triggered them to evacuate the vessel without delay.

- Regular visual inspection of electrical equipment to check for bare wires, that appropriate fuses are in place, and for signs of burning, together with regular PAT, would provide an effective means for reducing the risk of electrical fires.

Issued a flyer to the fishing industry highlighting the safety issues identified in this report, and endorsing the practice of regular visual inspection and PAT of electrical equipment as an effective means for reducing the risk of electrical fires.
