ACCIDENT

Aircraft Type and Registration:	Spitfire IXT, G-LFIX	
No & Type of Engines:	1 Rolls-Royce Merlin 25 piston engine	
Year of Manufacture:	1944 (Serial no: ML407)	
Date & Time (UTC):	15 September 2016 at 1520 hrs	
Location:	Sywell Aerodrome, Northampton	
Type of Flight:	Commercial Operation	
Persons on Board:	Crew - 1	Passengers - 1
Injuries:	Crew - None	Passengers - None
Nature of Damage:	Heavy damage to propeller, minor damage to engine cowls, landing gear doors and wingtip	
Commander's Licence:	Airline Transport Pilot's Licence	
Commander's Age:	60 years	
Commander's Flying Experience:	23,500 hours (of which 500 were on type) Last 90 days - 150 hours Last 28 days - 40 hours	
Information Source:	AAIB Field Investigation

Synopsis

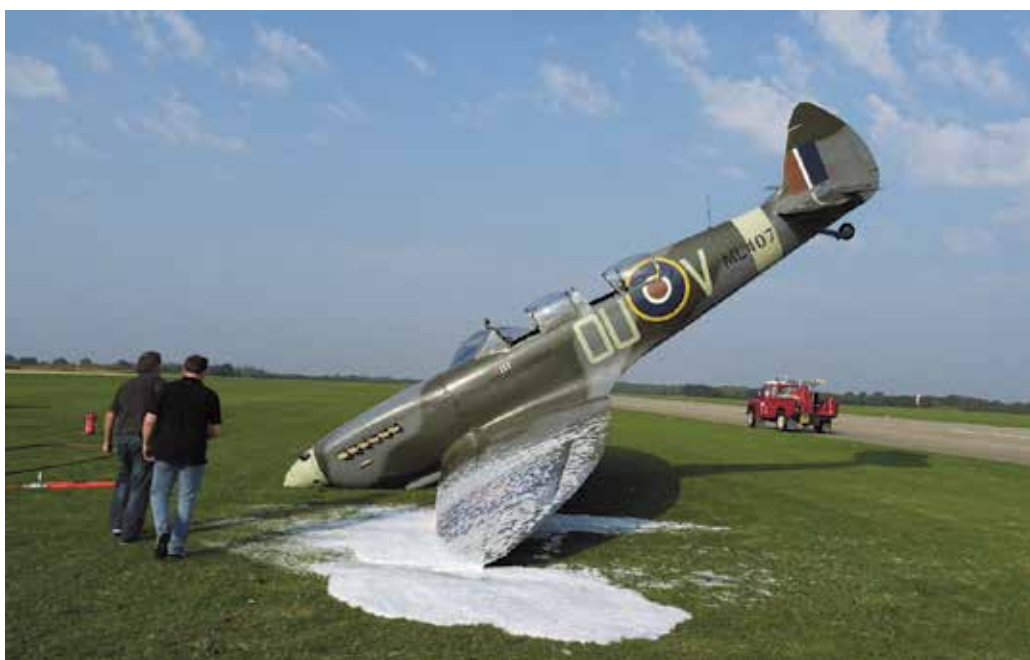
Figure 1

35 kt the left wing started to lower. The pilot tried to counteract this with full right aileron and full rudder as the aircraft started to yaw rapidly to the left, departing the runway onto grass beside it. The pilot switched the engine's magneto switches off as the aircraft came to rest on its nose (Figure 1). The aerodrome's RFFS were quickly on the scene.

G-LFIX after the landing gear collapse

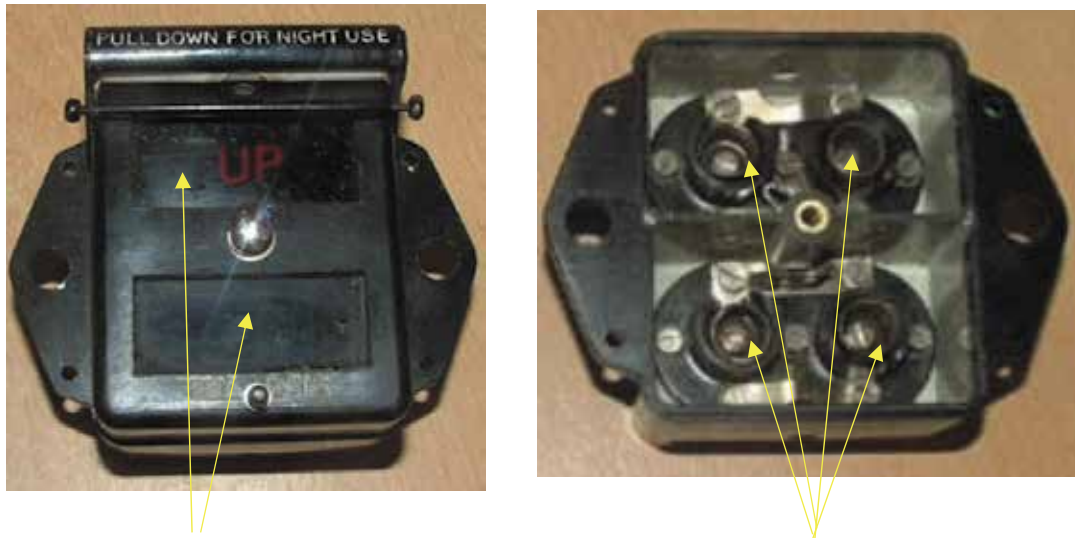
Figure 2

Landing gear indication panel

The landing gear indication system fitted to G-LFIX had been modified so that instead of both bulbs behind the relevant caption illuminating only when both landing gear legs were in the relevant position, the left bulb in each panel would indicate the position of the left landing gear leg and the right bulb the position of the right landing gear leg. This meant that the letters 'D' and 'O' of the word DOWN in the panel would be illuminated by the left bulb and the letters 'W' and 'N' would be illuminated by the right bulb.

During their investigation of the event the maintenance organisation carried out tests on the landing gear position indication system. These confirmed that the indication system was serviceable. They also showed that, in the event that the left bulb in the DOWN indicator panel did not illuminate, the indirect light produced by the bulb on the right side of the indicator was sufficient to partially illuminate the letters D and O of the DOWN indication.

No defects were found within the landing gear position indication system. The fact that the left landing gear did not achieve a locked position meant that the left light bulb in the landing gear position indicator would not have illuminated. However, tests showed that sufficient light was produced by the right bulb to illuminate the D and O of the DOWN caption.

In order to prevent the illumination of the complete word “DOWN” in the landing gear position indicator in the event that one landing gear has not achieved the fully locked position, the maintenance organisation modified the landing gear indicator to prevent light from either of the indicator bulbs illuminating the complete DOWN caption.
