## ACCIDENT

<b>Aircraft Type and Registration:</b>	Sud-Aviation SE-313B Alouette II, HA-PPC	
<b>No &amp; Type of Engines:</b>	1 Turbomeca Artouste II C6 turboshaft engine	
<b>Year of Manufacture:</b>	1960 (s/n 1500)	
<b>Date &amp; Time (UTC):</b>	17 July 2016 at 1700 hrs	
<b>Location:</b>	Brighton Aerodrome, Yorkshire	
<b>Type of Flight:</b>	Private	
<b>Persons on Board:</b>	Crew - 1	Passengers - 4
<b>Injuries:</b>	Crew - 1 (Fatal)	Passengers - 4 (Serious)
<b>Nature of Damage:</b>	Aircraft destroyed	
<b>Commander's Licence:</b>	Private Pilot's Licence (H)	
<b>Commander's Age:</b>	36 years	
<b>Commander's Flying Experience:</b>	708 hours (of which more than 164 were on type) Last 90 days - 18 hours Last 28 days - 8 hours	
<b>Information Source:</b>	AAIB Field Investigation

## Synopsis

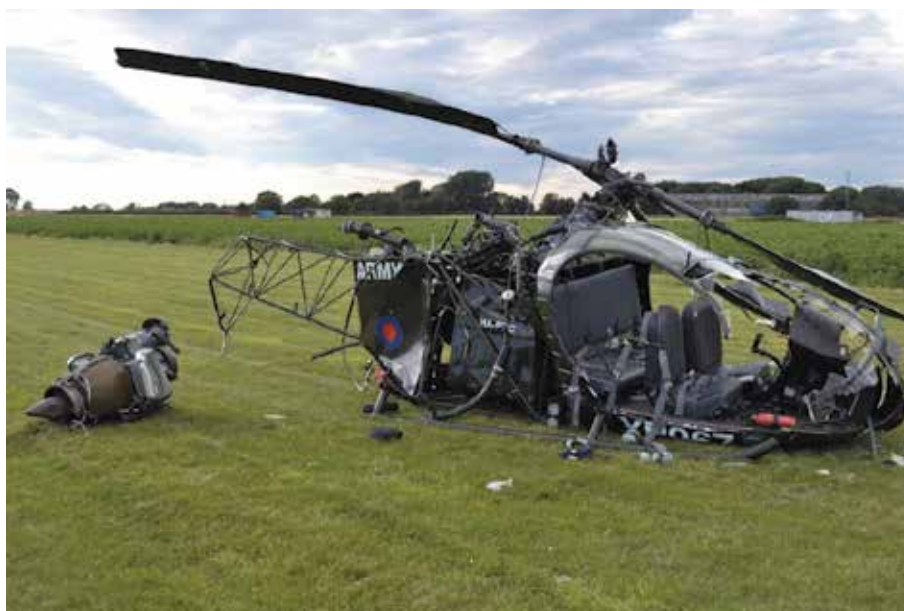
**Figure 1**

Helicopter wreckage

The helicopter had landed upright on its landing skids which had left deep indentations in the surface of the grass runway. The landing skids cross bars and inclined shock absorbers had bent, bringing cabin structure into close proximity with the ground. The cabin structure was distorted, the doors had detached and the majority of the cabin Perspex transparency had fragmented.

The tubular frame tail boom was in a highly disrupted state. All three tubes which make up the triangular section of the framework had been distorted and severed approximately half way up the tail boom. The tail rotor gearbox and associated framework had detached as had the tail rotor protective skid. There was no evidence that the underside of the tail rotor skid contacted the ground during the accident sequence. The stabiliser aerofoils and cross tube were severely damaged and had also detached. The centre section of the cross tube was heavily scuffed and flattened and the inboard face of the stabiliser was badly crushed at its trailing edge.

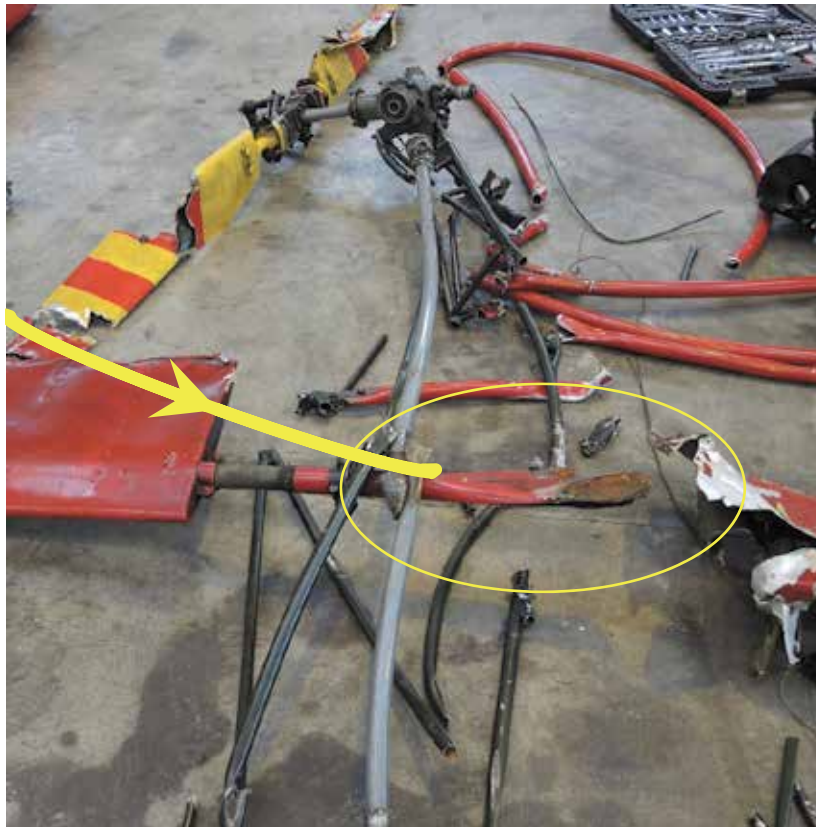
**Figure 3**

The helicopter component examination clearly shows that the main rotor disc came into contact with the tail boom structure. It is evident from the damage to the main rotor blades and their tips, along with the damage to the stabiliser and its cross tube, that the first impact was from the yellow blade closely followed by blue and the red blades in succession. The yellow blade tip missed the right stabiliser aerofoil but collided with the cross tube and on into the inboard trailing edge corner of the left stabiliser aerofoil. Figure 3 shows the damage to the stabiliser cross tube and path of the blade impact.

Damage to the stabiliser cross tube and path of the blade impact

This was the probable source of the “loud crack” described by the passengers and many of the witnesses. The tip fairing was crushed and detached and its deformation precisely matched the profile of the stabiliser trailing edge. In this initial impact, the cross tube was flattened and there is evidence that the yellow blade, whilst in contact with the cross tube, travelled underneath the tail rotor drive shaft and it is possible that it momentarily restricted
