ACCIDENT

Aircraft Type and Registration:	Rans S6-ESD (Modified) Coyote II, G-MYES	
No & Type of Engines:	1 Jabiru 2200A piston engine	
Year of Manufacture:	1992 (Serial no: PFA 204-12254)	
Date & Time (UTC):	30 May 2016 at 1557 hrs	
Location:	Near Shifnal Airfield, Shropshire	
Type of Flight:	Private	
Persons on Board:	Crew - 1	Passengers - 1
Injuries:	Crew - 1 (Fatal)	Passengers - 1 (Fatal)
Nature of Damage:	Aircraft destroyed	
Commander's Licence:	UK National Private Pilot's Licence	
Commander's Age:	64 years	
Commander's Flying Experience:	185 hours (of which 8 were on type) Last 90 days - 13 hours Last 28 days - 10 hours	
Information Source:	AAIB Field Investigation

Synopsis

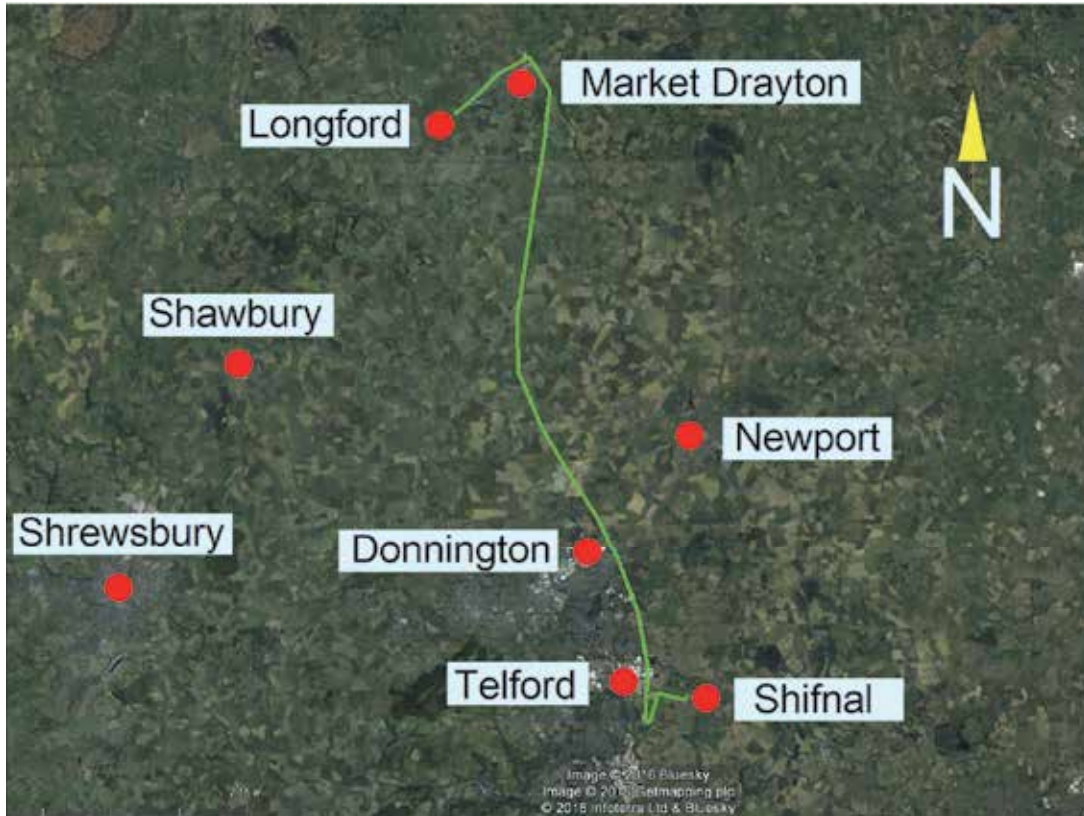
Figure 5

The aircraft took off at 1536 hrs from the north-easterly runway at Longford. The recording on the smartphone of the takeoff and initial climb showed nothing unusual. Shortly after, the aircraft made a right turn onto a southerly heading, whilst climbing initially to about 1,700 ft amsl. As the aircraft approached the town of Donnington, it then climbed progressively. At 1552 hrs, on a southerly track, the aircraft passed just less than half a mile to the west of Shifnal Airfield. During the next three minutes, the aircraft was recorded operating in an area 0.5 nm to the south-west of Shifnal Airfield, during which it descended from a peak recorded altitude of 1,967 ft amsl to 1,050 ft amsl (600 ft agl).

GPS track of flight from Longford

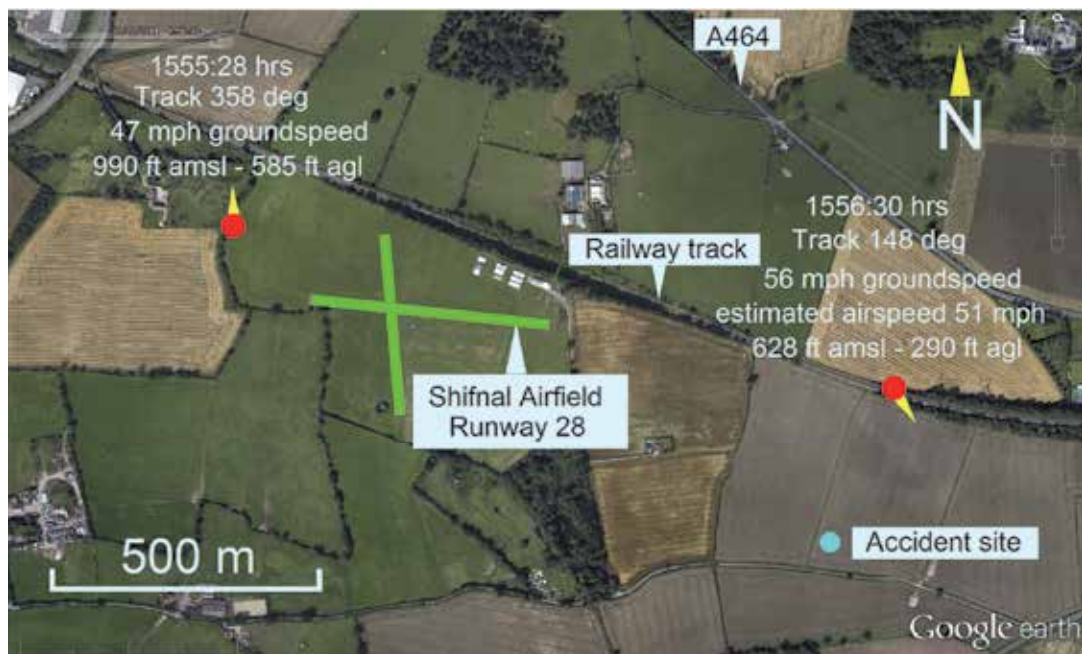
Figure 6

At 1556:30 hrs, the last GPS data point was recorded. This indicated that the aircraft was at an altitude of 628 ft amsl (290 ft agl), on a track of 148°M, with a groundspeed of 56 mph (an estimated indicated airspeed of 51 mph (44 KIAS) based on the METAR for Shawbury). The aircraft was 670 m from the threshold of Runway 28 and 300 m from the accident site. Analysis of the tablet computer indicated that the aircraft struck the ground shortly after, at about 1557 hrs.

Final GPS points during approach to Shifnal

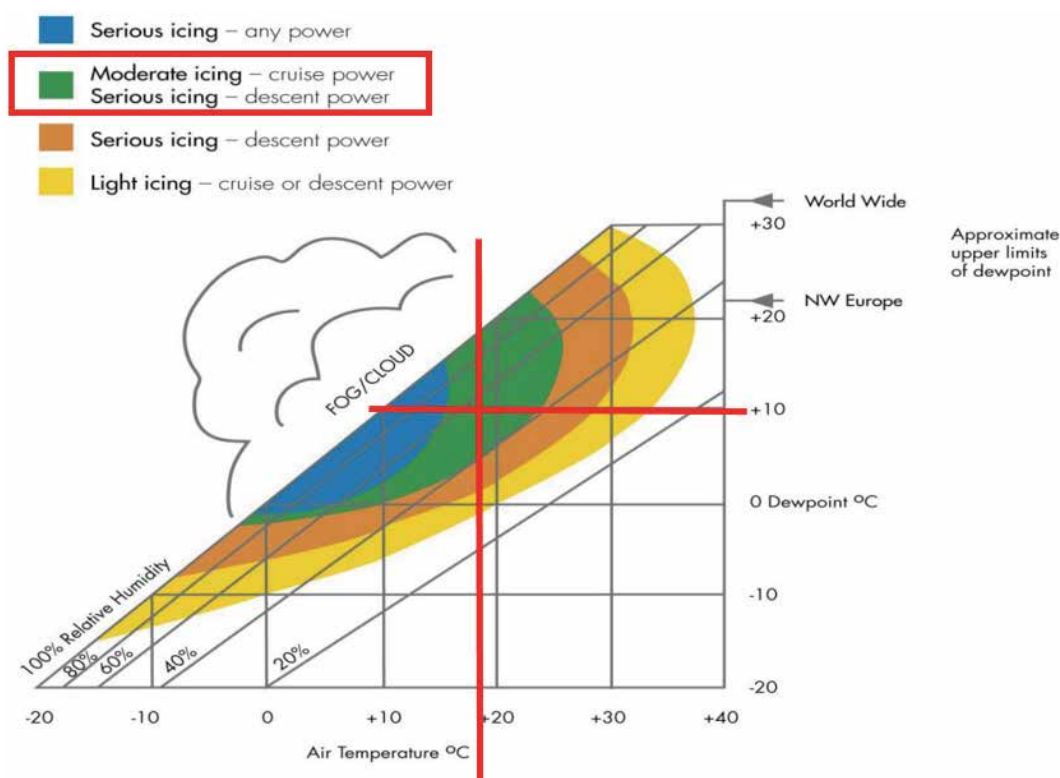
Figure 8

The leaflet incorporates a graph of temperature and dew point (Figure 8), depicting the probability of carburettor icing at various power settings. In the reported conditions, the graph shows that moderate icing could be expected at cruise power, and serious icing at descent power.

CAA Chart showing probability of carburettor icing; the red lines show the approximate values of temperature and dew point at the time of the accident

The possibility of carburettor icing causing a reduction or loss of engine power could not be dismissed. In the prevailing conditions, moderate carburettor icing could have occurred at cruise power and serious carburettor icing at descent power. If carburettor ice had built up during the descent and circuit, it could have caused a lack of power during
