INCIDENT

Aircraft Type and Registration:	Agusta AW139, G-VINB	
No & Type of Engines:	2 Pratt & Whitney Canada PT6C-67C turboshaft engines	
Year of Manufacture:	2012 (Serial no: 31398)	
Date & Time (UTC):	20 January 2017 at 1627 hrs	
Location:	Ravenspurn North Platform, North Sea	
Type of Flight:	Commercial Air Transport (Passenger)	
Persons on Board:	Crew - 2	Passengers - None
Injuries:	Crew - None	Passengers - N/A
Nature of Damage:	None	
Commander's Licence:	Airline Transport Pilot's Licence	
Commander's Age:	43 years	
Commander's Flying Experience:	6,035 hours (of which 1,964 were on type) Last 90 days - 99 hours Last 28 days - 20 hours	
Information Source:	Aircraft Accident Report Form submitted by the pilot

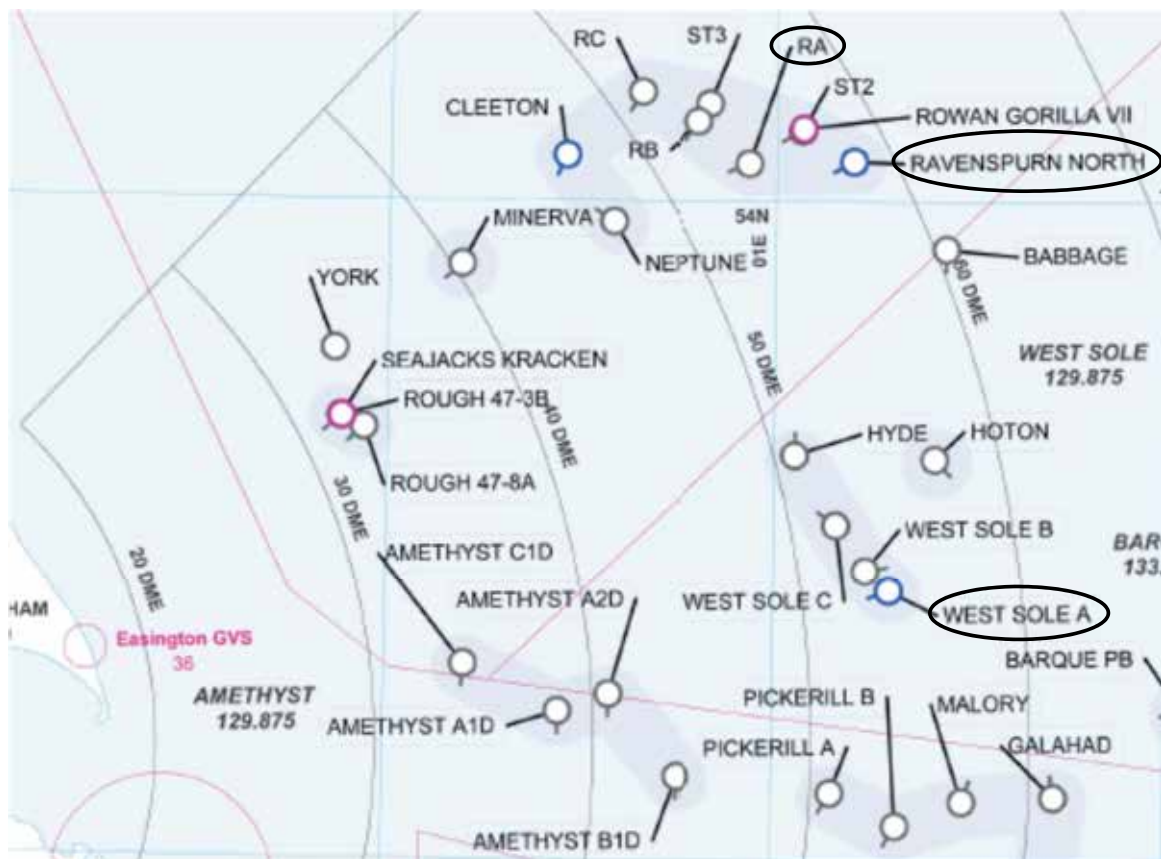
Figure 1

On departing the West Sole Alpha platform, the helicopter proceeded to the Ravenspurn field. The co-pilot made a radio call to request helideck availability from the Ravenspurn Field Helicopter Landing Officer (HLO) but only used the word "Ravenspurn" when providing the name of the platform on which the crew intended to land, instead of "Ravenspurn North". The HLO responded: "Ravenspurn Alpha deck is available, standing by on the north side". However, the crew did not pick up on the discrepancy between their intended destination and the clearance and carried out an approach and landing to Ravenspurn North. There was no helideck crew present, as required by the operator, and a radio call alerted the crew to the fact they had landed on Ravenspurn North rather than Ravenspurn Alpha, where they were expected (Figure 1).

Rig map of the Ravenspurn Field (Ravenspurn Alpha is denoted as RA)
