History of the failed mooring line

Bridon comments in response to the condition of *Al Ghuwairiya* mooring lines

## LNG Mooring Line Failures

**Mooring line failure resulting in serious injury to a  
deck officer on board  
*Zarga*  
alongside South Hook LNG terminal,  
Milford Haven  
on 2 March 2015**

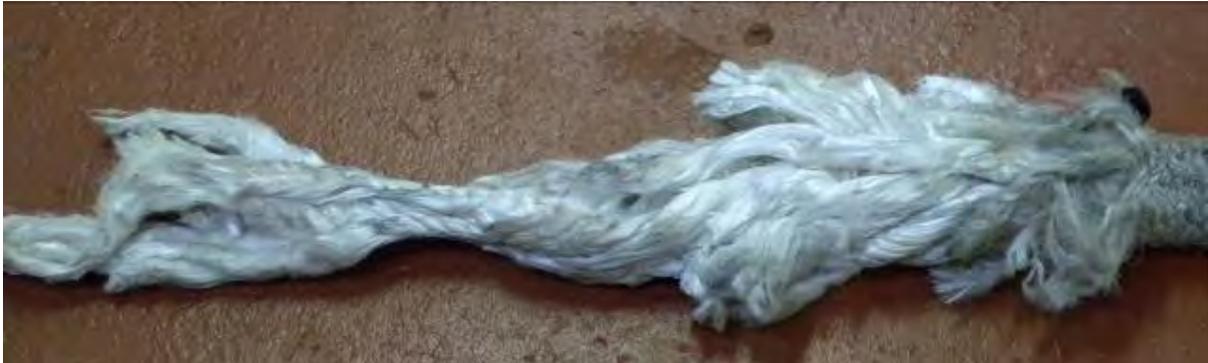
**Figure 4:** Typical modest abrasion, complex shear/torsional forces induced failure, BG vessel Methane Shirley Elisabeth

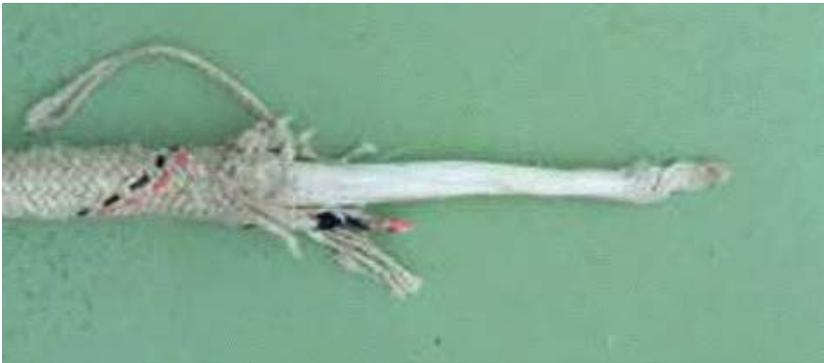
**Figure 5:** Typical wear, bending and final creep failure, British Sapphire

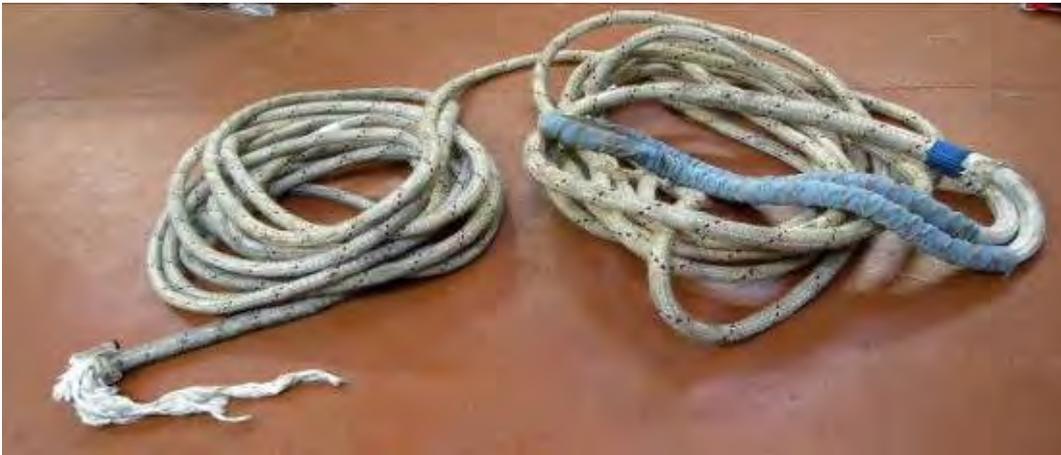
**Figure 6:** Mixed mode failure, Methane Shirley Elisabeth

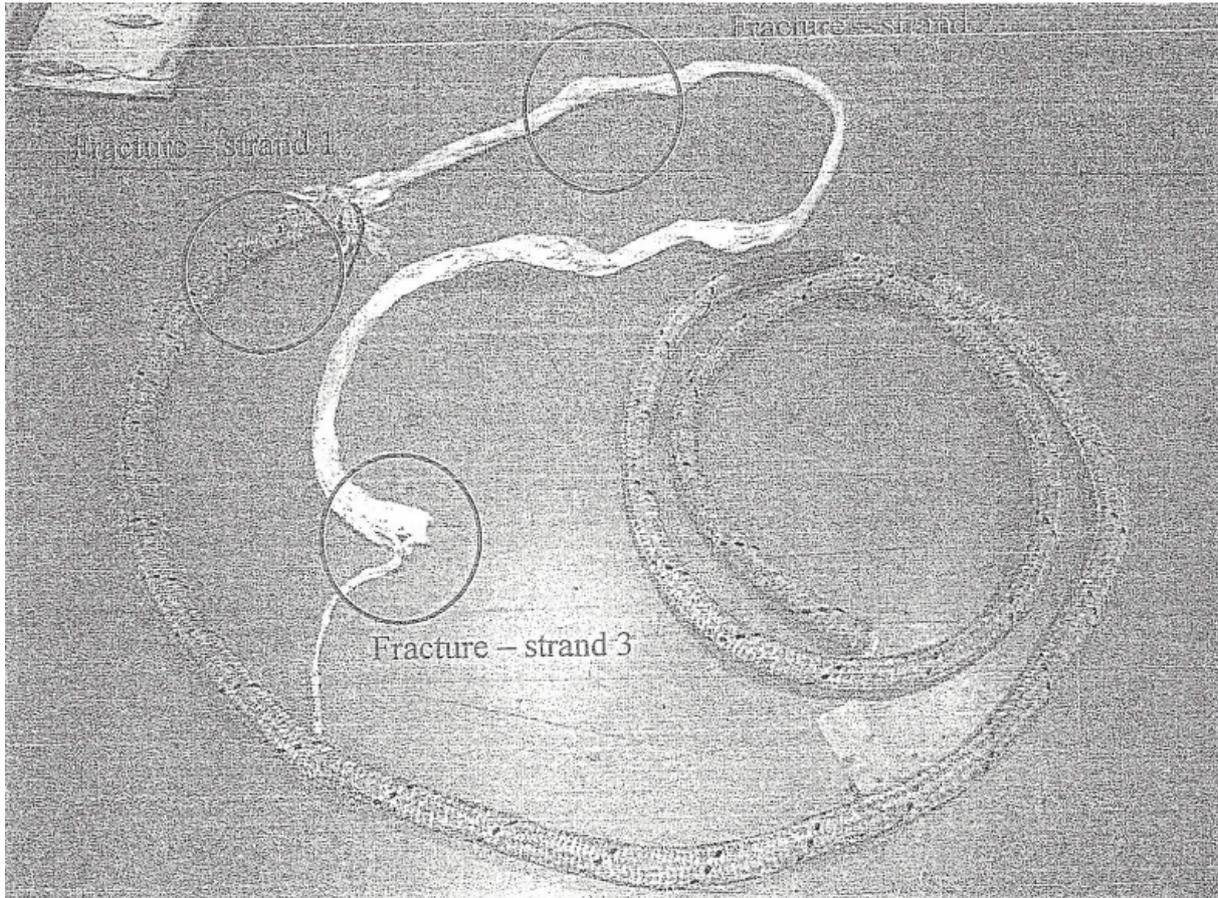
This series of failures of Bridon core with jacket rope on the LNG Nigeria vessel River Orashi at Bilbao in 2011 was conducted by BW Fleet Management and DNV. The key reason for failure was attributed to a sawing action of the rope in a fairlead caused by first order vessel motions of the vessel during high swell. Figure 7 shows three positions on the rope core where cutting/abrasion damage has occurred due to the motion of the vessel in the fairlead. One cut is under the jacket as circled.

**Figure 7:** Sawing action at fairlead

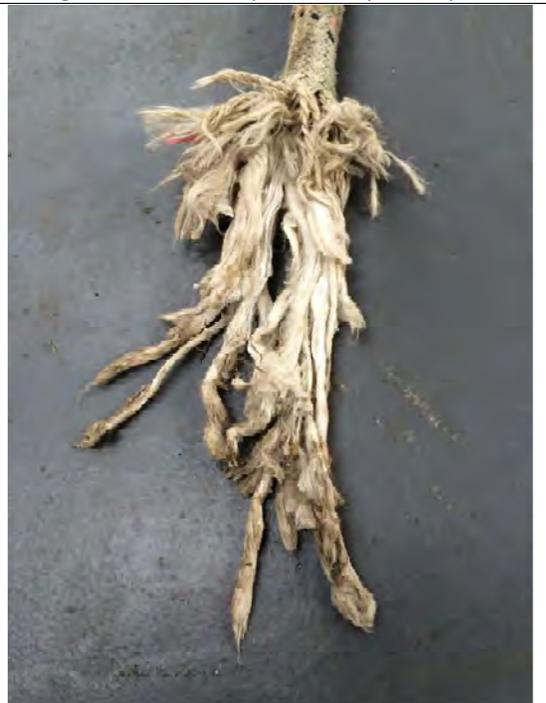
Figure 3.1.4 – Shore end failed end

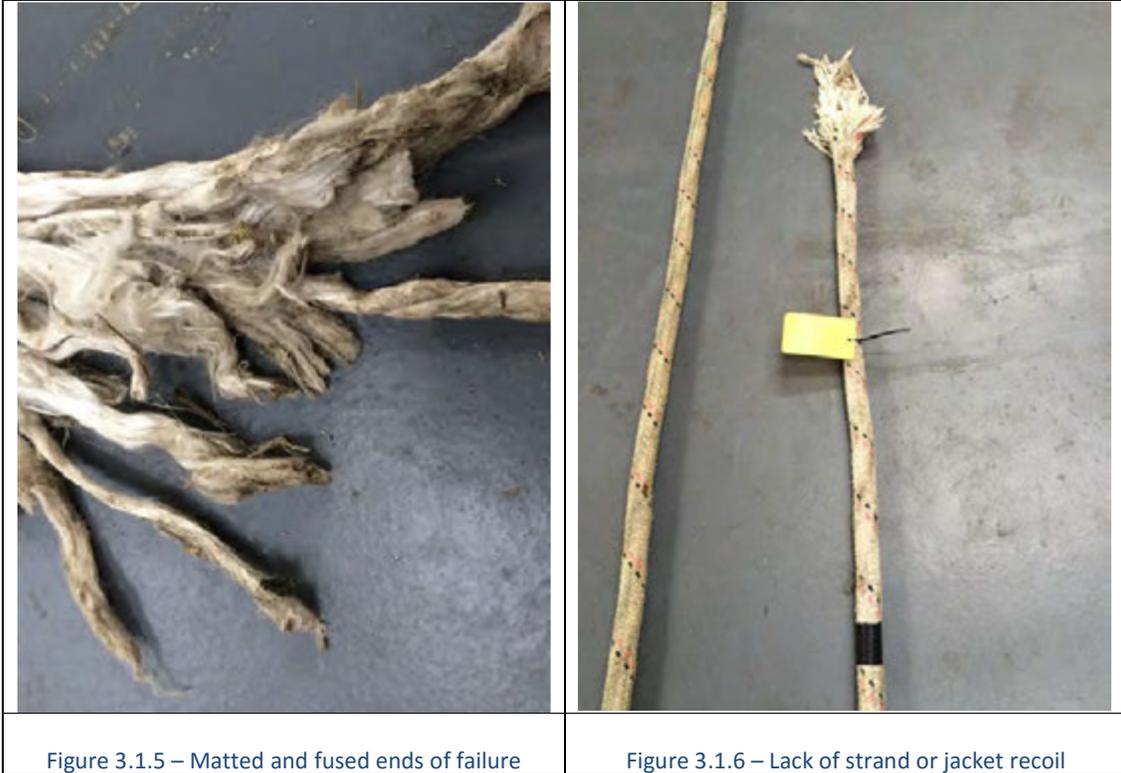
Figure 3.1.5 – Matted and fused ends of failure

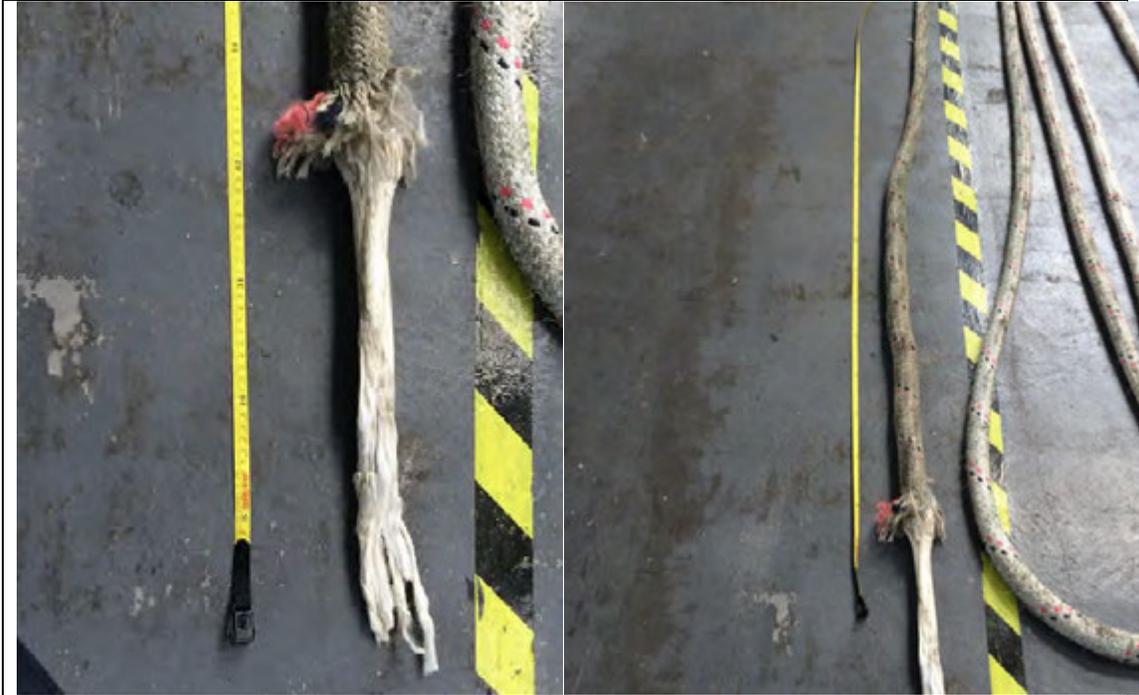
Figure 3.2.3 – Vessel end failure

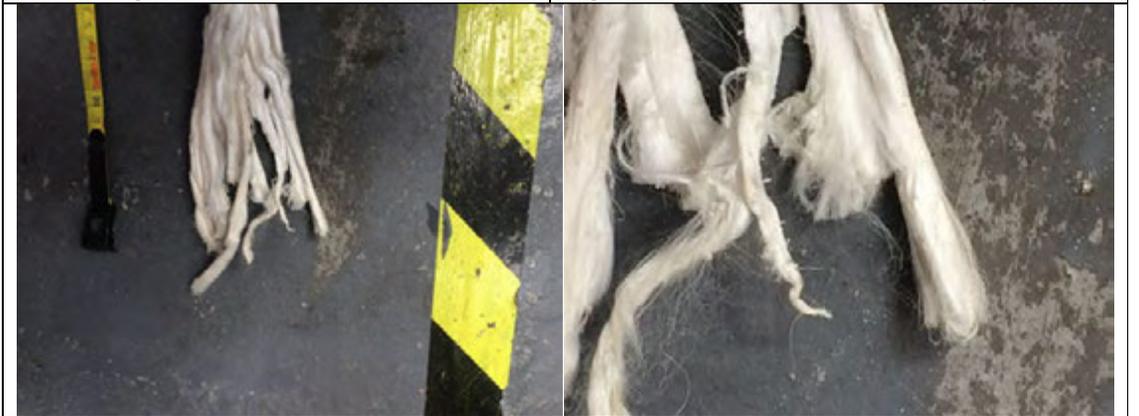
Figure 3.2.5 – Vessel end failure

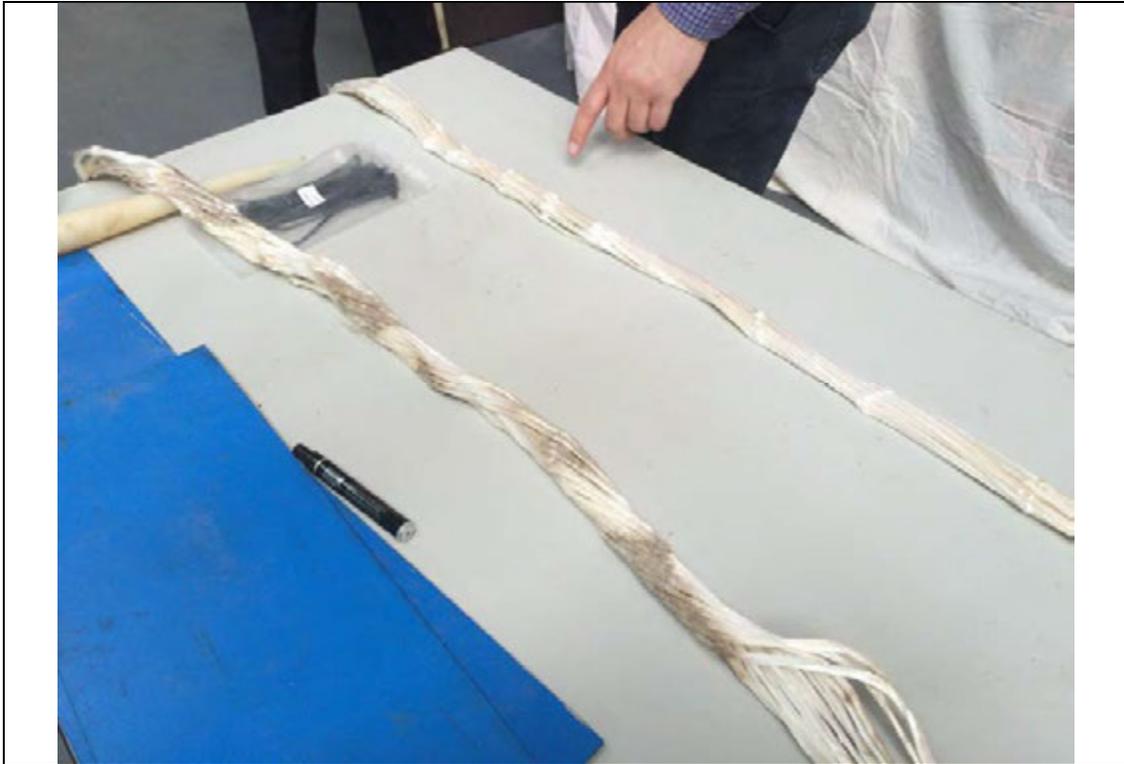
Figure 4.1.3 – Original Shore Side Sample - kink bands noted in both inner and outer yarn

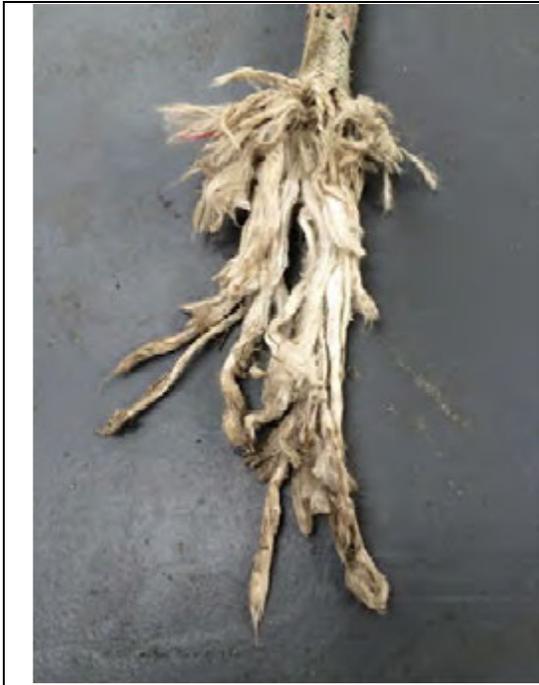
Figure 5.1.1 – Shore side failure end

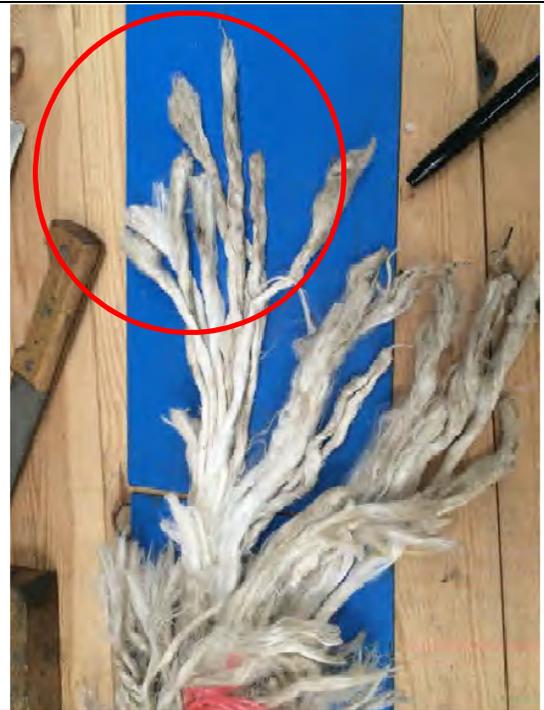
Figure 5.1.2 – Shore side failure

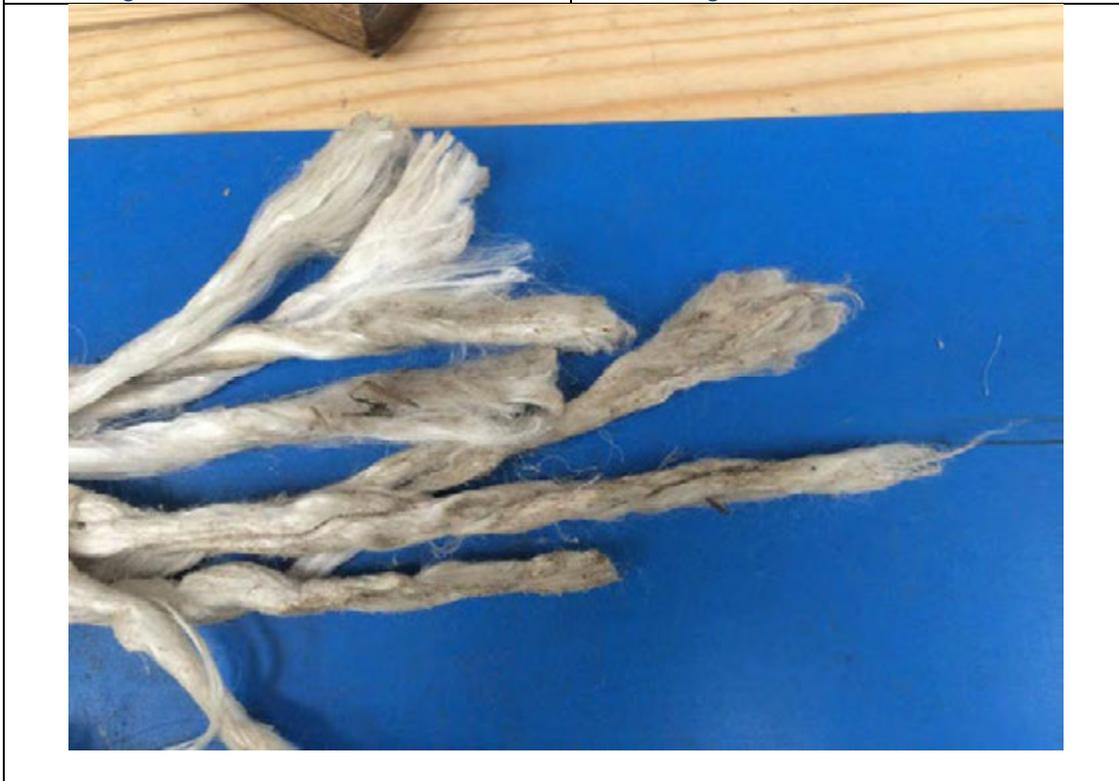
Figure 5.1.3 – Shore Side failure – regular and irregular yarn failures

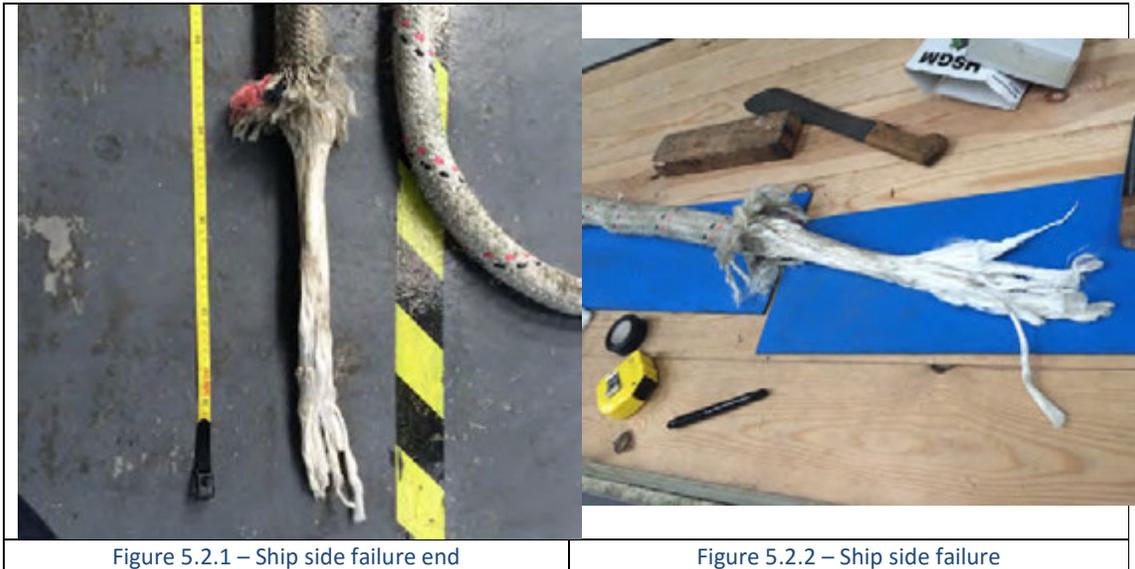
Figure 5.2.1 – Ship side failure end

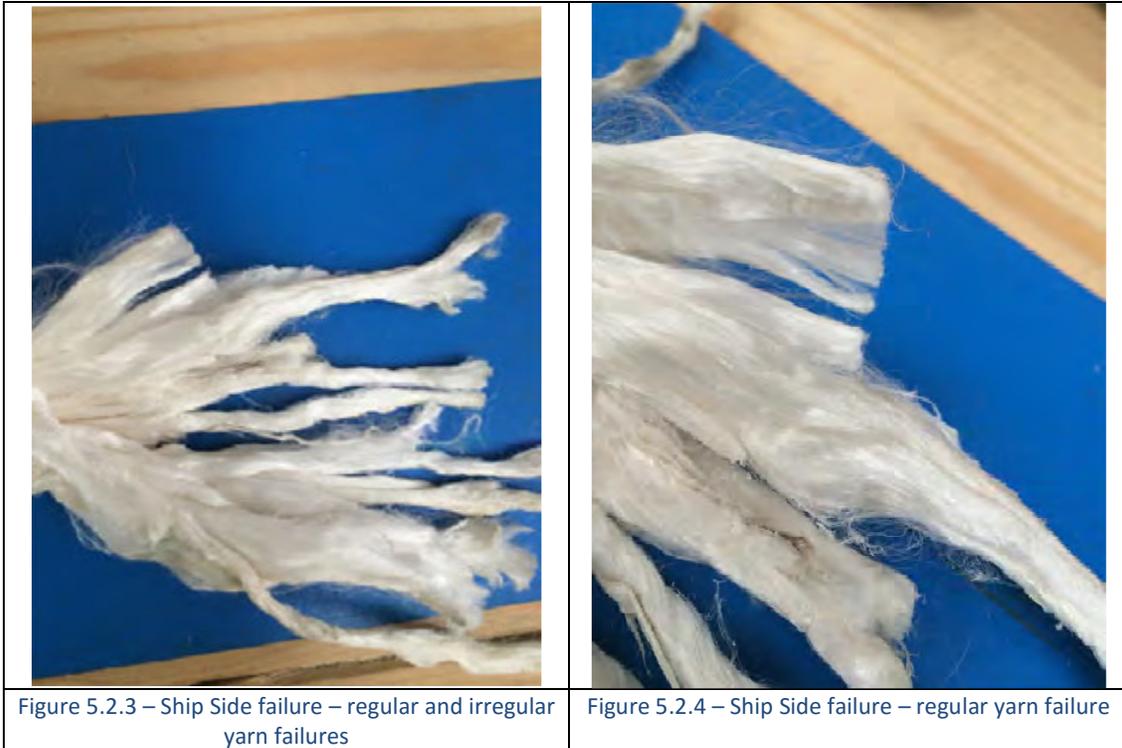
Figures 5.2.3 and 5.2.4, clearly show these regular yarn breaks and multiple ones were found through the failure. Again as with the shore break, sections of yarn were removed for SEM examination. Results can be found in section 8.

Figure 5.2.3 – Ship Side failure – regular and irregular yarn failures

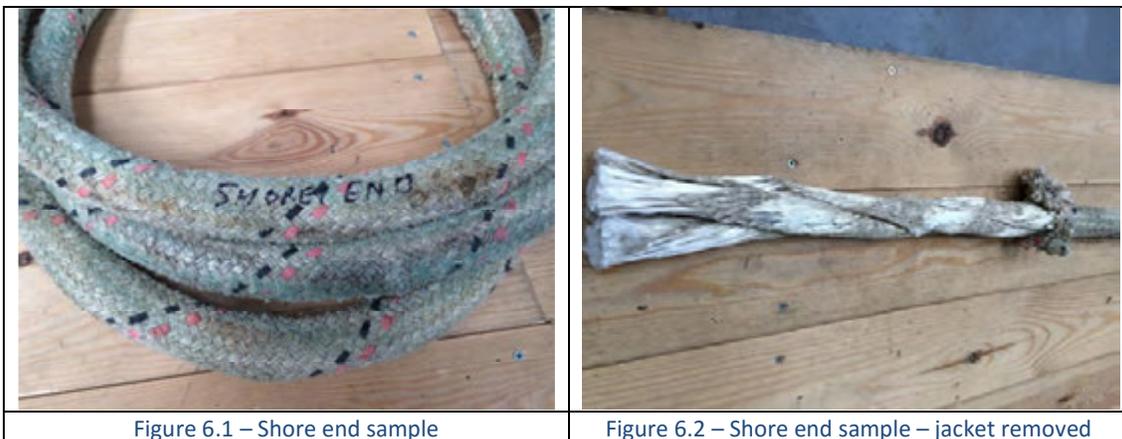
The following photographs shows evidence of yarn distortion and partial and full yarn failure particularly in the shore end sample. Figure 6.5 shows a partial failure at a kinkband, confirming the failure mechanism gives a regular end as shown in figure 6.6 where complete yarn breakage has occurred.

Figure 6.1 – Shore end sample

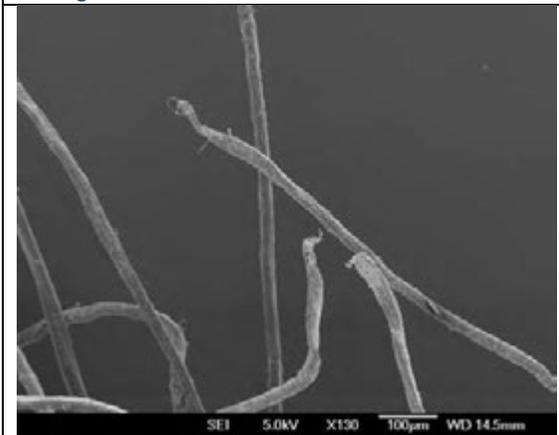
Figure 8.11 – Filament failure at kinkband

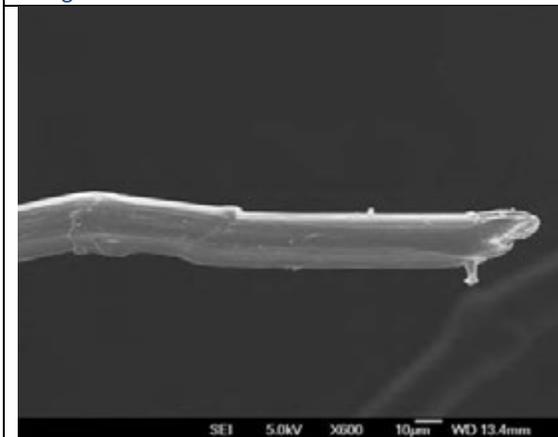
Figure 8.17 – Area A – Kinkband filament failure

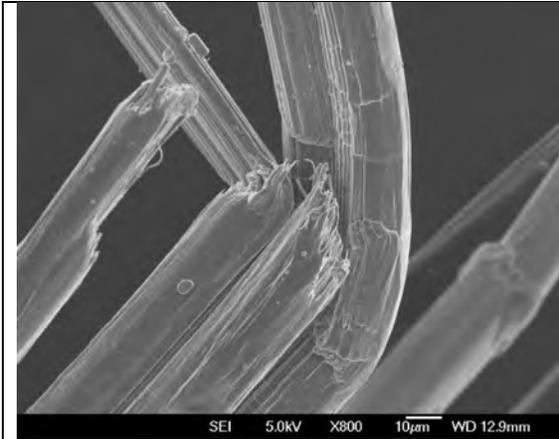
Figure 8.19 – Area B – Close up of bands and filament failure

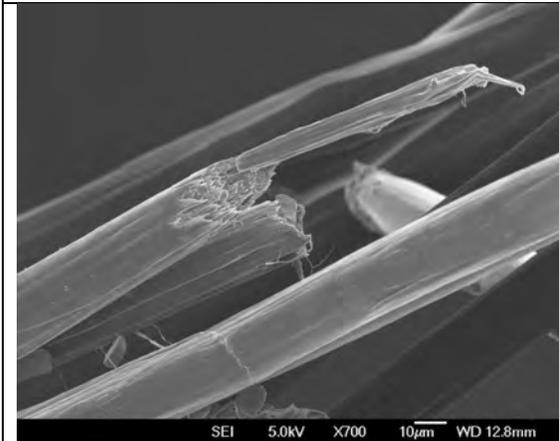
Figure 8.21 – Area B – Filament failure

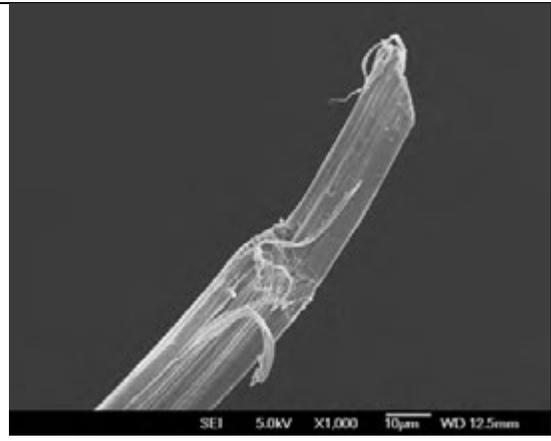
Figure 8.22 – Area B – Filament failure

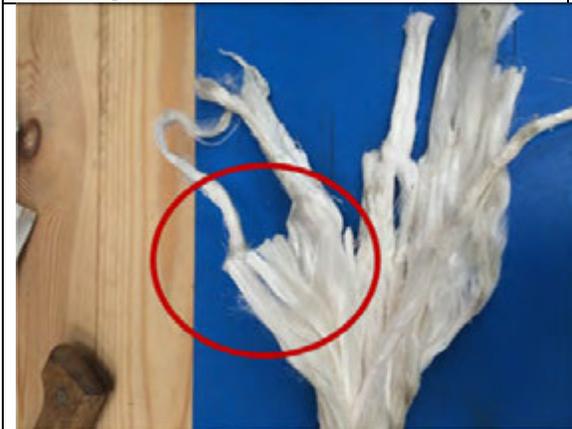
Figure 8.23 – Vessel end possible kinkband failure

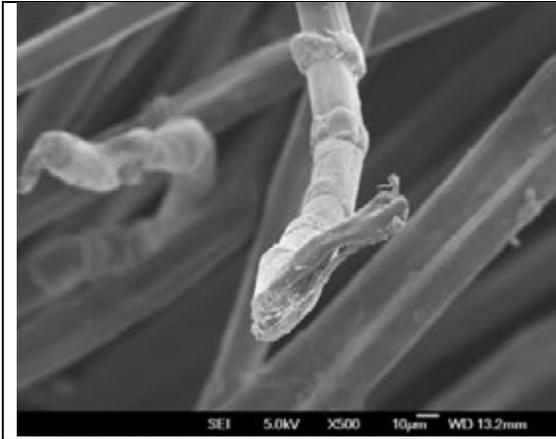
Figure 8.25 – Filament failure

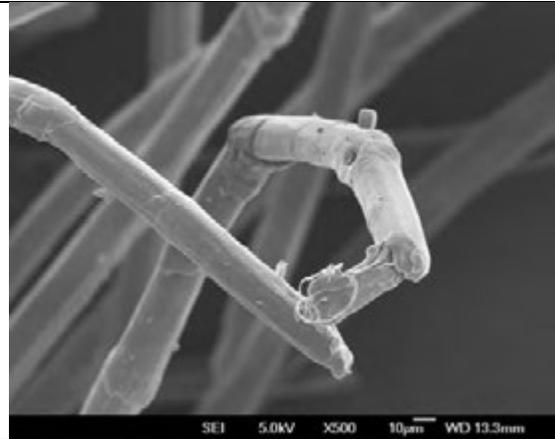
Figure 8.26 – Filament failure

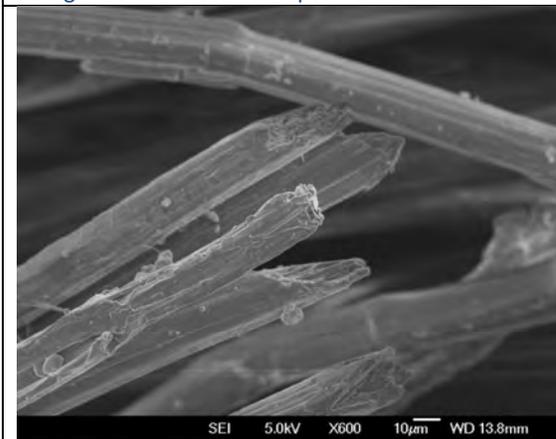
Figure 8.29 – Vessel end filament tensile failure

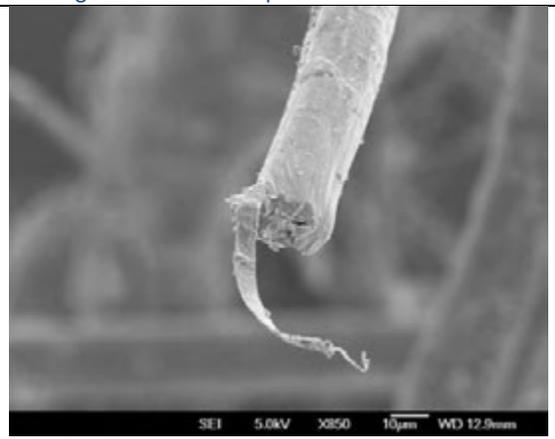
Figure 8.30 – Vessel end filament tensile failure

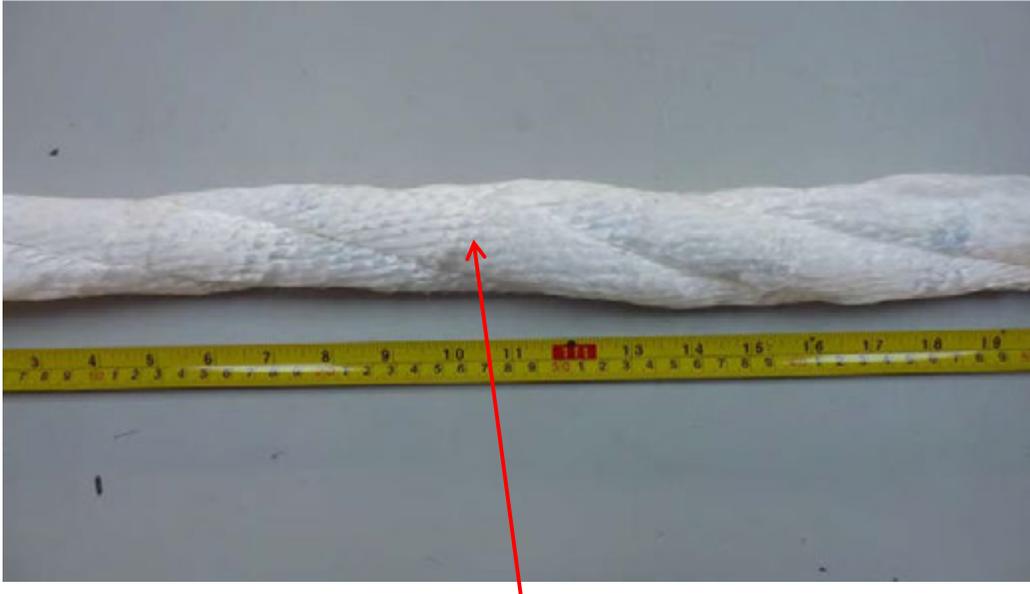
Figure 4.1.1: Sample 1, 3 strand subrope, very minor buckling in outer layer

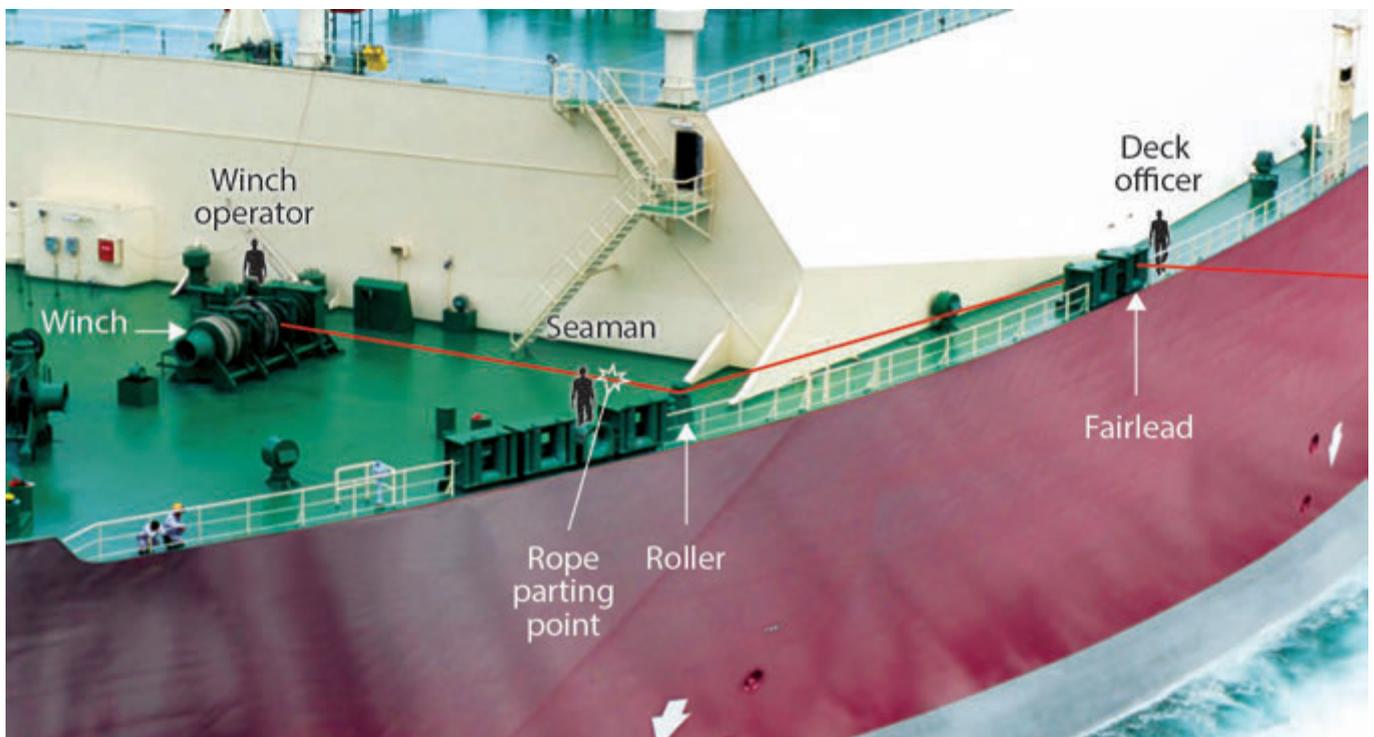
Figure 1: Location of injured deck officer relative to rope parting point
