Report on the investigation of
the grounding and evacuation of the
domestic passenger vessel

Surprise

at Western Rocks, Isles of Scilly

on 15 May 2016

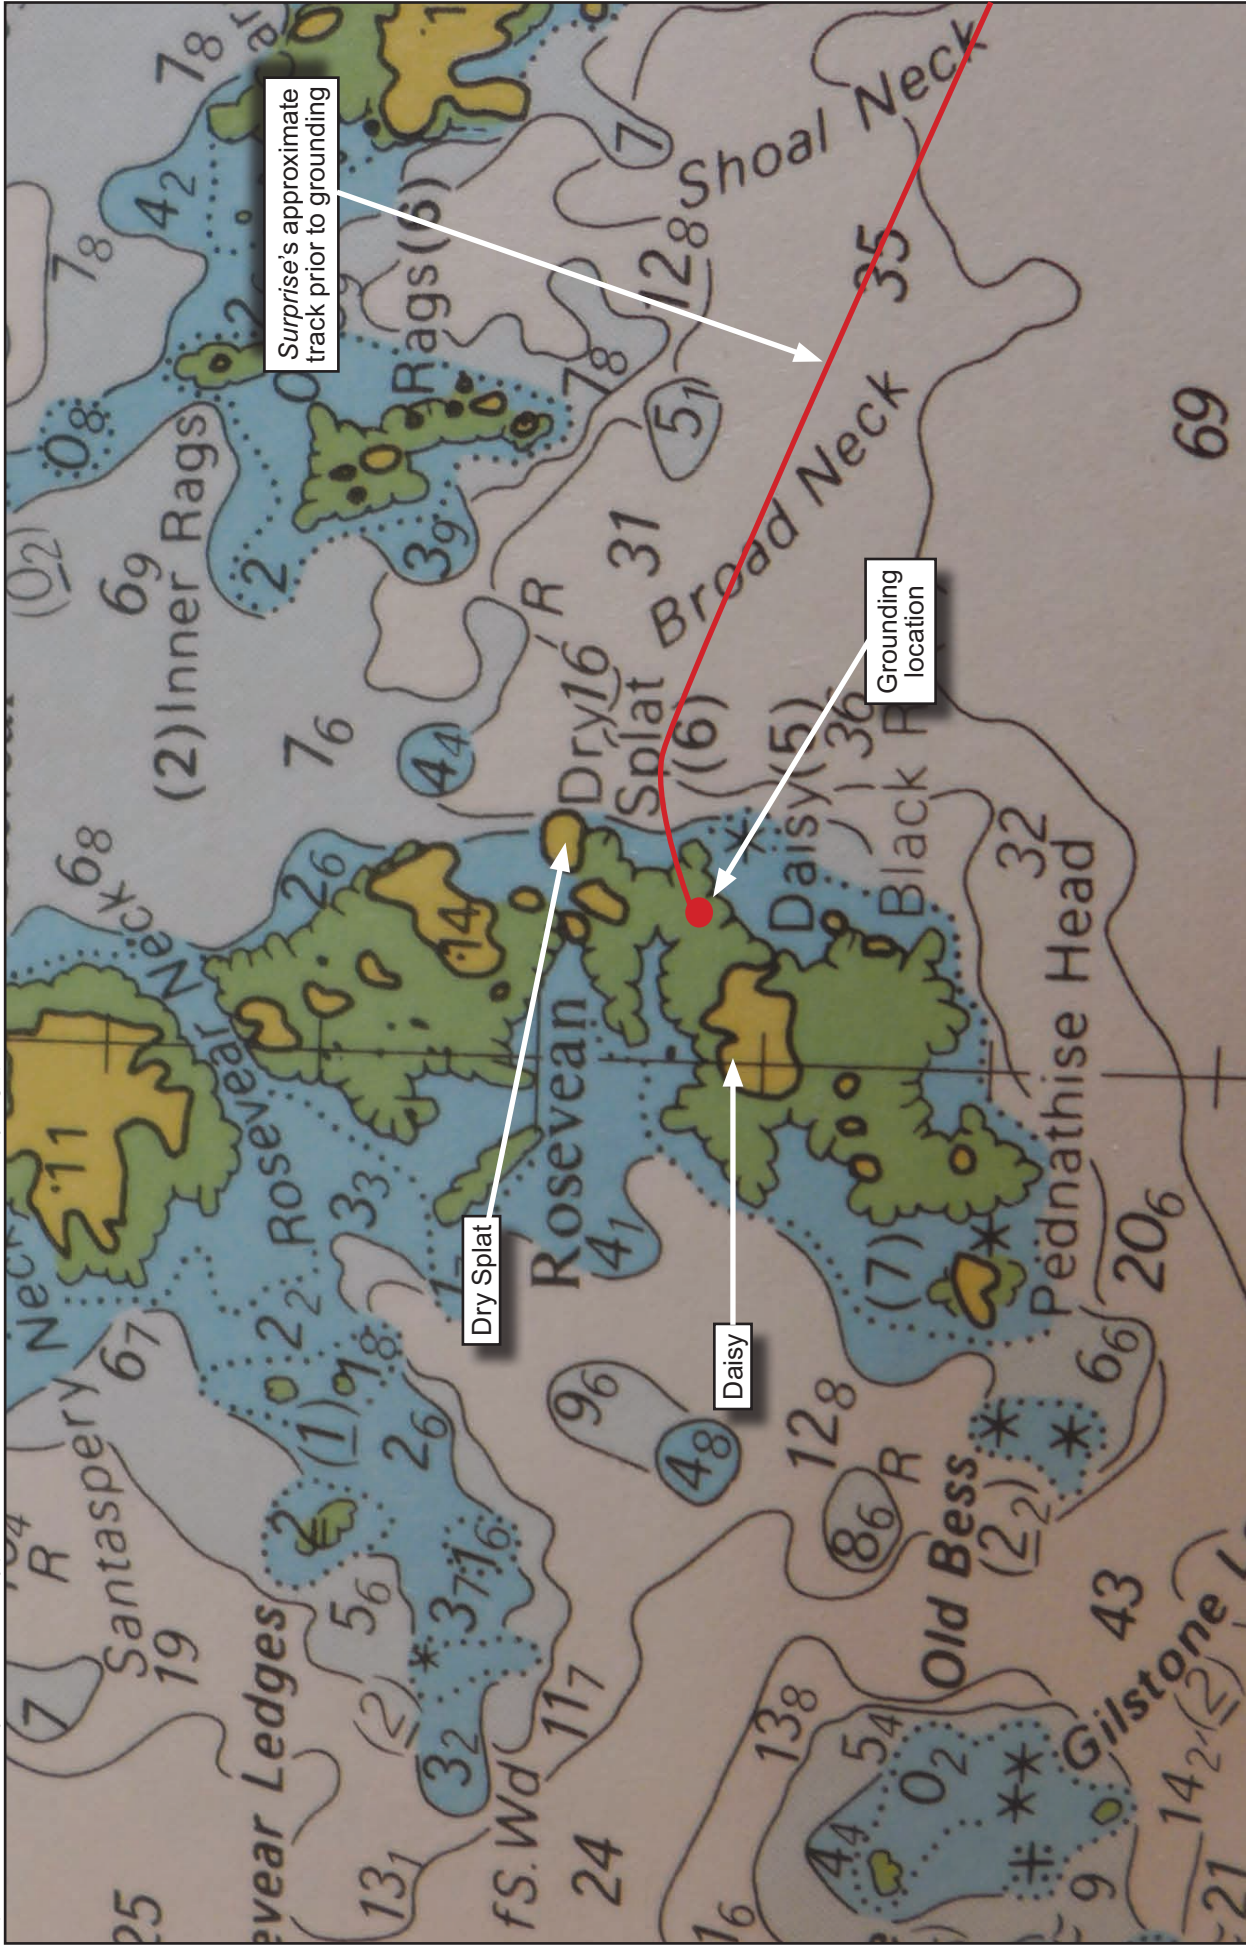
Figure 3: Approximate route of Surprise immediately prior to grounding and the accident location

Surprise was holed below the waterline and started to flood when it grounded on one of several subsurface rocks while being manoeuvred in a small bay in the intertidal zone. The skipper had entered the bay to give his passengers a close-up view of basking seals. He had undertaken similar trips many times before, was familiar with the area and was aware that it contained rocky hazards.

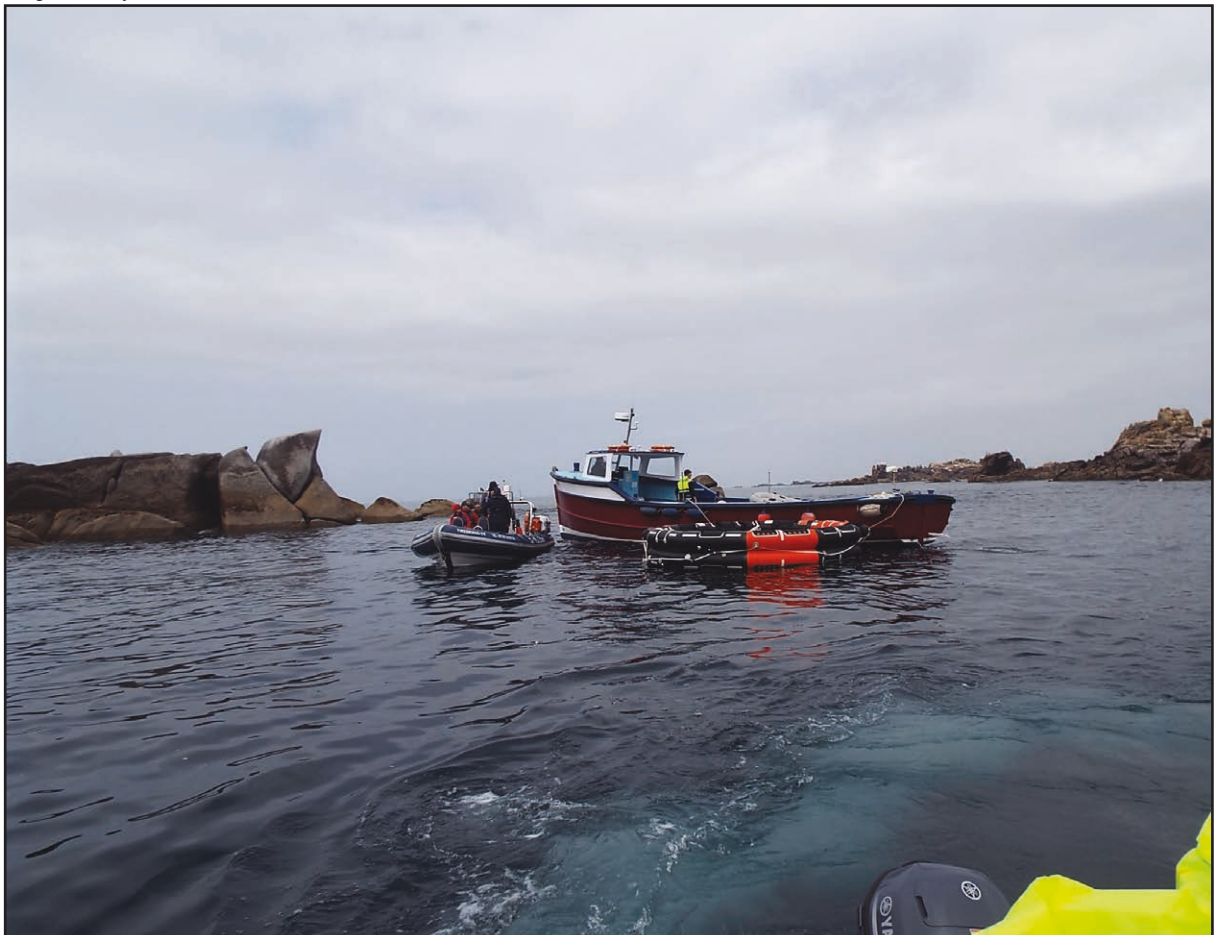
Figure 7: *Surprise* in the accident location after all the passengers had been evacuated

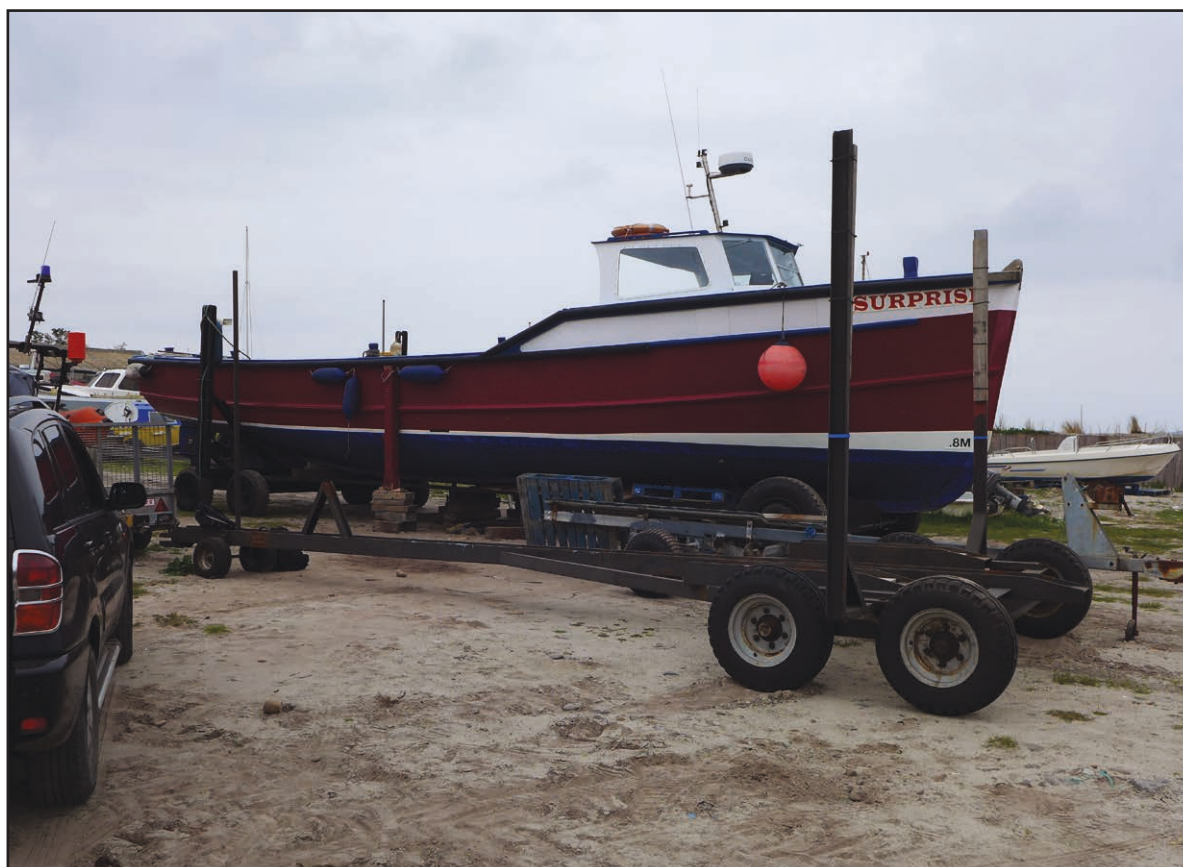
and they were allowed to return to their accommodation. *Surprise* arrived in St Mary's about 25 minutes later and proceeded to a boatyard, where it was lifted out of the water for inspection and subsequent repair (**Figure 10**).

Figure 10: *Surprise* out of the water after the accident

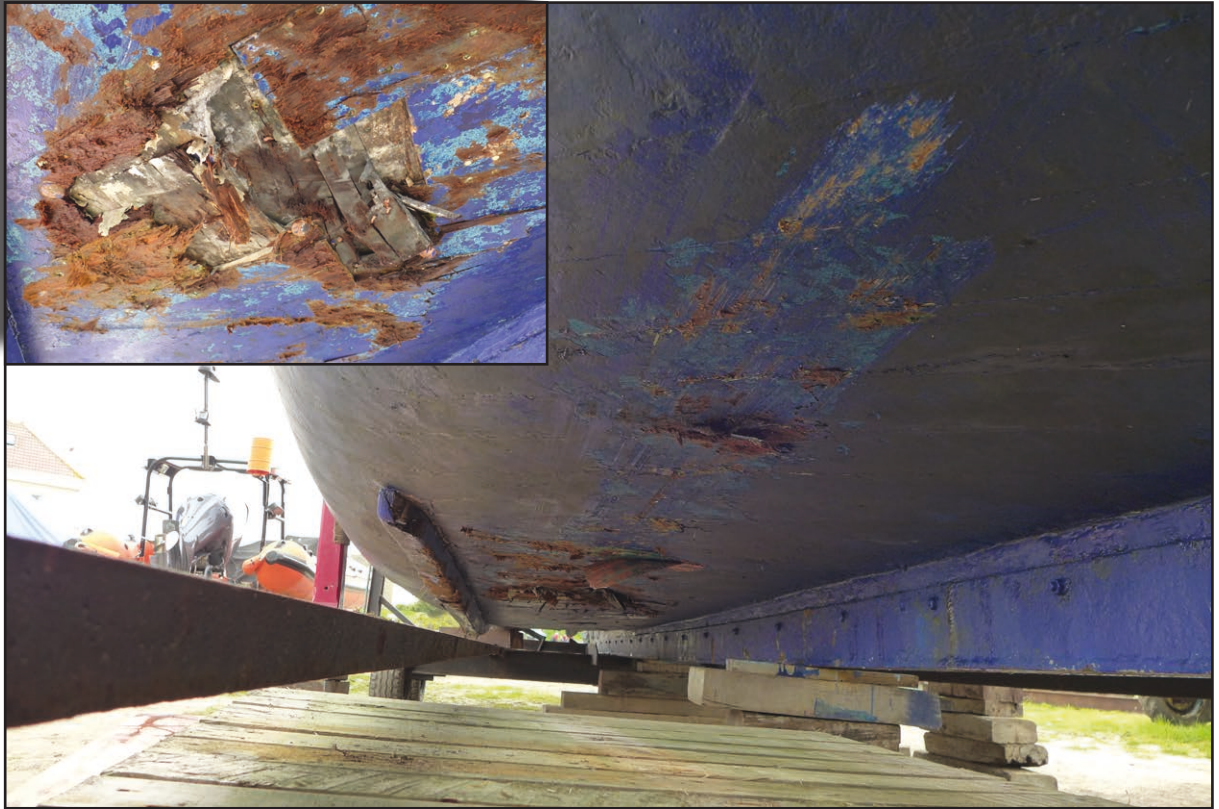
Surprise had a 1.5m long scrape mark along the starboard side of its hull and a single area of significant damage where the hull had been penetrated; the damage was also visible internally (**Figures 11 and 12**).

Figure 11: Hull damage to *Surprise's* starboard side with detail inset

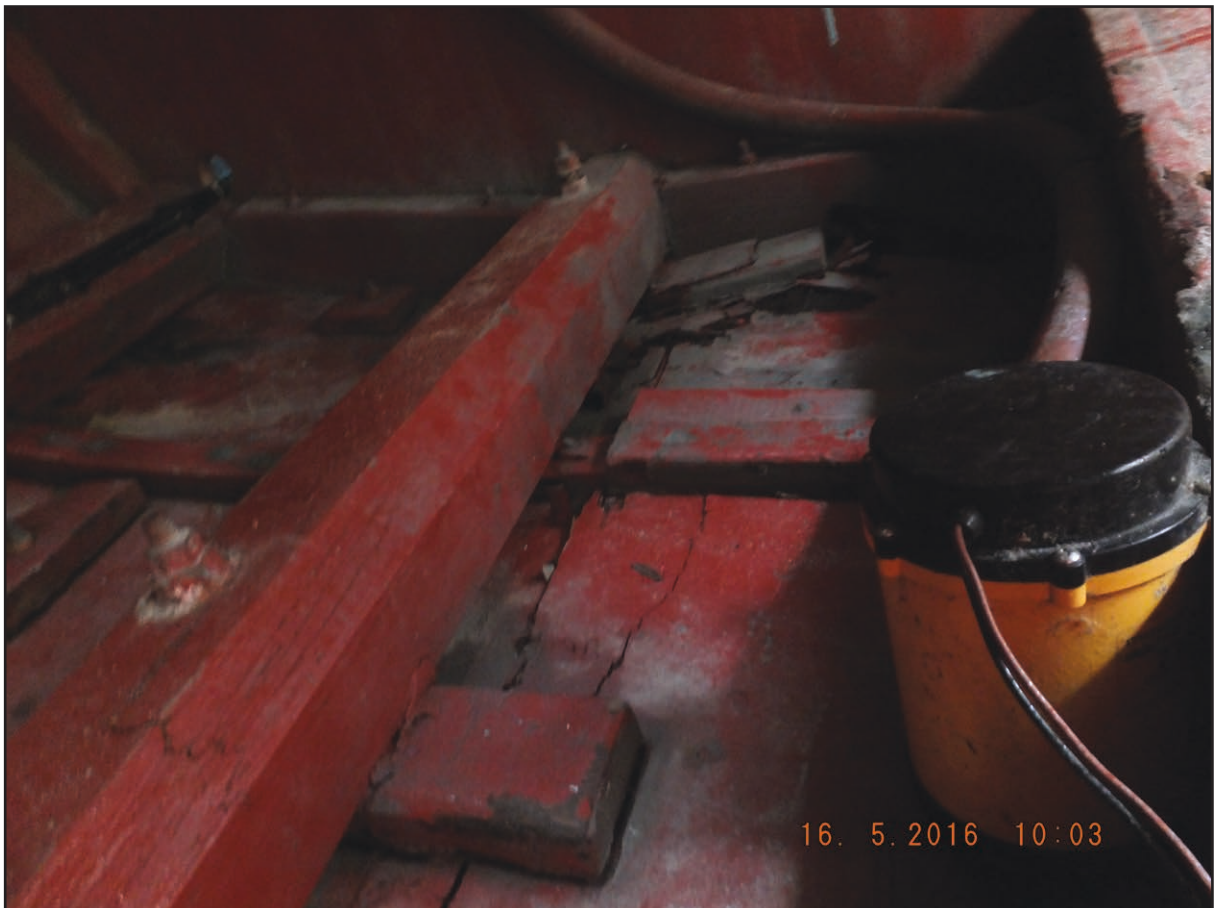
Figure 12: Internal hull damage and electric bilge pump

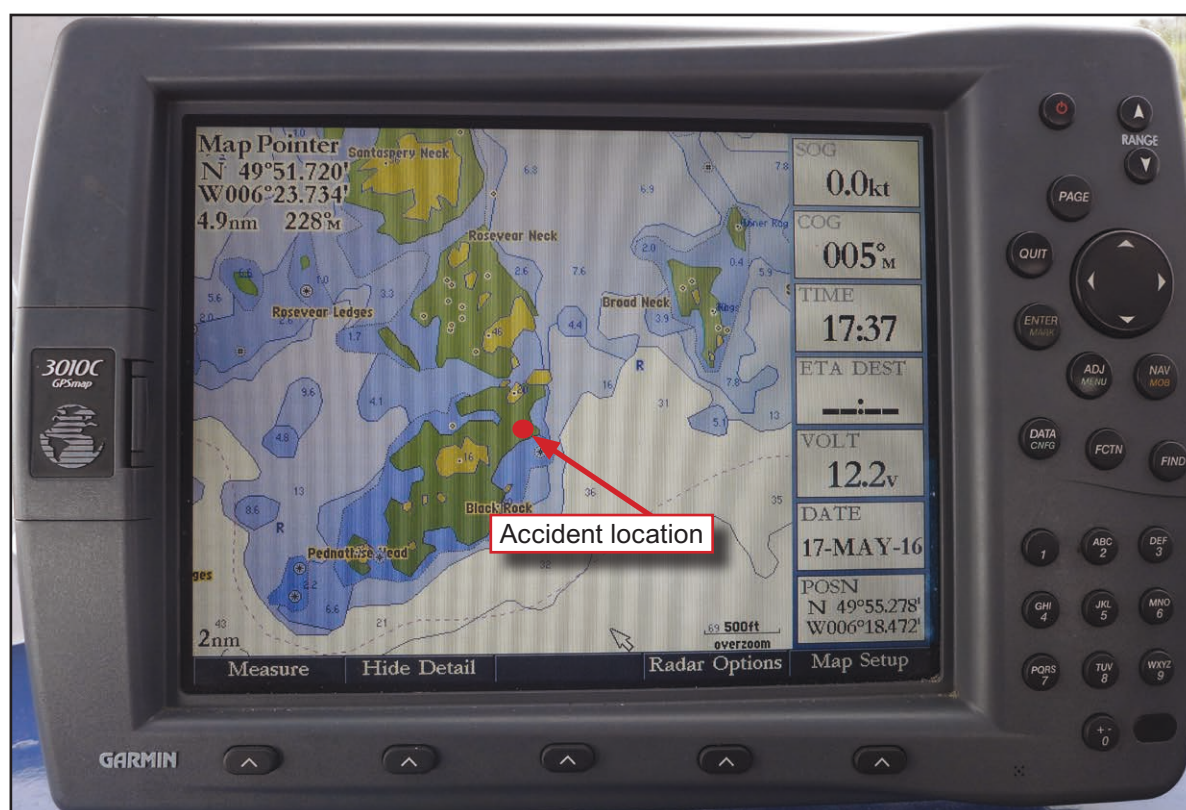
The location of the grounding was in an intertidal zone. Intertidal zones are coloured green on Admiralty charts and electronic plotters and contain areas and isolated hazards that will be dry at low tide and submerged at high tide. Drying heights⁵ for these areas and hazards are typically marked on charts. There were no drying heights shown in the vicinity of the grounding on either the Admiralty chart or *Surprise's* plotter (**Figure 15**). The information on the Admiralty chart was based on data collected during surveys conducted between 1966 and 1975. The quality of surveys would not have provided full seafloor coverage or identified all isolated dangers⁶.

Figure 15: Reconstruction of *Surprise's* chart plotter display at the time of the grounding

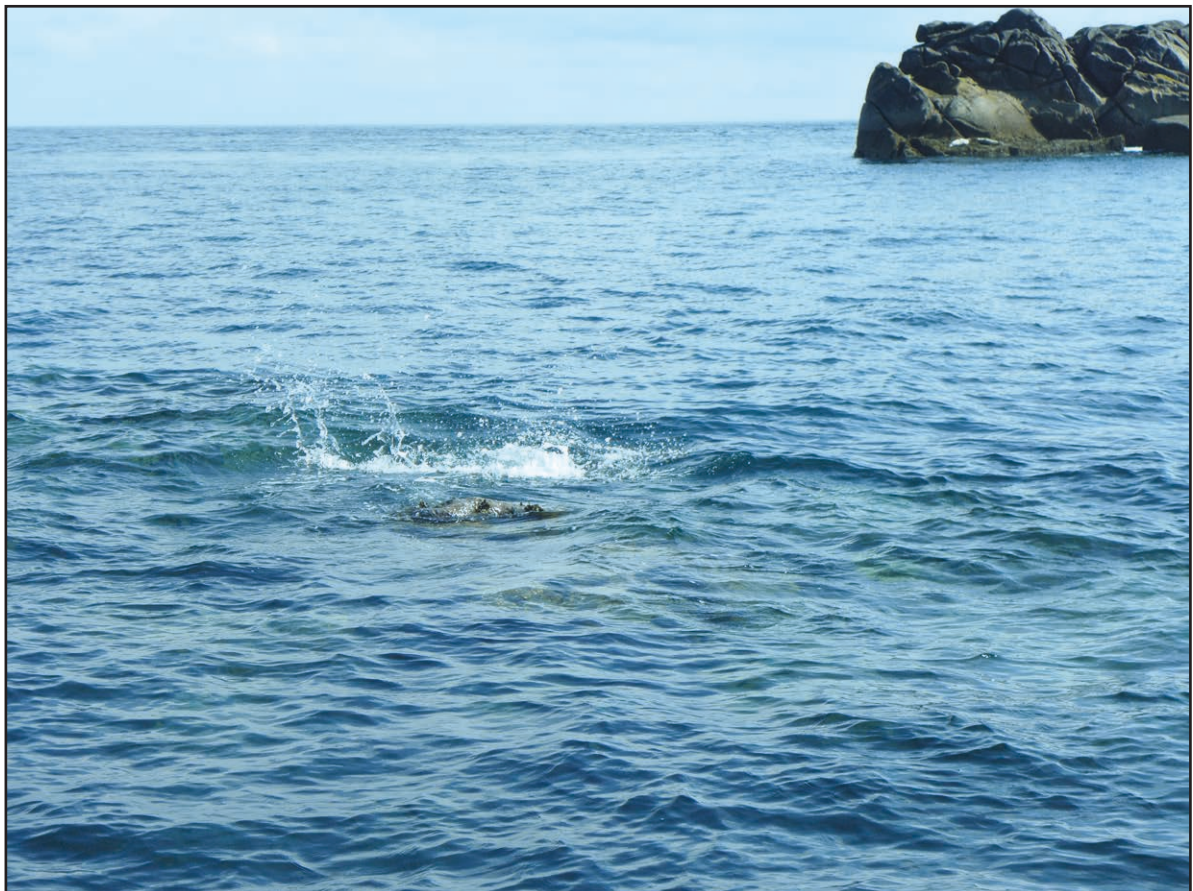
Figure 18: Example of rock wash around an isolated rock hazard

3. The skipper relied upon an amount of wash around shallow rocks to aid him avoiding these hazards. The glassy calm conditions at the time of the accident meant that this indicator was not present. [2.2]

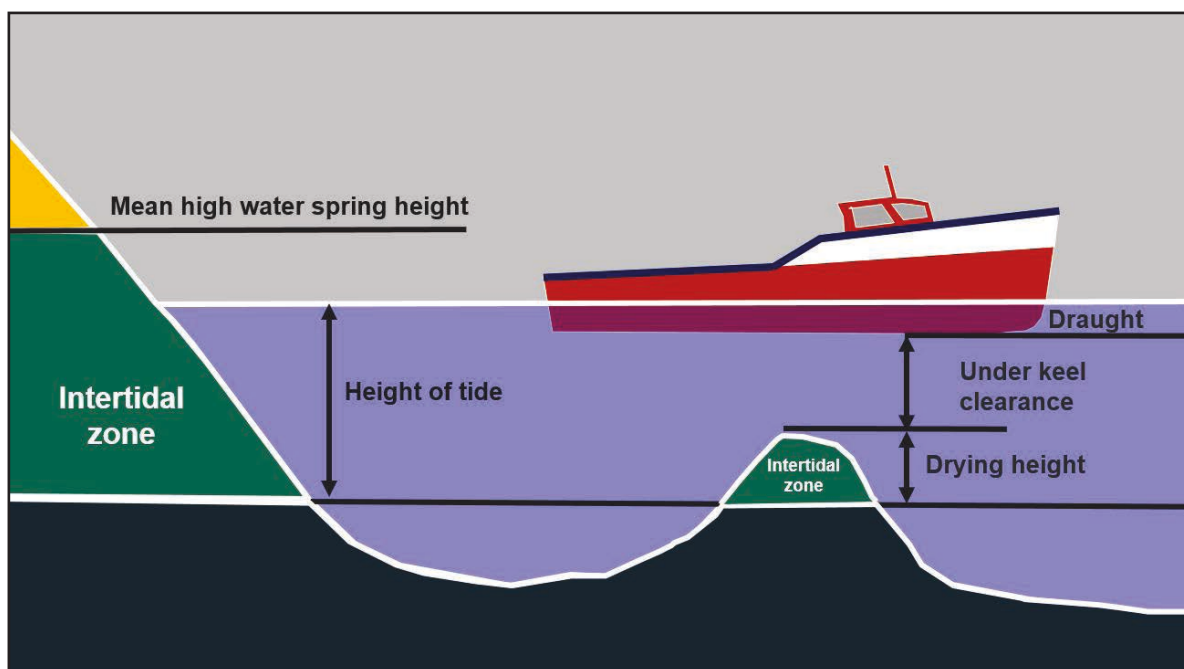
The location of the grounding was marked as an intertidal zone on the Admiralty chart and *Surprise's* plotter, but it did not have any charted drying heights. To operate safely in an intertidal zone, the height of tide needs to be known and appropriate limiting danger lines need to be calculated. The calculation of a limiting danger line is no more than the application of a basic navigational principle. In the case of *Surprise*, a working draught of 1.0m and minimum UKC of, perhaps, 0.5m could have been combined with the height of tide to assess the safe and unsafe areas for each trip (**Figure 19**).

Had such conventional navigation techniques been applied, it would have been apparent that the vicinity of the grounding, in an intertidal zone without a drying height, would have been unsafe to proceed into without detailed knowledge of every hazard at all states of tide. Although the skipper had undertaken similar trips before, the multitude of hazards in the area meant that he could not have been expected to know the location and height of every submerged rock. Thus, entering the intertidal zone where the seals were basking was unsafe and the passengers' sightseeing experience should have been provided by staying in deeper water.

Figure 19: Illustration of a vessel navigating safely in an intertidal area where drying heights are shown and there is sufficient height of tide
