Serious injury to a deckhand on board *Sea Harvester* (N822) Firth of Clyde, Scotland 3 August 2016

SUMMARY

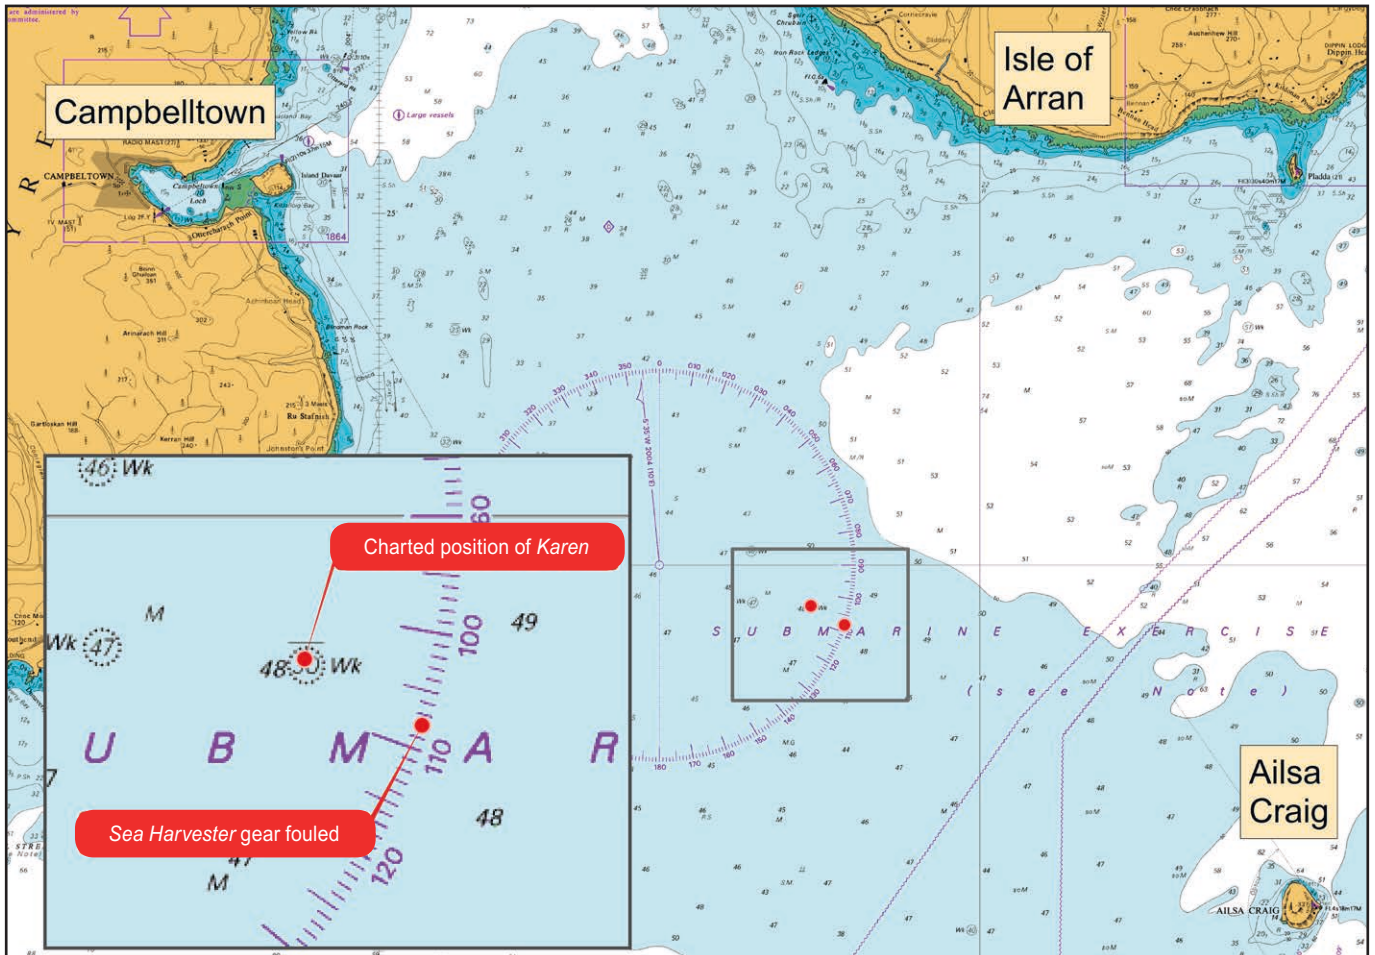
Figure 1: Chart 2126 showing the position of the accident

It is possible that the underwater obstruction caught by *Sea Harvester's* trawls was the wreck of the fishing vessel *Karen* (**Figure 1**), the position of which had not been formally verified by survey. The obstruction was within 0.5nm to the south-east of the wreck's chartered position, and it coincided with the position of the wreck input into *Bonaventure's* chart plotter, which had probably been based on local knowledge passed on by word of mouth.

- Issued a flyer to the fishing industry to highlight the safety issues identified in this report.
- Informed the UKHO of the potential inaccuracy of the position of the wreck of the fishing vessel *Karen* shown on Admiralty charts.
- Requested the MCA verify the position of the wreck.

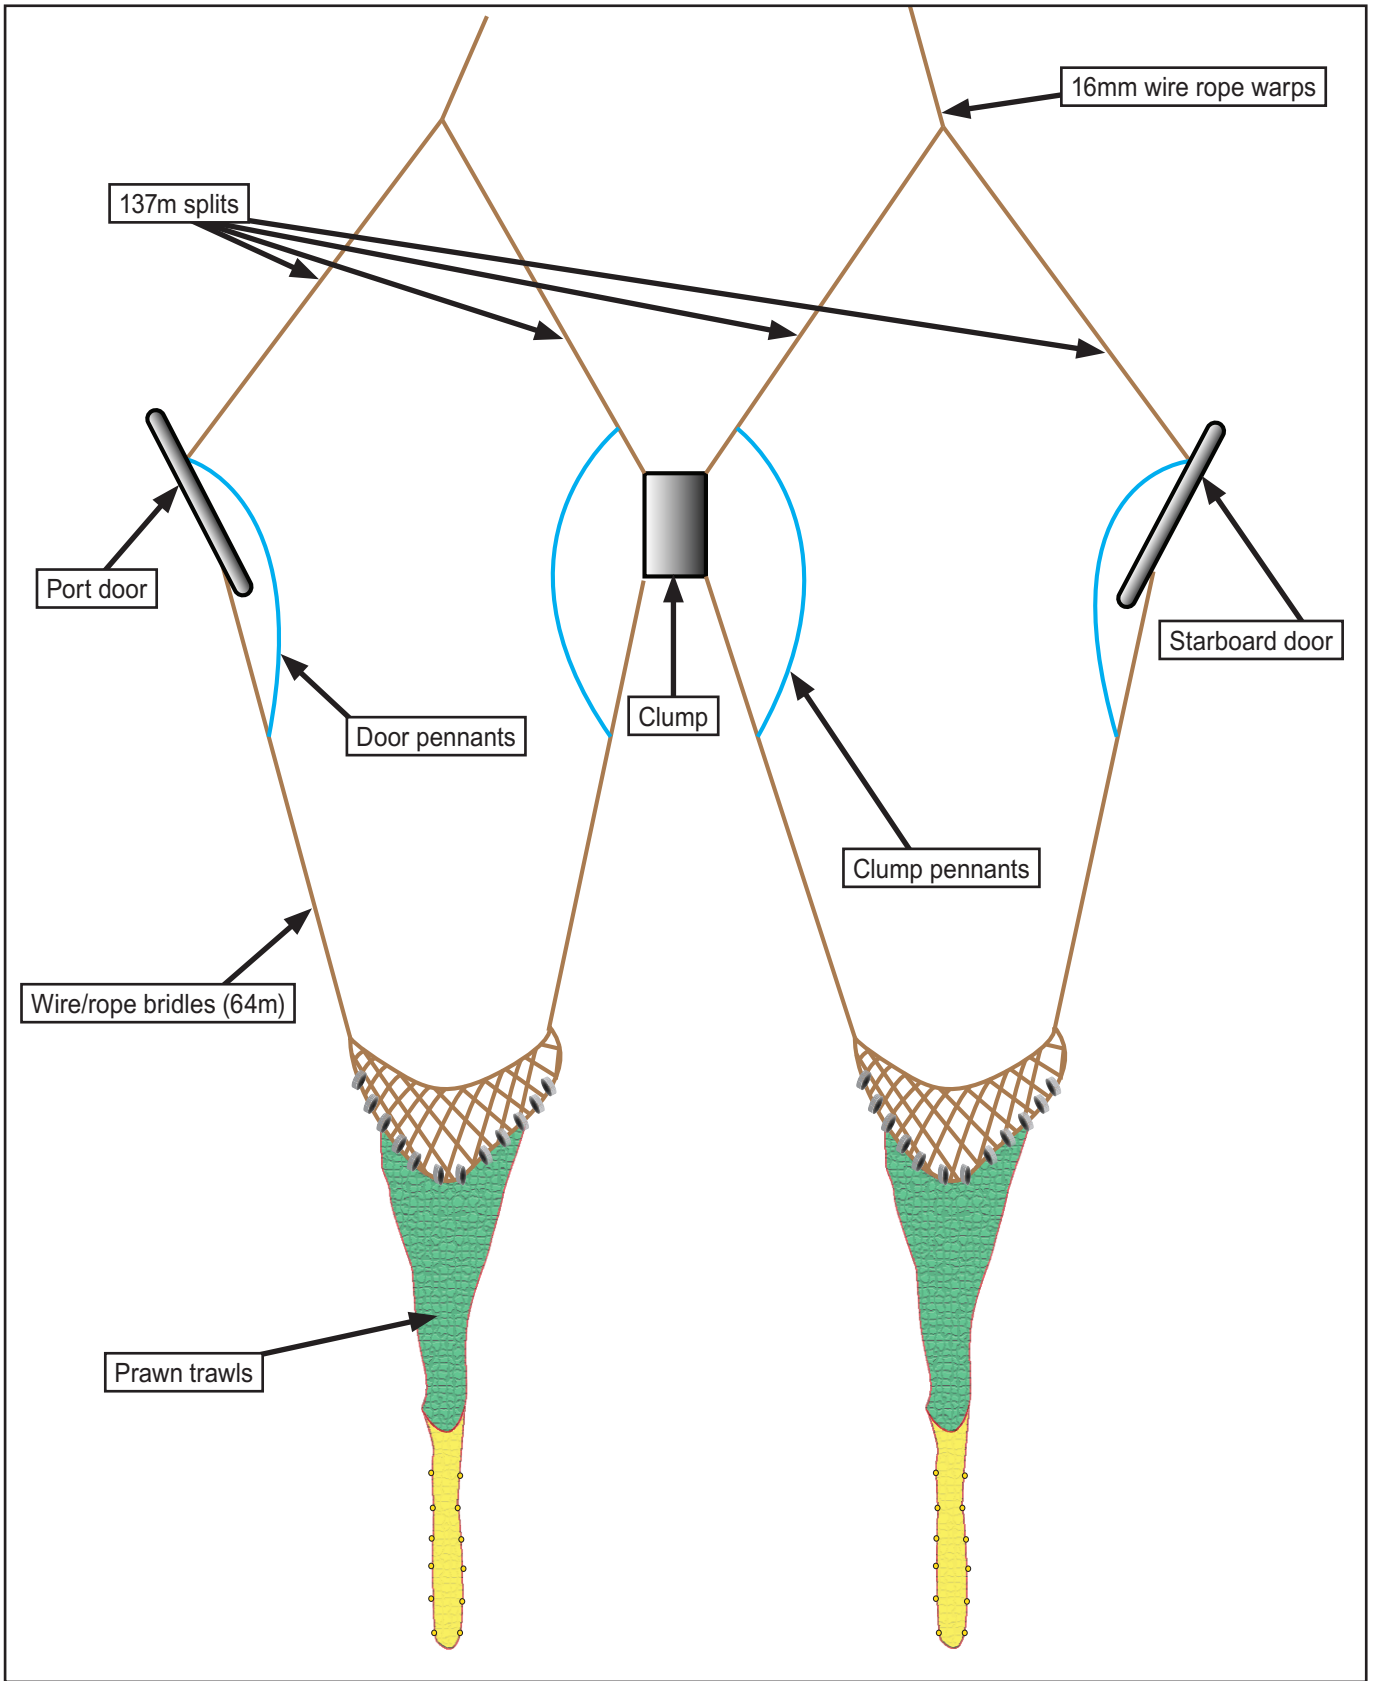
Figure 2: Twin rig gear set-up (not to scale)

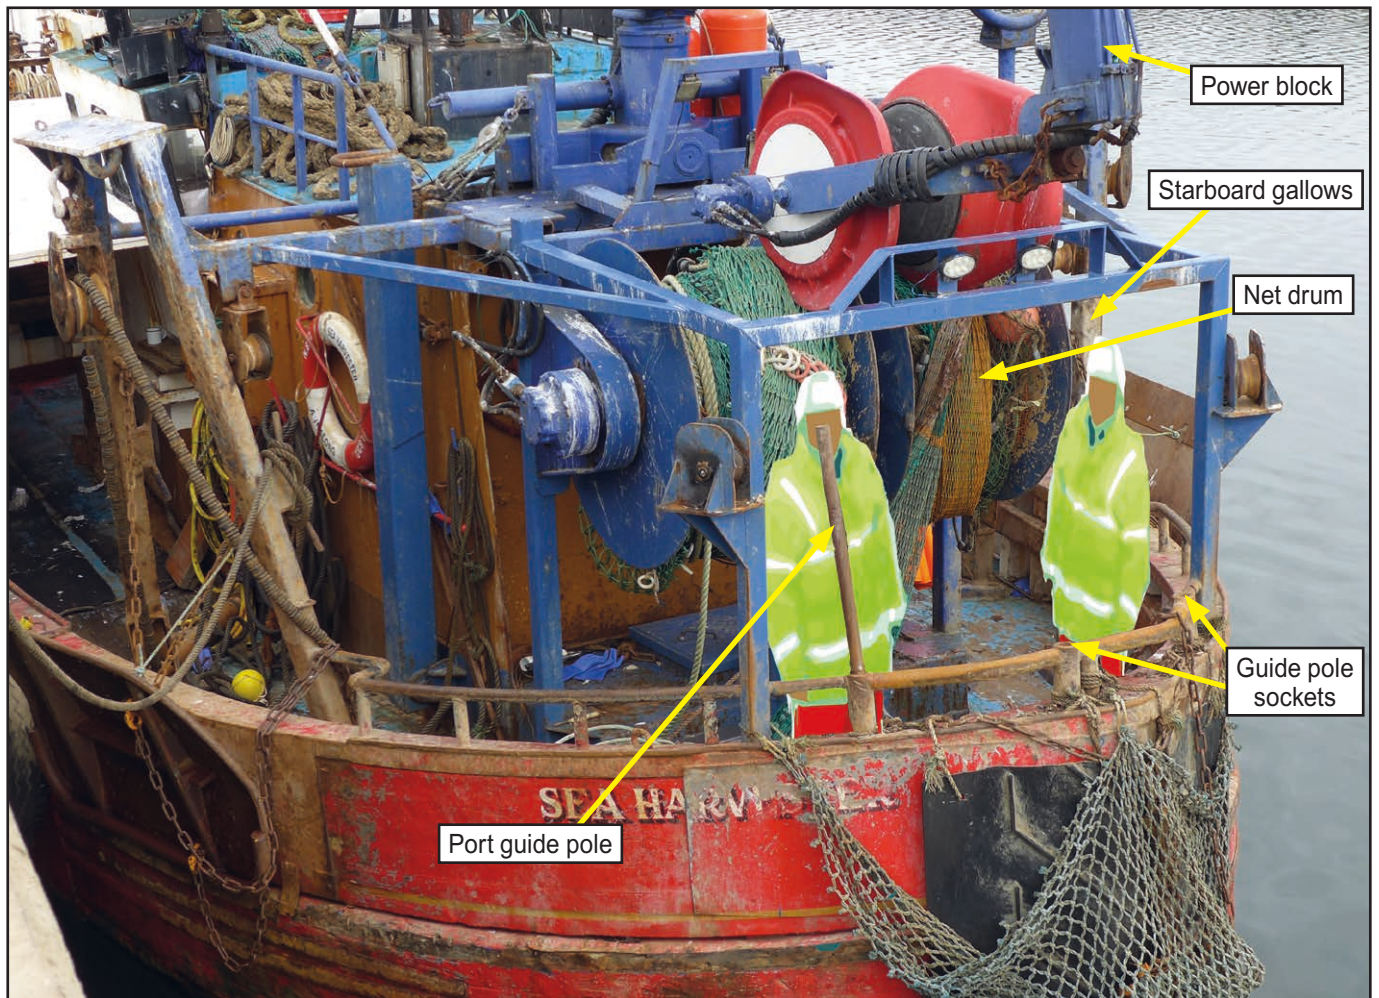
Figure 3: Aft deck area showing approximate positions of deckhands

When hauling, steel guide-poles (**Figures 3, 4 and 5**) were used to guide the port and starboard trawls onto the split net drum. Two poles were carried, which were usually fitted into the two outer sockets on the top of the gunwale at the stern. The third socket, located on the centreline, was not usually used. The sockets were 230mm deep with an internal diameter of 54mm.

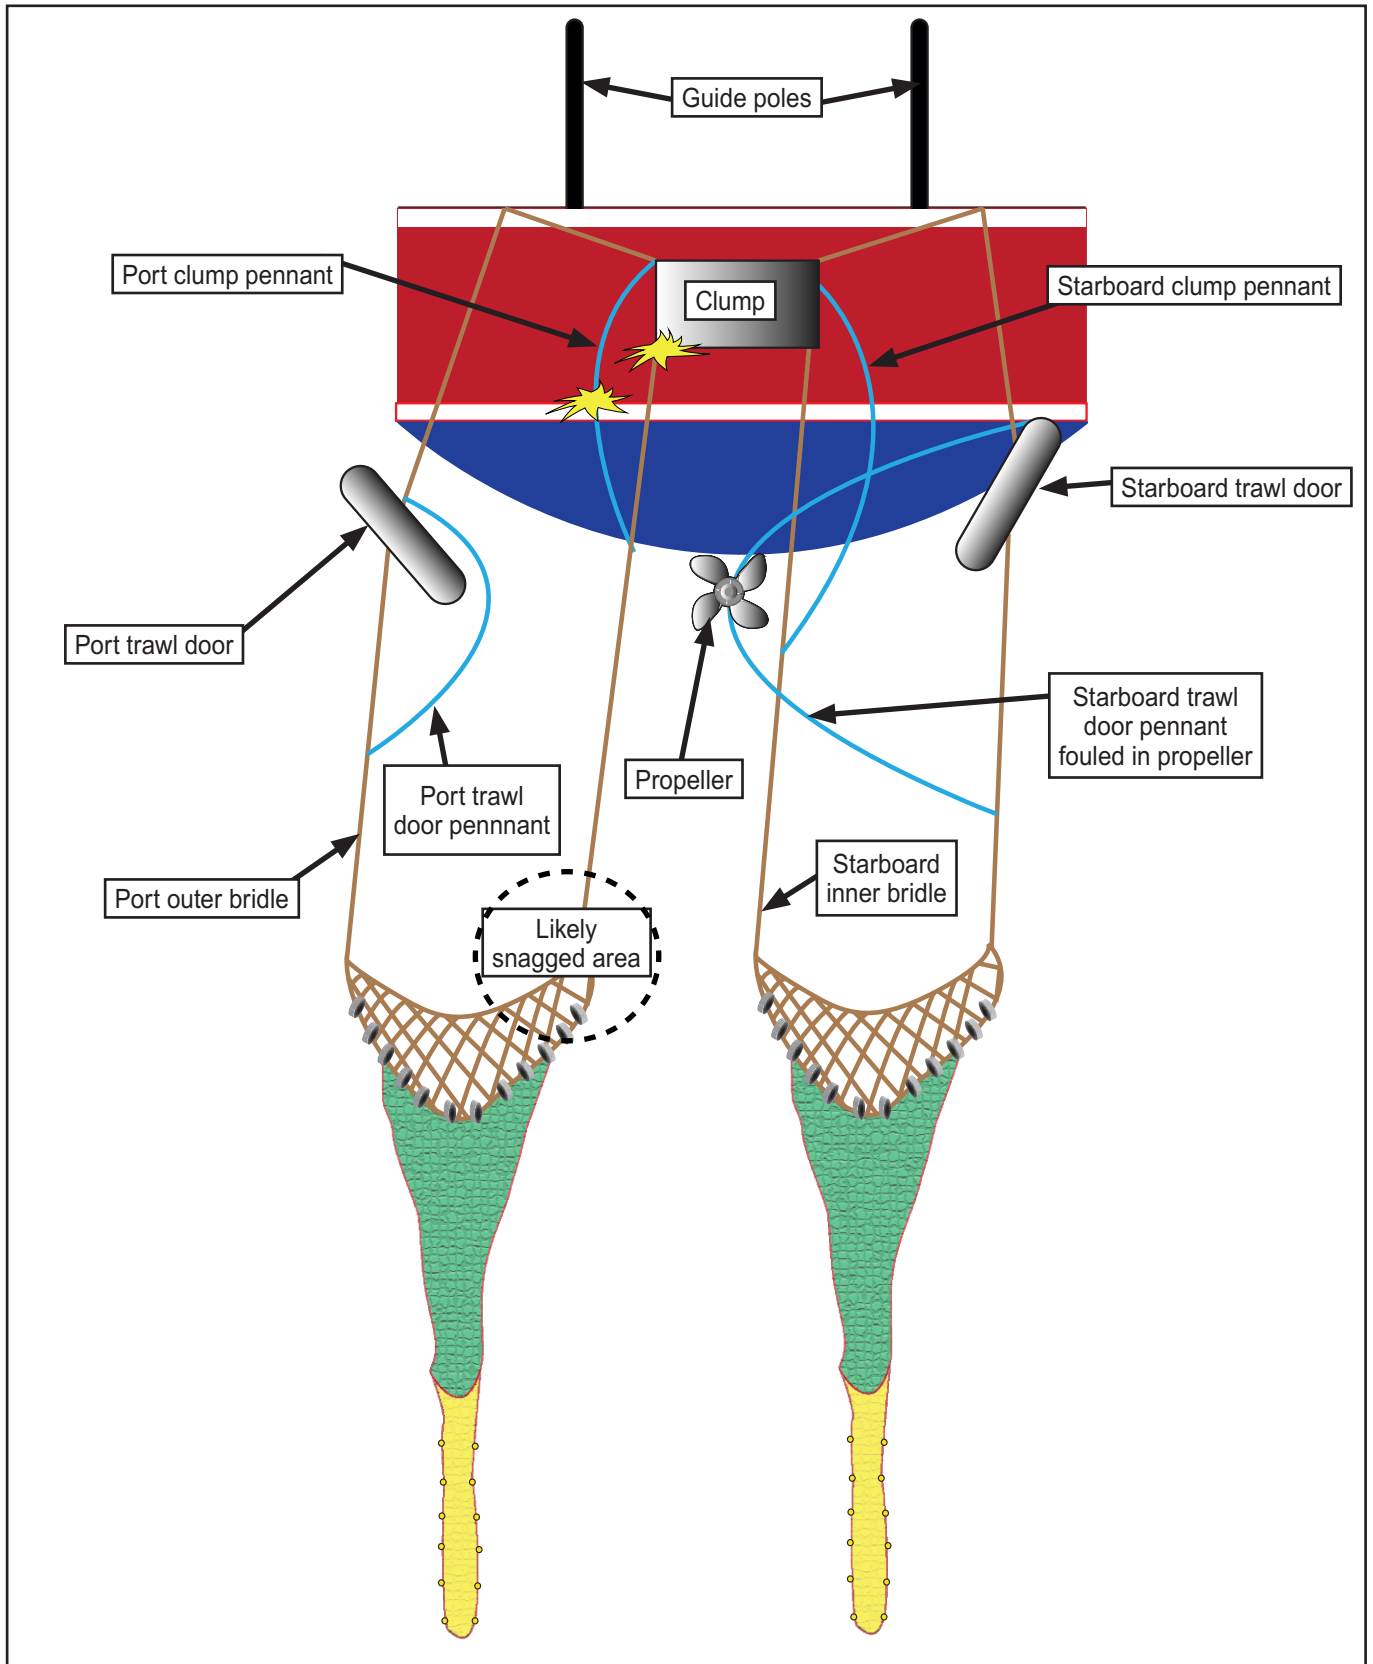
The skipper saw that the pennant⁵ attached to the starboard trawl door was close to the propeller and told one of the deckhands, Aurelian Dinu, to hold it clear. As the skipper then made his way to the wheelhouse to take *Sea Harvester's* engine out of gear, the door pennant became caught in the propeller and the engine stopped. Shortly after, the lug connecting the inner port bridle to the clump failed and the port clump pennant parted (**Figure 4**).

Figure 4: Showing starboard pennant in propeller and failure of port inner pennant and bridle (not to scale)

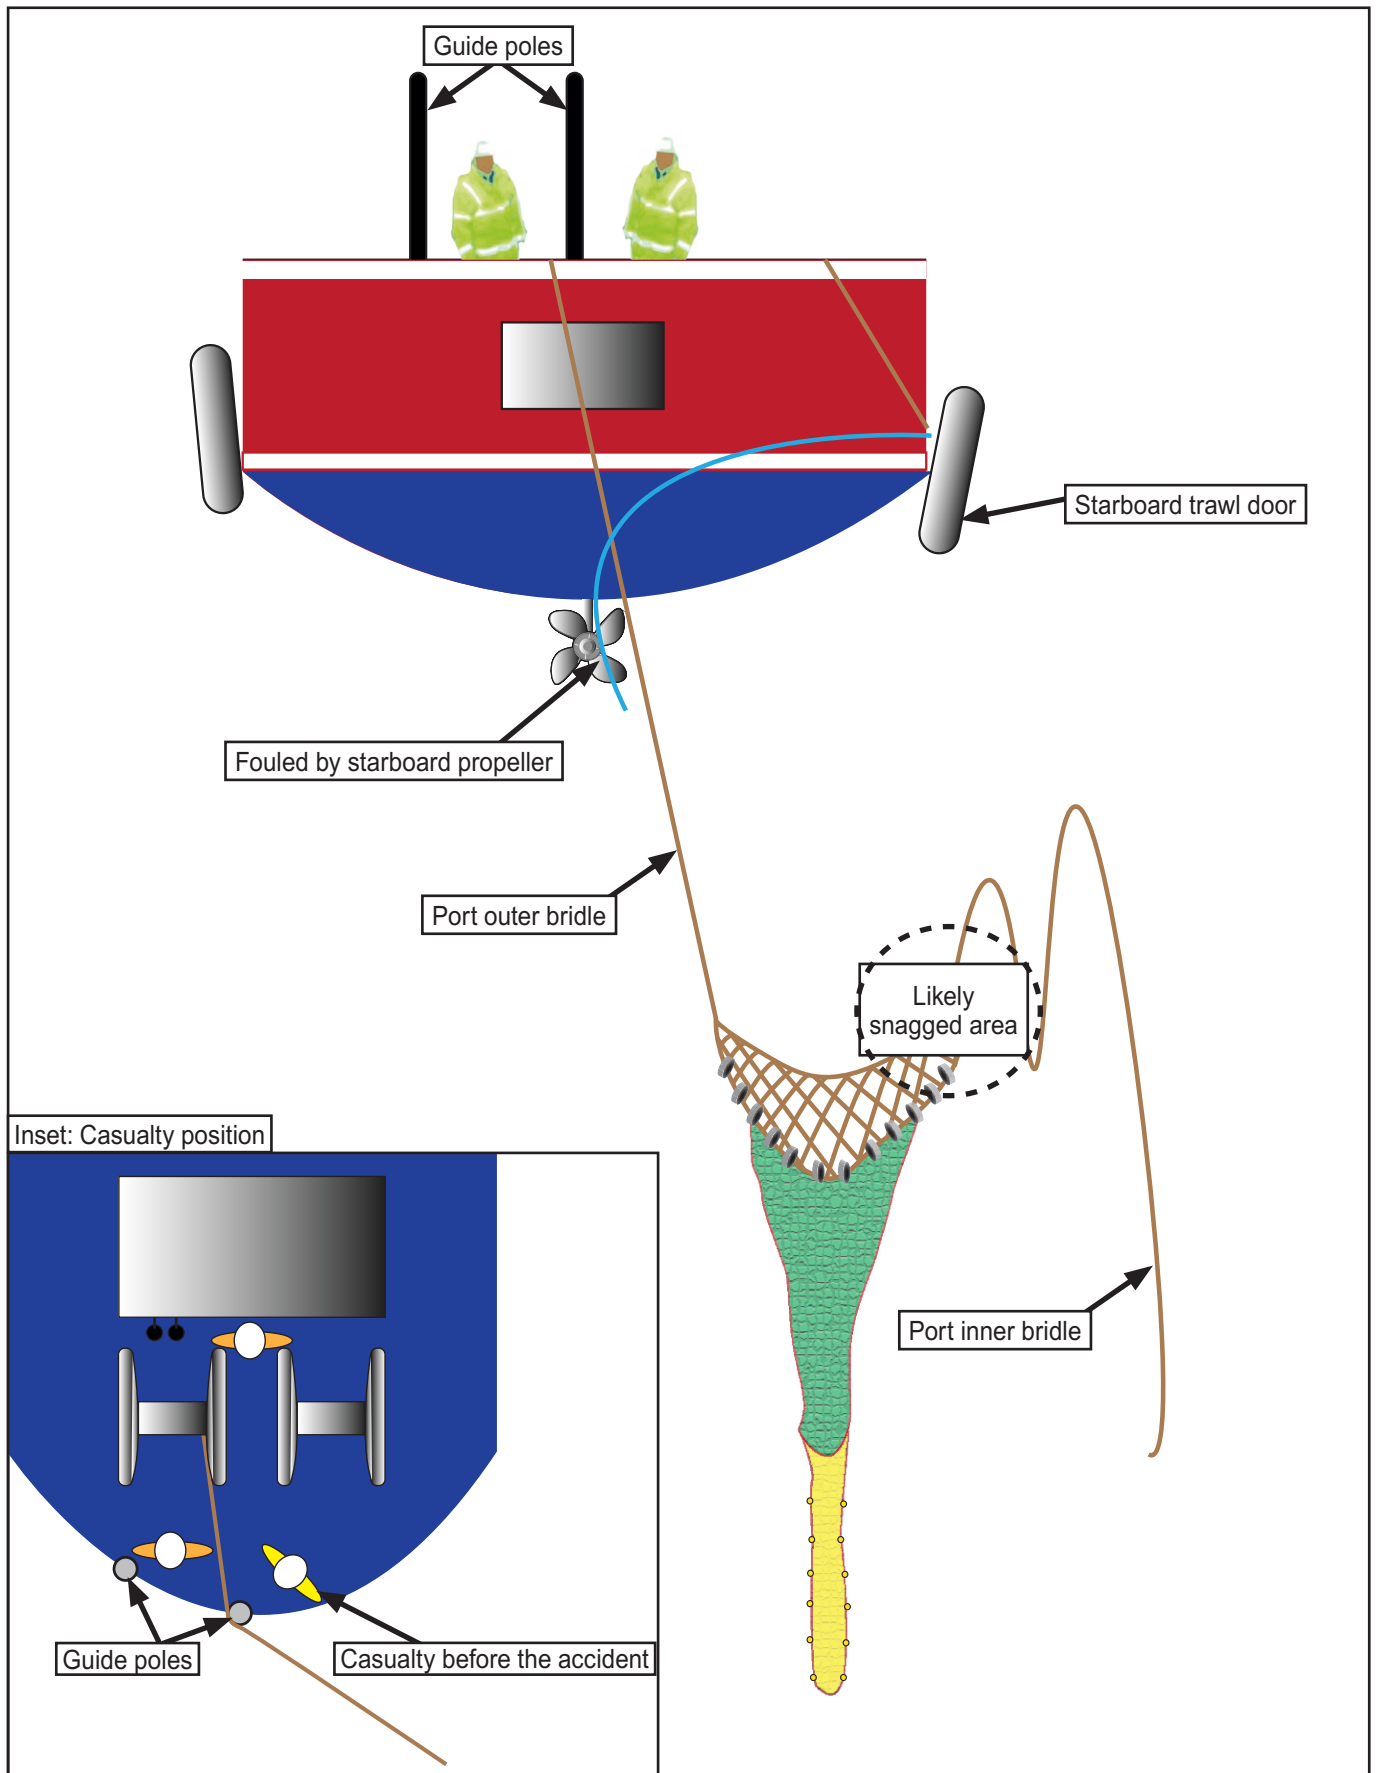
The port trawl's outer bridle was then connected to the port net drum. *Sea Harvester* was rolling heavily and lying broadside to the sea with the result that the port trawl's outer bridle led over the stern and to starboard. To bring the lead of the bridle and the net perpendicular to the net drum, the guide-pole on the starboard side of the aft gunwale was moved to the centreline socket (**Figure 5**).

Figure 5: Port trawl retrieval (not to scale)

The pole was propelled from its socket by the force exerted by the port bridle acting in conjunction with the vessel's motion. Although the socket in which the guide-pole was seated was 230mm deep, the pole was not secured. The pole's diameter, which might have been reduced by wear similar to the pole remaining on board, allowed it to rotate and to move upwards. Indeed, the pole had to be pushed down and re-seated by Aurelian several times before the accident.

- Modified the securing arrangement for *Sea Harvester's* guide-poles to reduce the likelihood of them dislodging when hauling.
- Reviewed similar arrangements on other vessels they own together.
- Completed a health and safety risk assessment.

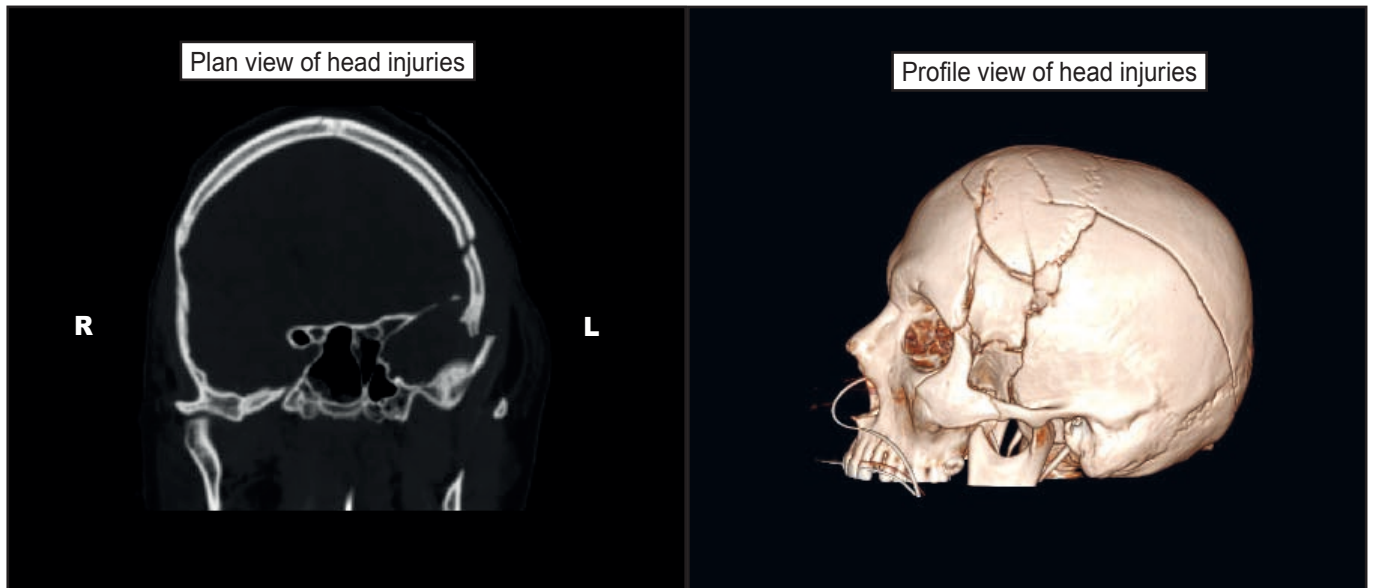
Aurelian Dinu suffered a head injury (**Figure 6**) with multiple contusions. Following an emergency craniotomy⁷ and the evacuation of contusions, he later had a cranioplasty⁸ and a feeding tube inserted. Aurelian's injuries left him faecally incontinent and with a urinary catheter in situ. He was totally dependent on all care and was unable to follow commands.

Figure 6: Casualty's injuries

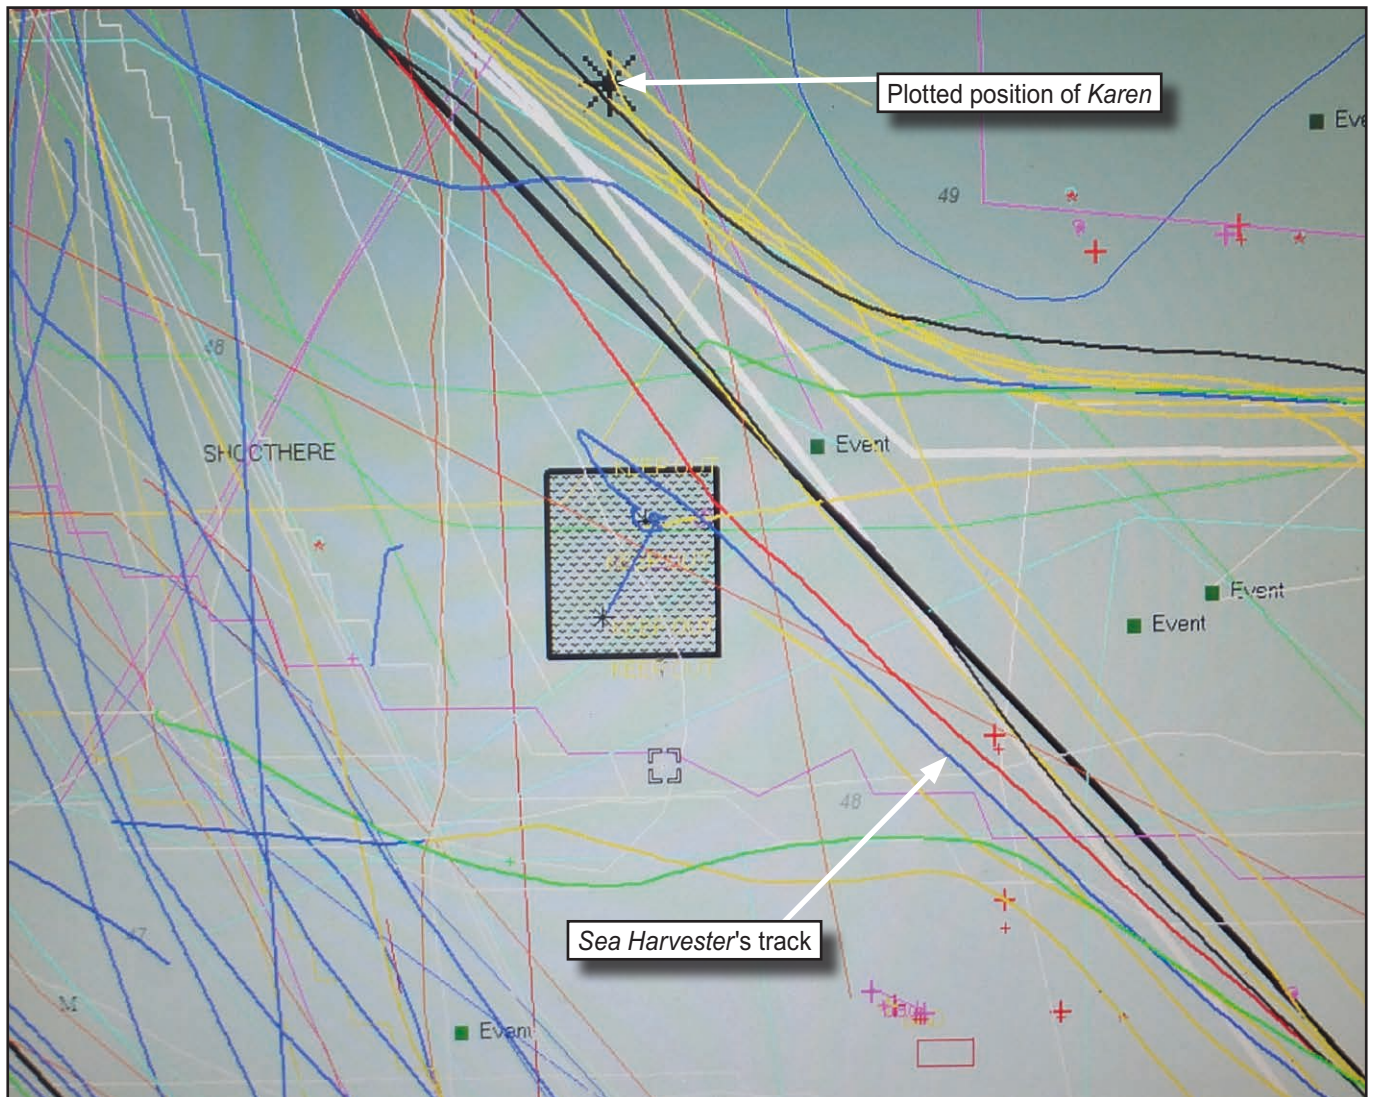
Figure 7: Image of *Sea Harvester's* plotter

If the obstruction was *Karen's* wreck, then the position of the wreck input into *Sea Harvester's* chart plotter, which did not coincide with either its charted position or the position shown on board *Bonaventure*, was also inaccurate. Consequently, instead of passing 0.5nm to the south of the wreck as *Sea Harvester's* skipper intended (**Figure 7**), the vessel passed directly over it.
