ACCIDENT

Aircraft Type and Registration:	Druine D.31 Turbulent, G-ARNZ
No & Type of Engines:	1 Volkswagen 1600 piston engine
Year of Manufacture:	1961 (Serial no: PFA 579)
Date & Time (UTC):	14 August 2016 at 1430 hrs
Location:	In the intertidal zone, Herne Bay Beach, Kent
Type of Flight:	Private
Persons on Board:	Crew - 1 Passengers - None
Injuries:	Crew - 1 (Minor) Passengers - N/A
Nature of Damage:	Damage to the wing and from salt water immersion
Commander's Licence:	Private Pilot's Licence
Commander's Age:	71 years
Commander's Flying Experience:	922 hours (of which 360 were on type) Last 90 days - 8 hours Last 28 days - 2 hours
Information Source:	AAIB Field Investigation

Synopsis

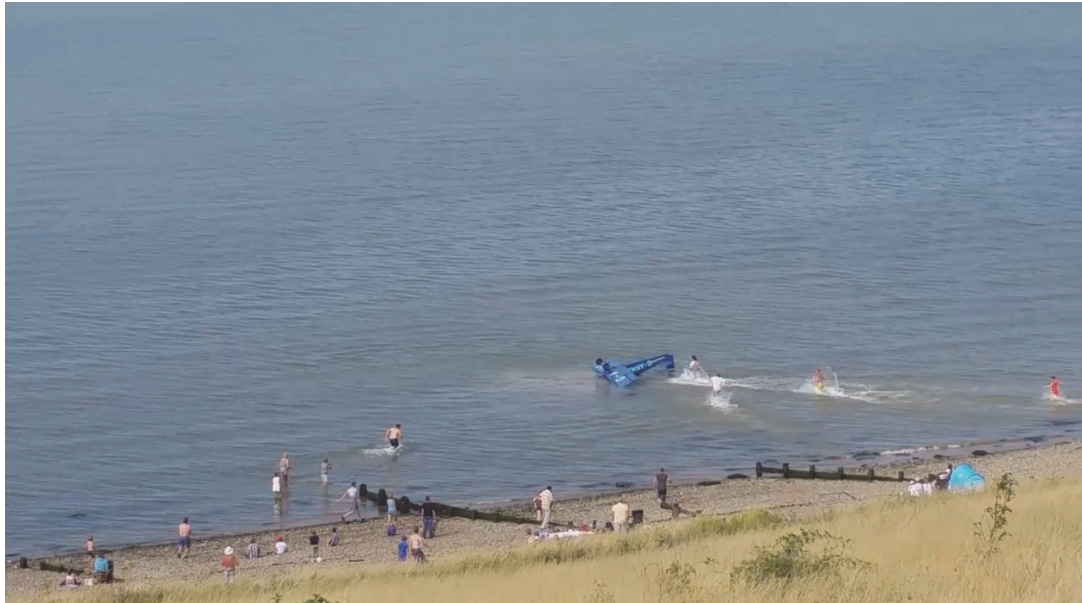
Figure 1

The aircraft's descent continued until it was a few feet above the water, when the pilot flared the aircraft to "hold off". The aircraft's mainwheels touched the water first and the drag they experienced caused the aircraft to pitch forward rapidly onto its back (Figure 1). Although the pilot was able to unfasten his straps, he found himself trapped in the cockpit, with his head close to the sea bed and insufficient space to manoeuvre himself out of the cockpit. Moreover, his automatic lifejacket had inflated and its bulk and buoyancy were pressing him up into the inverted cockpit.

Inverted aircraft just prior to pilot's rescue

With insufficient range to reach open ground onshore, the pilot elected to ditch the aircraft beyond the display area and just off the beach, where there were fewer people than along other parts of the seafront. He intended to stall the aircraft on to the surface of the sea tail first, so that the aircraft remained upright. In the event, the main wheels touched the surface first and the aircraft pitched forward, coming to rest inverted in shallow water. The pilot, who had remained conscious found that his head was close to the sea bed. He released his harness but his lifejacket inflated automatically, as designed, and he was unable to extricate himself from his position in the cockpit.

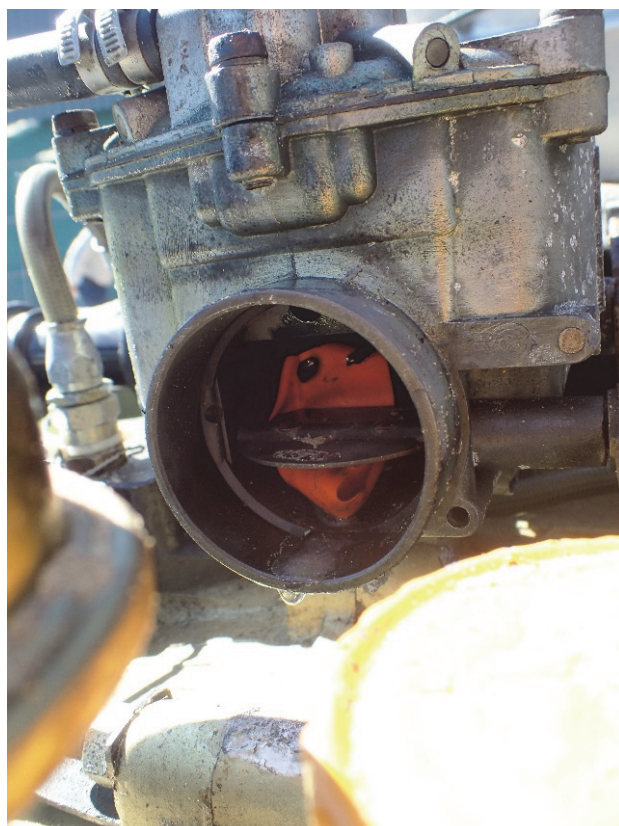
Figure 2

Further detailed examination of the engine found a piece of balloon, approximately 50 mm in diameter, lodged in the air path of the carburettor (Figure 2).

Balloon fragment (orange) lodged in the carburettor air path

A fragment of balloon was found lodged in the carburettor causing a significant restriction to the airflow through the carburettor, causing the loss of engine power experienced by the pilot.

The operators of the aircraft developed a modification to fit a screen to the engine's carburettor intake, with the intention of preventing the ingress of similar debris to the balloon fragment. Should this screen become blocked, air can still be supplied to the carburettor via the alternative hot air supply, thereby allowing the engine to operate normally. After satisfactory testing, the modification was approved by the Light Aircraft Association.
