ACCIDENT

| Aircraft Type and Registration: | Denney Kitfox Mk 2, G-TWTW | |

Synopsis

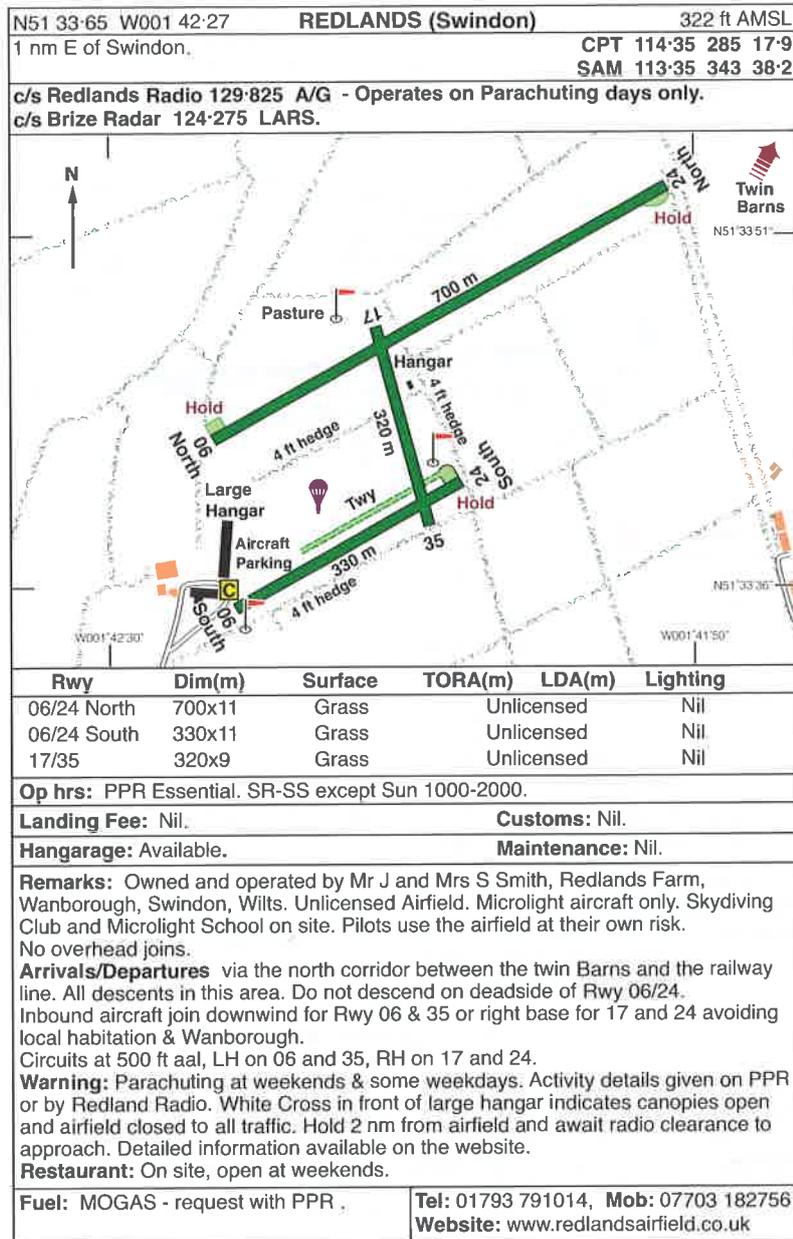
The aircraft stopped close to a hedge, which has a gap through which the runway passes at approximately its mid-point, see Figure 1 for a layout of the airfield. There was some

Layout of Redlands Airfield

He also noted this runway is unusual because there is a hedge running across the upwind end, as well as the one with the gap through which the runway passes near the mid-point. His unfamiliarity with the airfield led him to believe the hedge near the midpoint was the hedge at the end of the runway so, if he had appreciated the layout better, he could have turned earlier and had sufficient landing distance beyond the first hedgerow. This would have meant he had more height in hand and therefore more time to complete the turn and stabilise the final approach.
