Capsize of tug *Domingue* while assisting *CMA CGM Simba* resulting in two fatalities Tulear, Madagascar 20 September 2016

The scope of the MAIB investigation has focused on aspects concerning the involvement of *CMA CGM Simba* (**Figure 1**) with only observations relating to the tug *Domingue* (**Figure 2**) owing to limited access to evidence. The Madagascar maritime authority, Agence Portuaire, Maritime et Fluviale (APMF), has confirmed it is conducting a safety investigation into the causes and circumstances of the accident in accordance with the International Maritime Organization's Casualty Investigation Code, but has not advised when its report will be published.

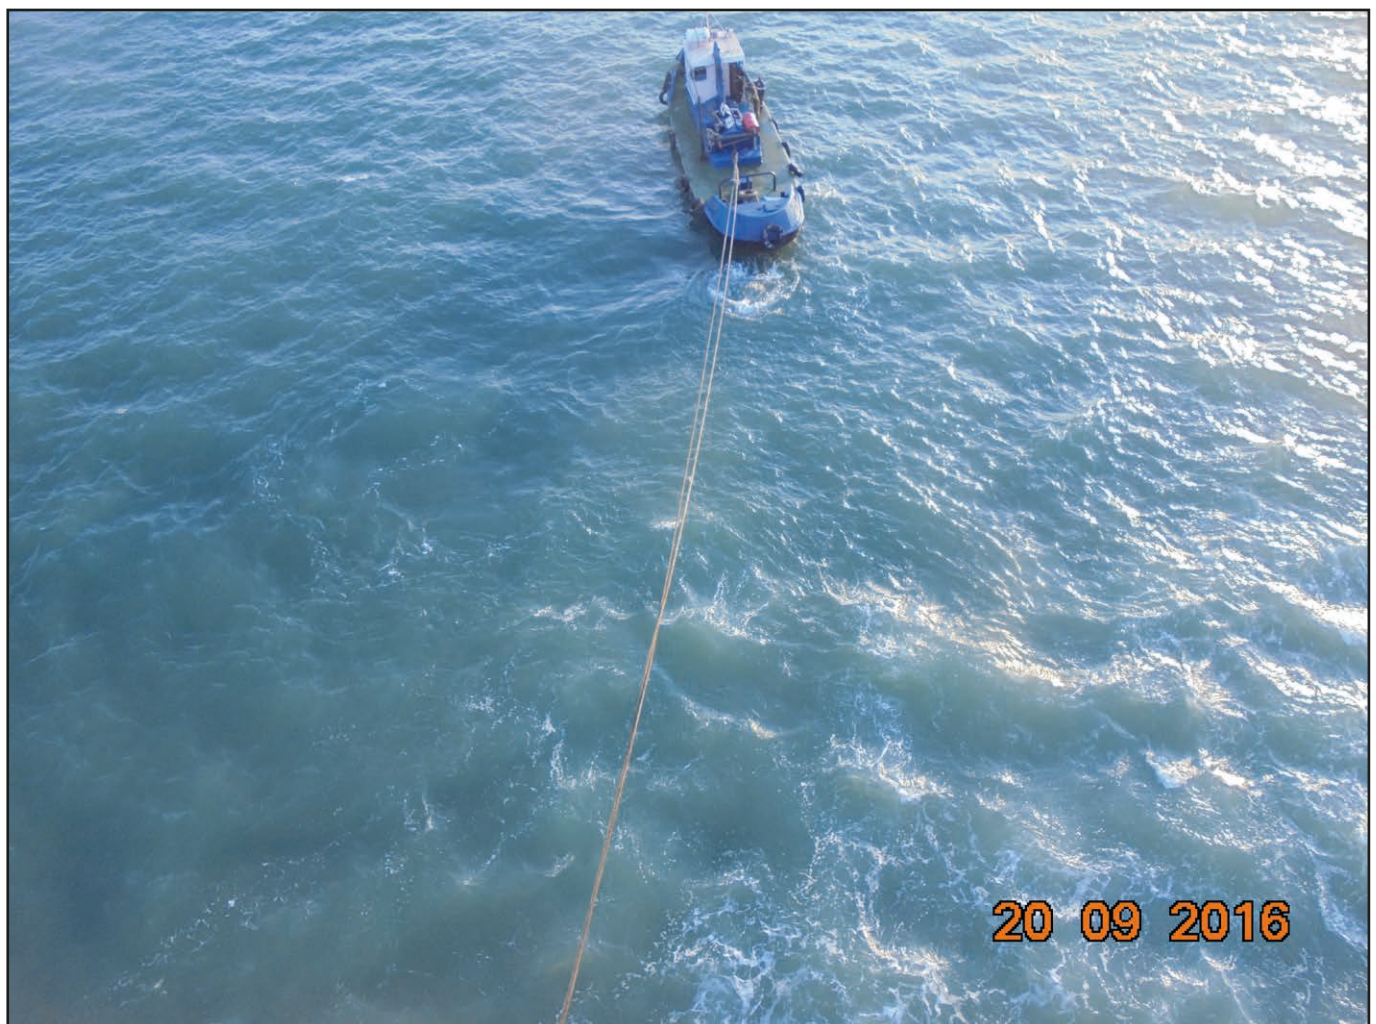
Figure 3: *Domingue*, connected to *CMA CGM Simba* with two of the ship's mooring ropes

Domingue had no gog rope rigged to prevent it from girting. The MAIB's *Asterix* investigation found that the gog rope was inappropriately rigged, while the MAIB's *Trijnie* investigation identified that no gog rope was used at all.

Domingue was not equipped with a towline emergency release mechanism and the tug's crew had no other means by which to release tow ropes under tension. It is imperative that tugs involved in towing operations are fitted with a functioning towline emergency release system and that the crew are competent in its use. A lack of familiarity with the towline emergency release was a significant finding in the MAIB's *Asterix* and *Trijnie* investigations.

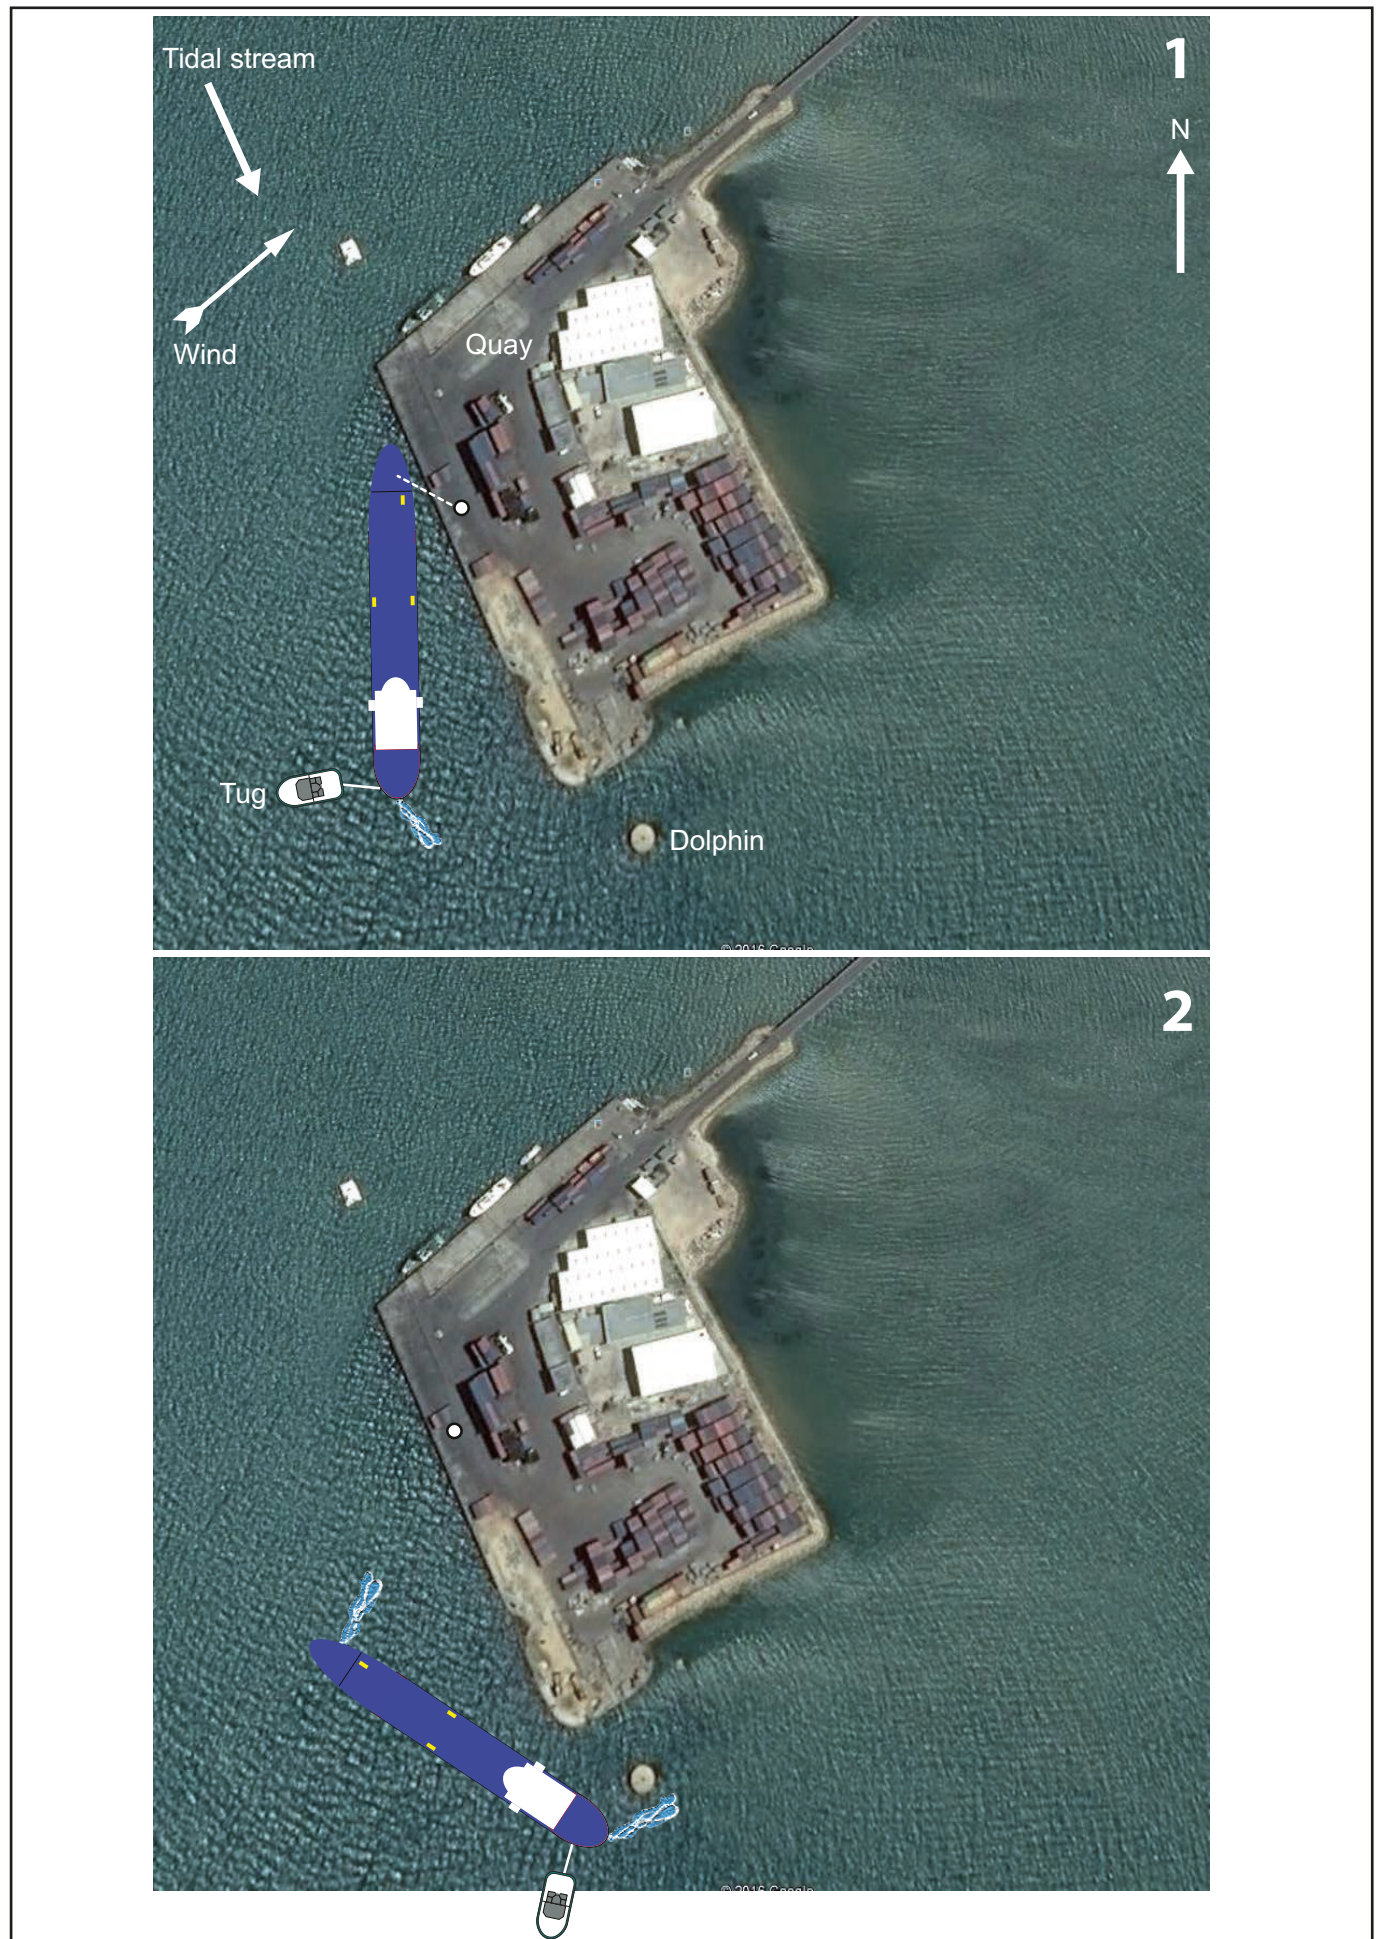
Figure 4: Tulear port, indicative movement of *CMA CGM Simba* during departure manoeuvre

Concerned about *Domingue*'s ability to assist the ship in conducting the planned departure manoeuvre, the master requested the pilot to direct the tug to pull on the port beam with full power. The tug then began to pull the ship's stern away from the quay. Satisfied that the tug had sufficient power, the master and pilot went to the starboard bridge wing, and the master gave the order to let go the remaining stern mooring ropes. With the stern ropes gone and the tug continuing to pull at full power, the master ordered the chief officer to apply ahead propulsion and the helmsman to apply starboard helm. The resulting actions caused the ship to pivot on the remaining forward backsprings, thereby enhancing the stern's movement away from the quay (**Figure 4.1**).

Noting that *CMA CGM Simba* was moving astern with its stern closing to within 3 metres of the mooring dolphin, the master ordered half ahead and bow thruster half to port, and then full ahead, hard to starboard helm and bow thruster full to port (**Figure 4.2**).

The effect of applying ahead propulsion and starboard helm, with the forward backsprings still secured, assisted the tug in its task of countering the effects of the onshore wind and tidal stream and moving the ship's stern away from the quay. However, once the backsprings had been let go, the effect of applying astern propulsion and full port bow thrust countered the tug's efforts and caused the ship's stern to close on the mooring dolphin.

The pilot and master became focused on trying to prevent the ship's stern from making contact with the mooring dolphin, and applied ahead propulsion. However, their intention to do so was not first communicated to the tug's crew by the pilot. This omission resulted in the ship moving rapidly ahead before the tug could be manoeuvred into a safe position.

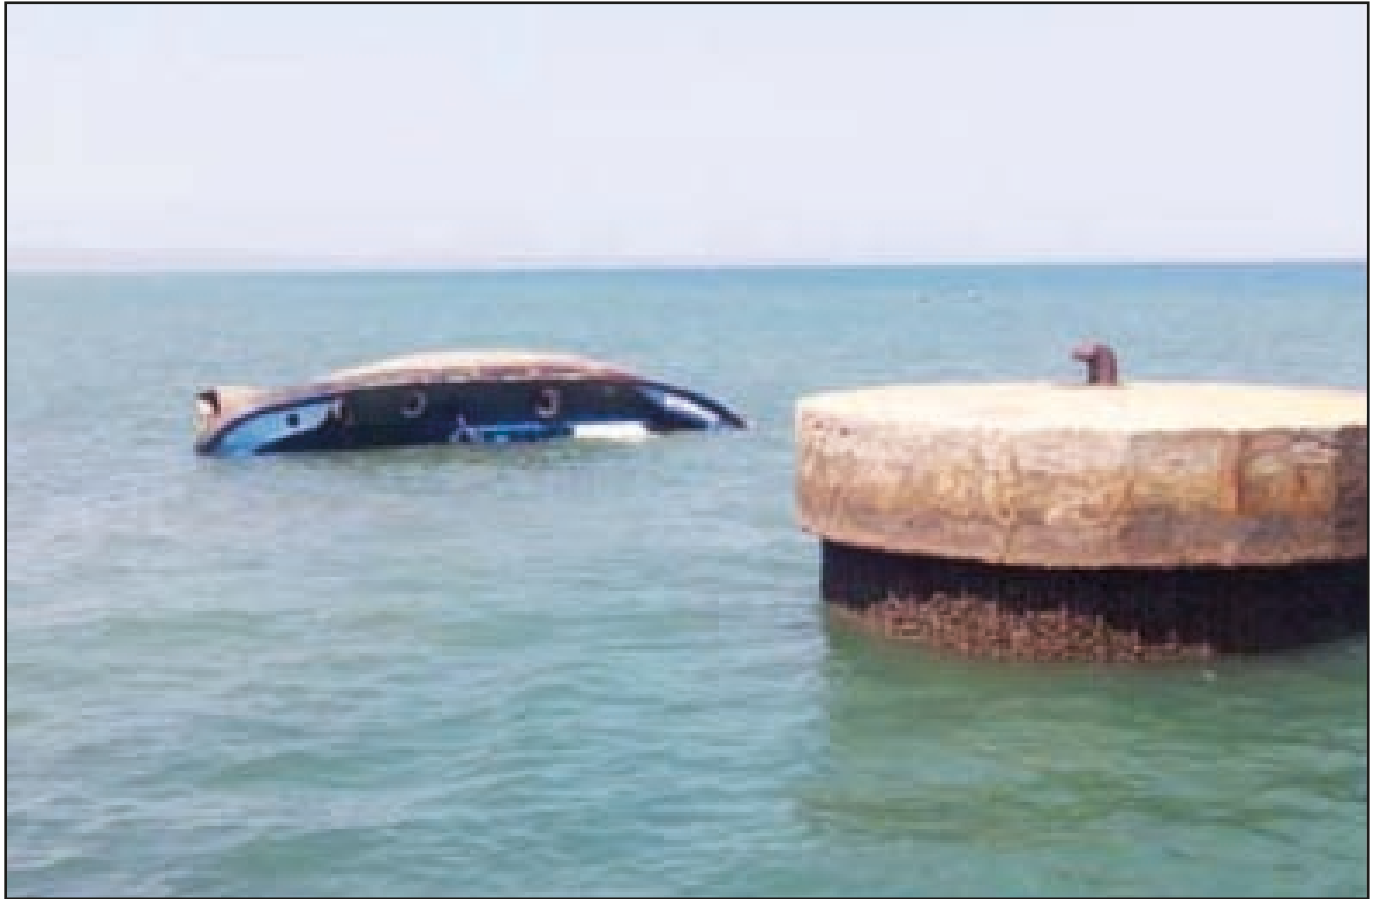
Figure 5: *Domingue*, capsized following accident

At 1745, the ship's speed over the ground had increased to 5.4 knots ahead. The tug, which was now astern of *CMA CGM Simba*, girted and capsized (**Figure 5**). Seeing the capsized tug, the second officer alerted the bridge by radio. The master ordered stop engines and instructed the second officer to cut the mooring ropes attached to the tug. However, both mooring rope eyes then came free from the tug, and the local pilot boat proceeded to assist the tug crew in the water.

The tug *Domingue* girted, capsized and foundered as it assisted *CMA CGM Simba* during the ship's departure from Tulear. The tug and its crew were able to counter the effects of the wind and tidal stream, but were neither able to counter the effect of the ship's movements nor prevent the tug from girting, capsizing and foundering.

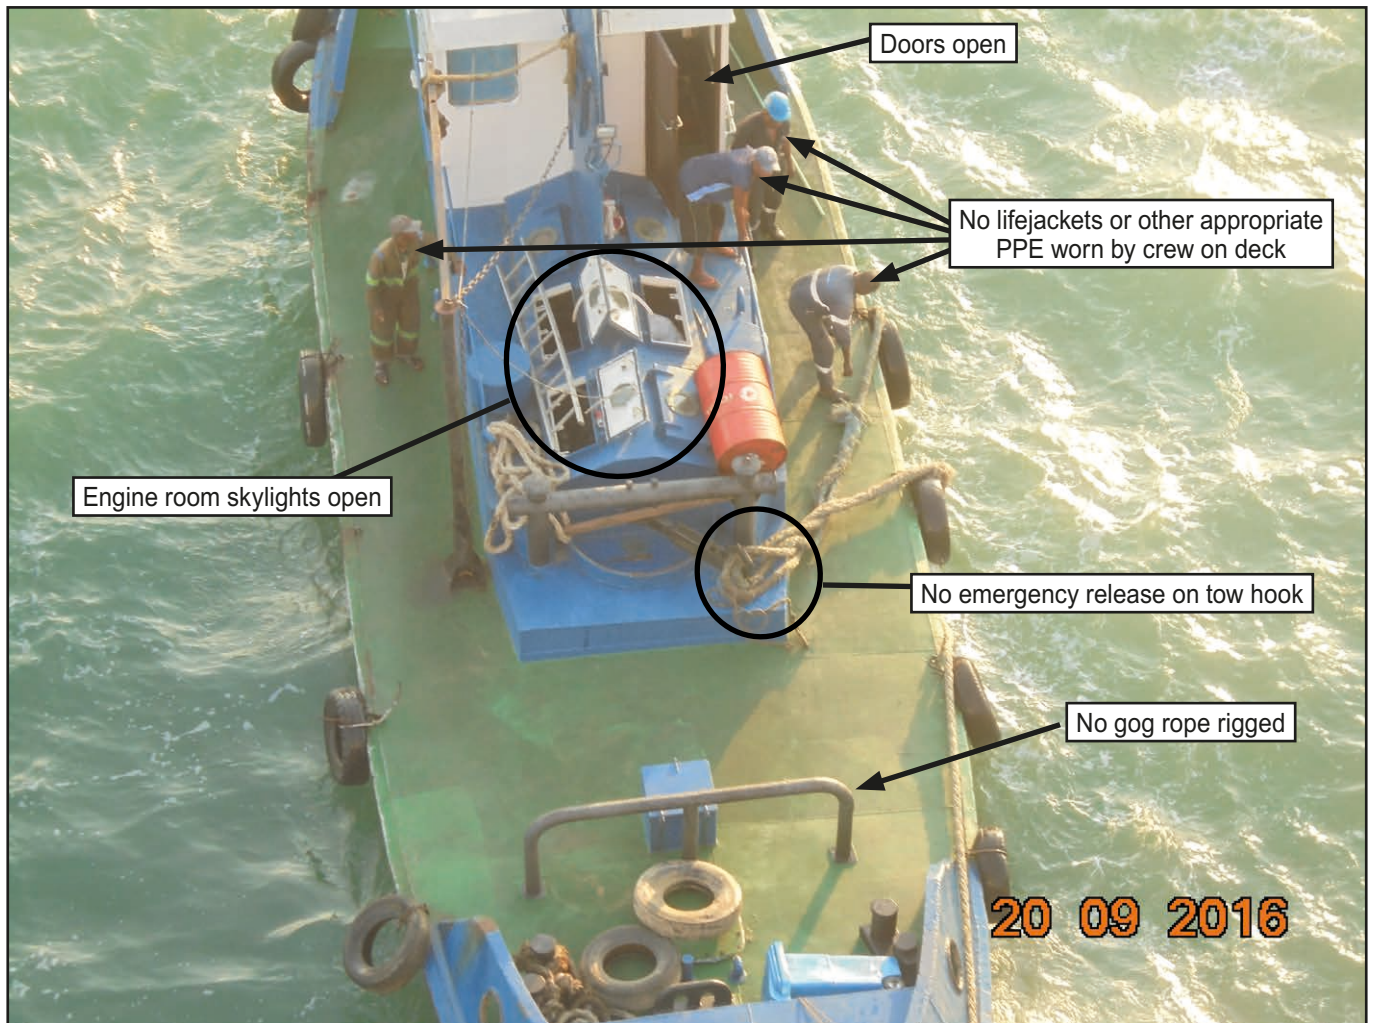
Figure 6: Crew of *Domingue* securing tow ropes from *CMA CGM Simba*

Domingue's single towing hook was not fitted with an emergency release mechanism, no gog⁴ rope was rigged, and doors and hatches were left open during the towing operation (**Figure 6**).

It is highly probable that the open doors and hatches contributed to the rapid capsizing of *Domingue* due to downflooding (**Figure 6**). Downflooding through open doors was a contributing factor identified in the MAIB's *Flying Phantom* investigation.

- It is highly probable that *Domingue*'s open doors and hatches contributed to its rapid capsize due to downflooding.
- The success of the departure manoeuvre relied on the tug and its crew being capable of meeting changing manoeuvring demands. This required a common, detailed understanding of the plan, proactive communications and an agreed means for monitoring the tug throughout the towing operation.
