Report on the investigation of the foundering of the  
fishing vessel

***Louisa SY30***

while at anchor off the Isle of Mingulay

on 9 April 2016

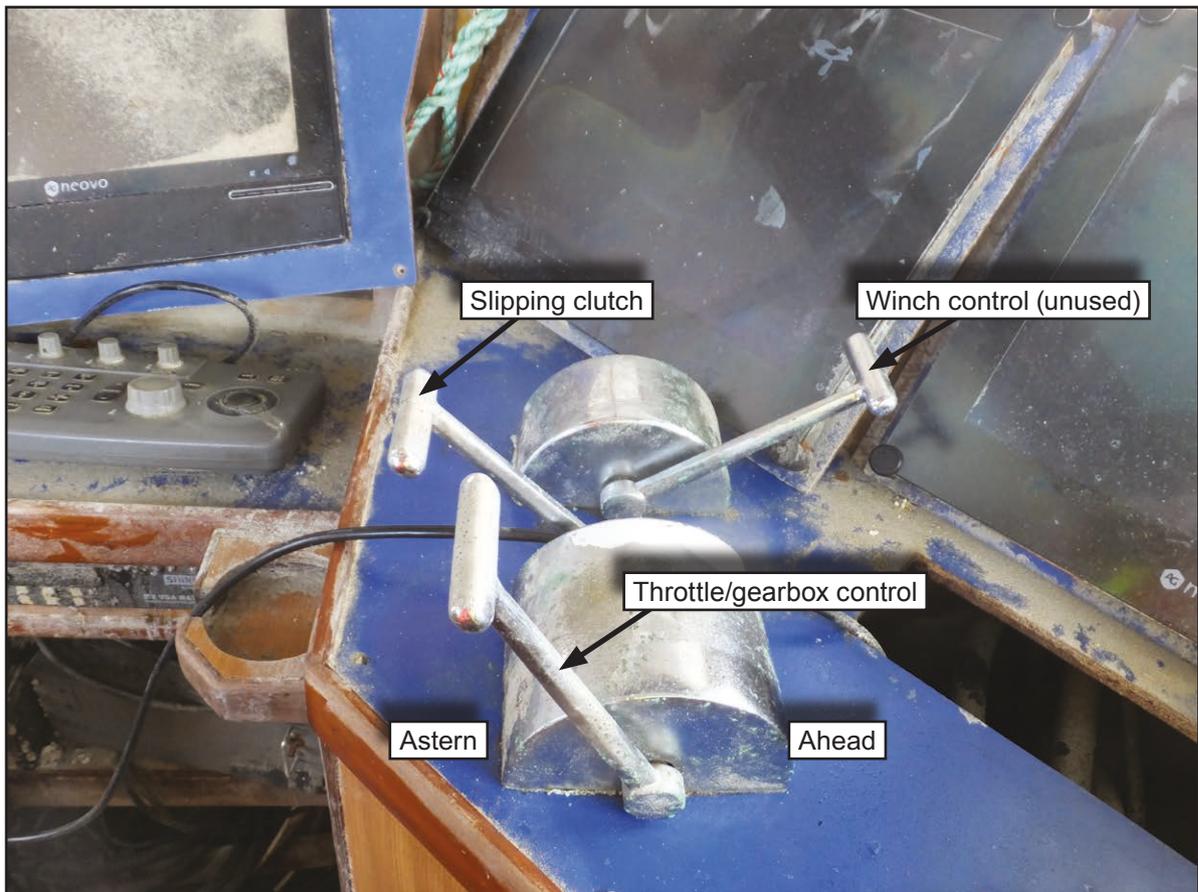
Figure 5: *Louisa* - engine controls as found

The initial focus of the examination centred on checking and recording the positions of all system valves and machinery controls. As identified during the dive survey, the main engine controls were found set to run at apparently low speed with the propeller engaged astern (**Figure 5**).

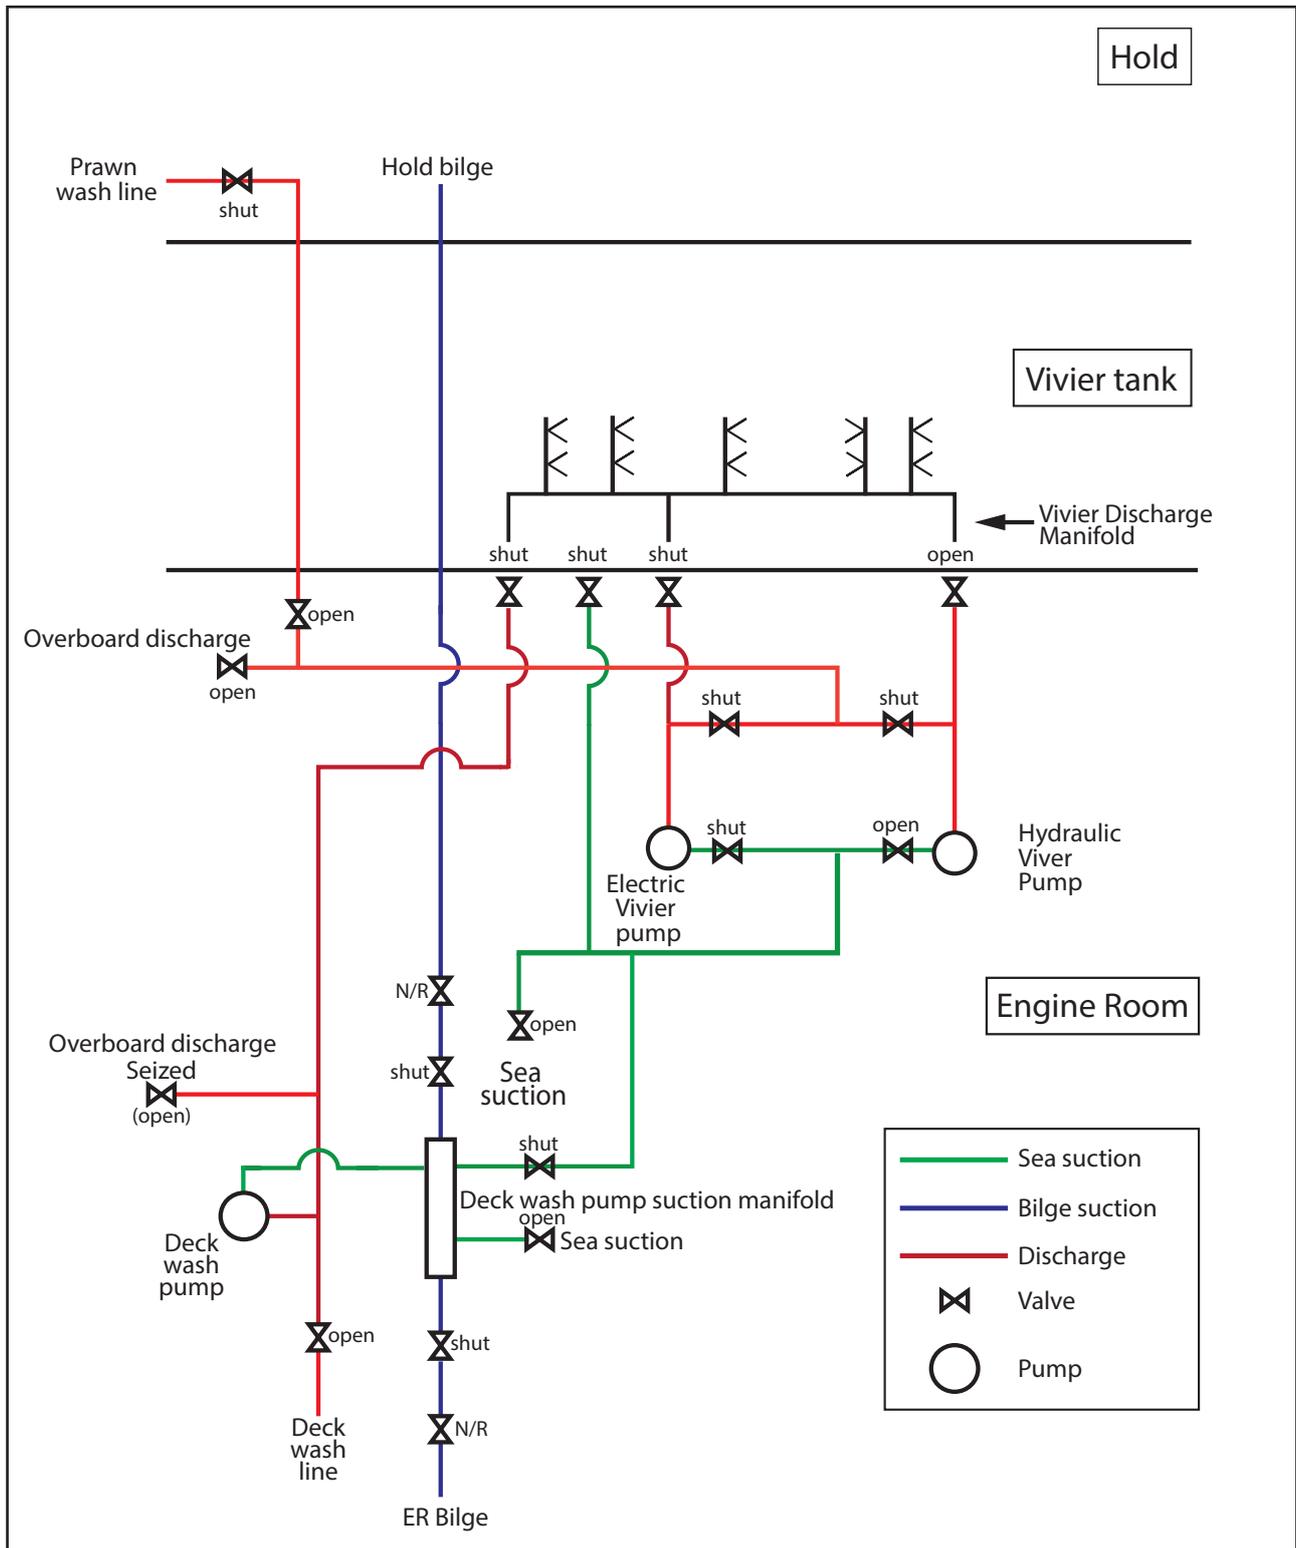
**Figure 6:** System drawing (valves as found)

All systems were confirmed as being intact, with no leakage noted.

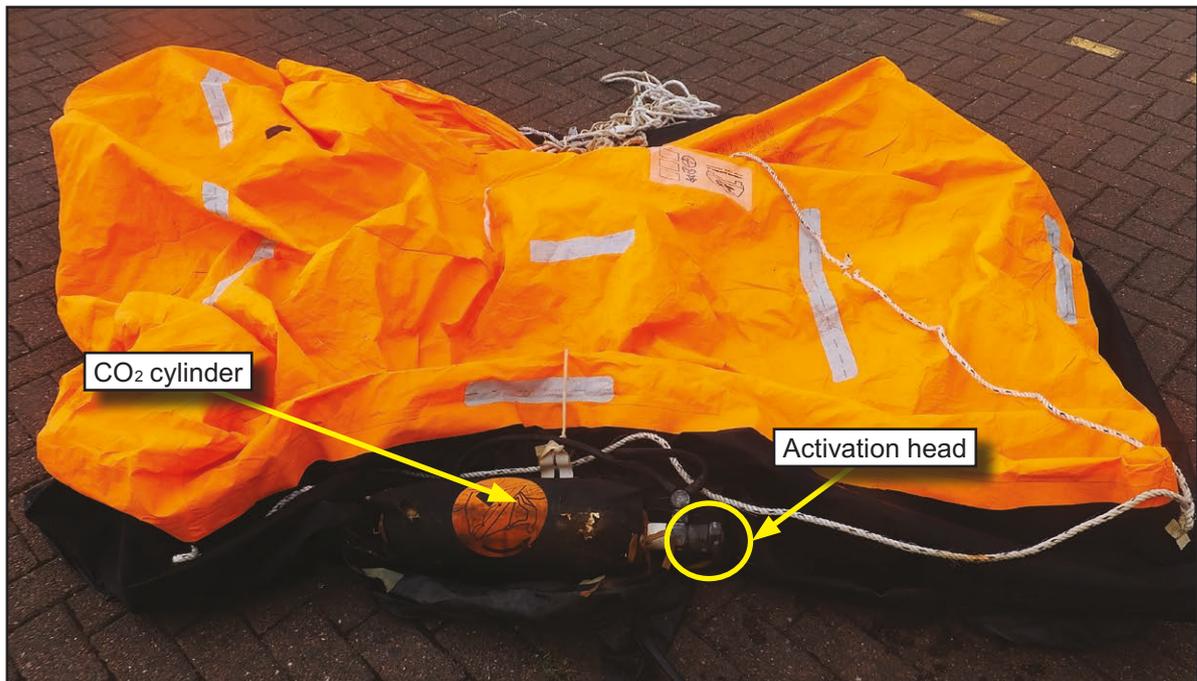
**Figure 7:** Liferaft at Barra police station

During examination of the recovered vessel, MAIB inspectors noted that the HRU had an expiry date of March 2015, and it had not been rigged correctly. The liferaft's painter, which should have been secured via a weak link (designed to part once the liferaft had inflated) had been tied directly to the cradle. In the event, these shortfalls were immaterial because the crew had deployed the liferaft manually before the vessel foundered; however, it had failed to inflate.

- The liferaft inflated successfully when subjected to a gas inflation test.
- The liferaft's condition indicated that it was suitable for use and that its condition was commensurate with its age.

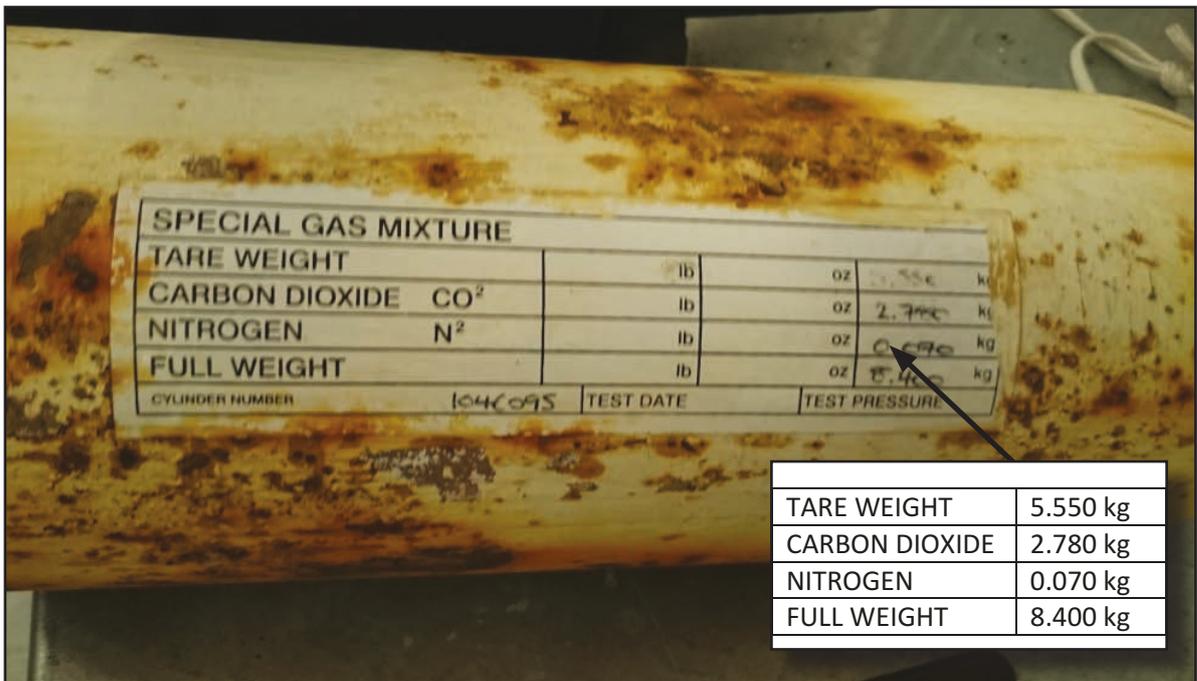
Figure 8: CO<sub>2</sub> cylinder as found

Inspection of the CO<sub>2</sub> inflation cylinder noted that it was devoid of gas but contained approximately 1.5 litres of water. Examination of the CO<sub>2</sub> cylinder at an independent test facility (**Annex A**), including dye penetrant testing, revealed surface cracks in the valve attachment threads at the neck of the cylinder. Laboratory analysis of the water (**Annex B**) highlighted a high saline content indicating that this was likely to have been seawater.

Examination of the valve assembly showed that the operating mechanism had been correctly activated. Further examination indicated that the valve assembly had not been tightened into the cylinder to the manufacturer's recommended torque setting.

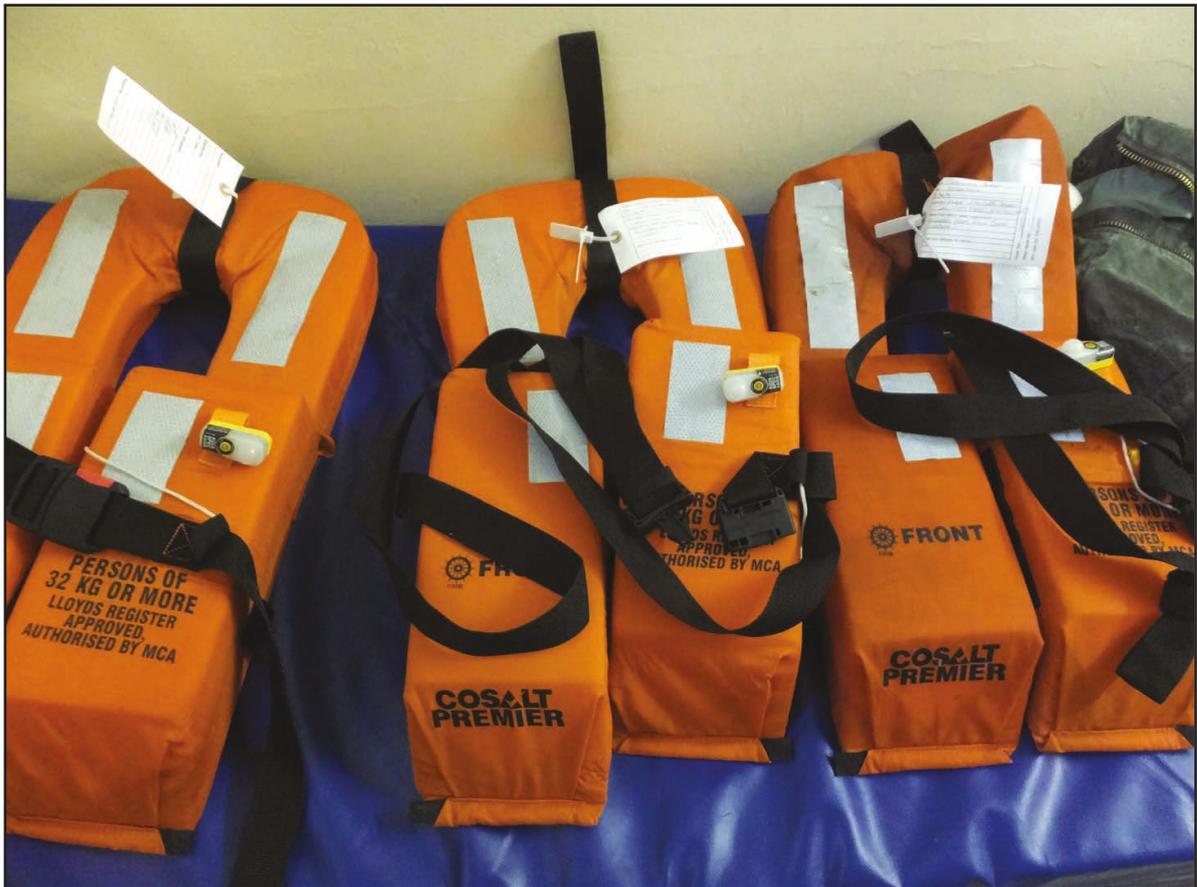
**Figure 10:** Lifejackets at Barra police station

During the first test, four of the eight test subjects exceeded 5s (albeit by up to only 0.5s) and, after exhalation, two of the eight test subjects exceeded 5s (by less than 1s).

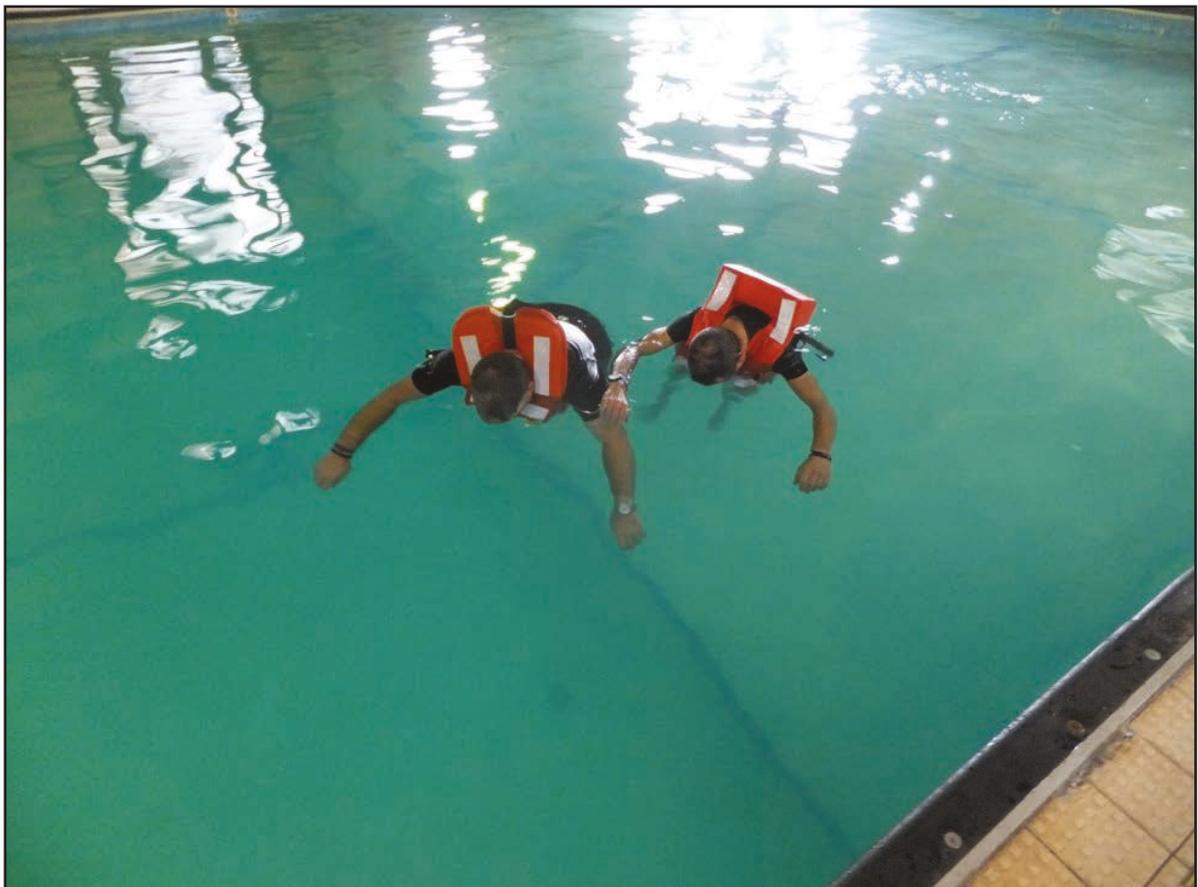
**Figure 11:** MAIB lifejacket trials

Both test subjects were approximately 176cm tall, one weighing 66kg and the other 104kg. Each subject trialed both of the solid-filled lifejackets. During the righting tests neither lifejacket was able to turn either test subject, leaving them floating face down in the water until they were forced to abort the test to take breath (in excess of 20s) (**Figure 11**). The inflatable PFD righted a face down test subject within 2s on each occasion.

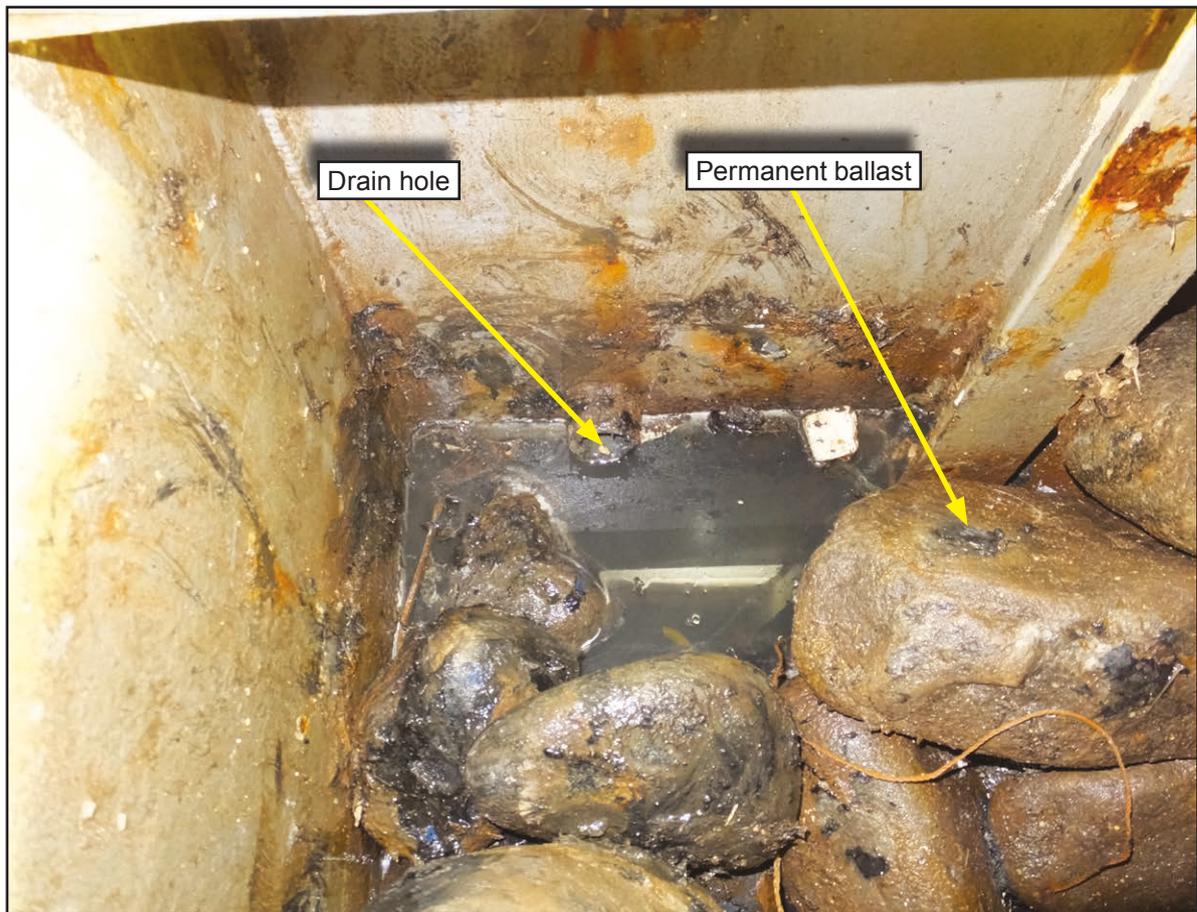
**Figure 14:** Hold/fore peak drain

The drainage hole between the hold and the fore peak effectively rendered these spaces as one compartment, exacerbating the effects of floodwater in the hold which, in turn, would have accelerated the foundering (**Figure 14**).

Following extensive trials and testing, and in the absence of any other plausible explanation, it is concluded that water probably entered the hold from the deck wash hose. When the crew went for their meal, the general service (deck wash) pump was probably running, the hold hatch cover was open and a number of bait boxes were stacked aft of the hatch coaming. It is probable that the hose, which could flail around the deck if not firmly secured, became wedged between the bait boxes, and

this allowed water to spray against the open hatch cover and fall into the hold. As the general service (deck wash) pump had a rated capacity of 35t/hr, the water in the hold could have accumulated to a critical point, in the worst case, within an hour.
