Climate Adaptation: Risk Management and Resilience Optimisation for Vulnerable Road Access in Africa

Recommendations for Phase 2

AfCAP Project GEN2014C

December 2016

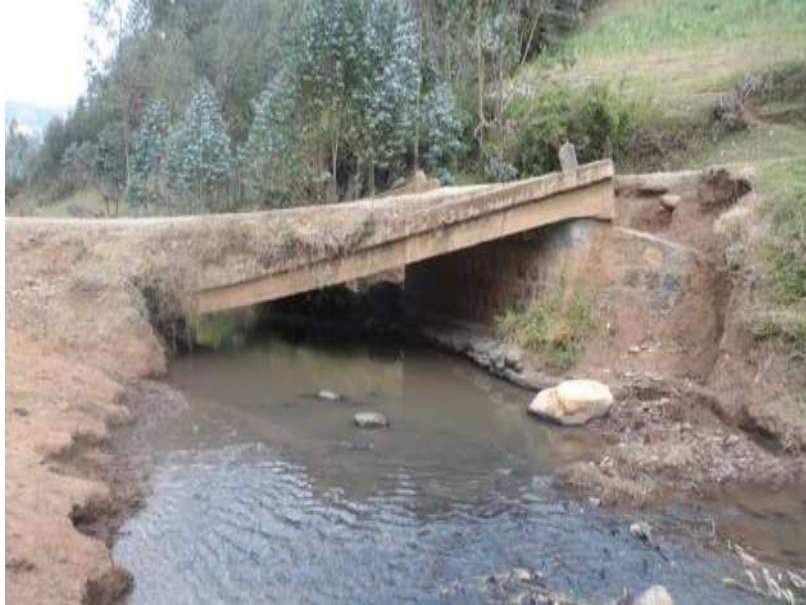
it appeared that the left abutment (in Figure 14) had been eroded/undercut causing collapse of the left side. Erosion of the approach fill (probably due to tilting of the deck) was evident on the right side. The collapsed section of the bridge has been filled with soil to allow continued passability. It was also clear that attempts to create a diversion channel with a new bridge had been made (Figure 15) but this appeared to be unsatisfactory with no possible water flow. On closer inspection from the upstream side (Figure 16), it was noted that the diversion passed through three pipes that were completely silted up on the downstream side.

Figure 14: Collapse of small bridge and erosion of approach fill

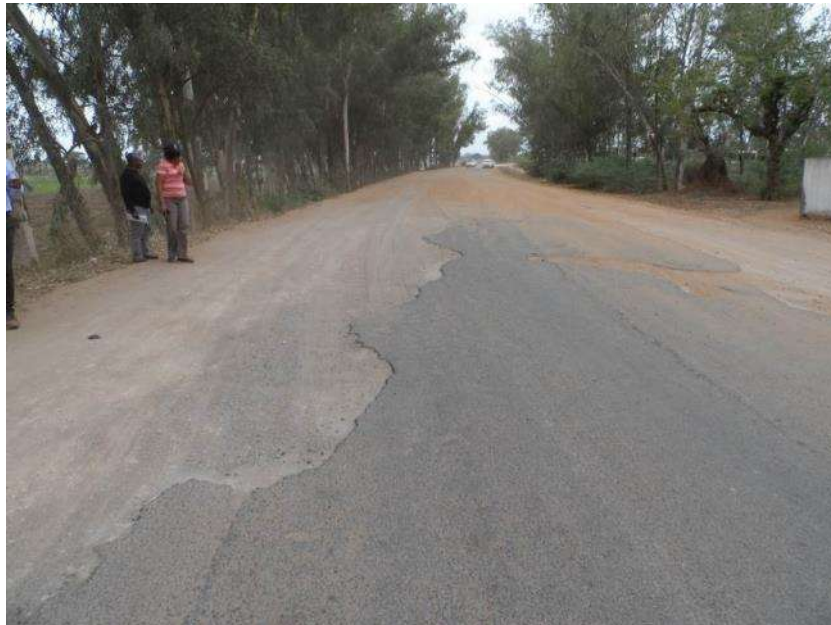
The surfacing at two places close to Chokwe was lost as the road was overtopped from the south west due to localised flooding. According to the ANE staff, this was apparently caused by rain falling in the catchment above the road and moving towards the Limpopo River (from left to right in Figure 25) and not from flooding of the Limpopo River. It was apparent that the velocity of the water flowing across the road removed the surfacing and washed away a part of the road.

Figure 25: Loss of surfacing due to overtopping

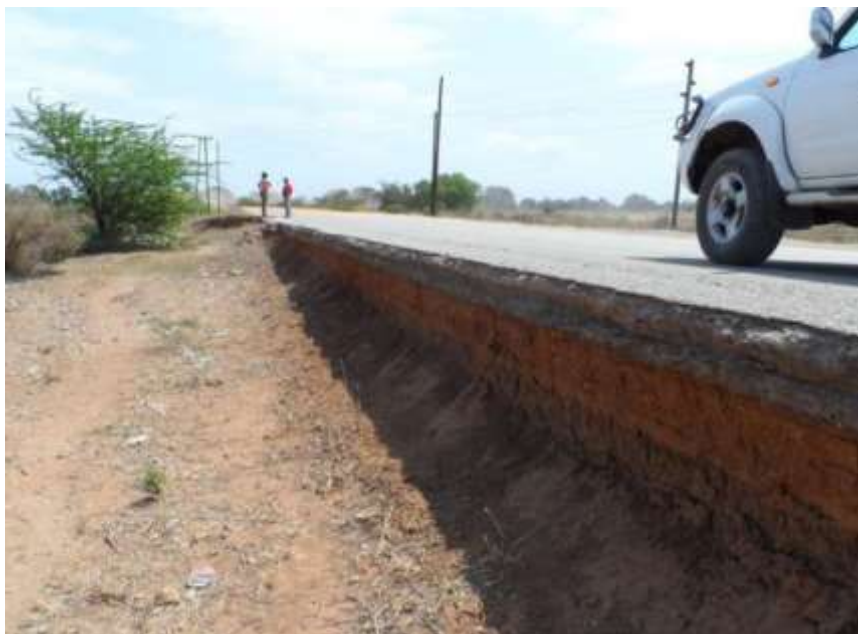
Once the shoulders had been eroded, the unstabilised layers beneath the stabilised base and subbase were easily eroded leading to “undermining” and collapse of the pavement structure (Figure 28).

Figure 28: Erosion of embankment and undercutting of pavement caused by overtopping

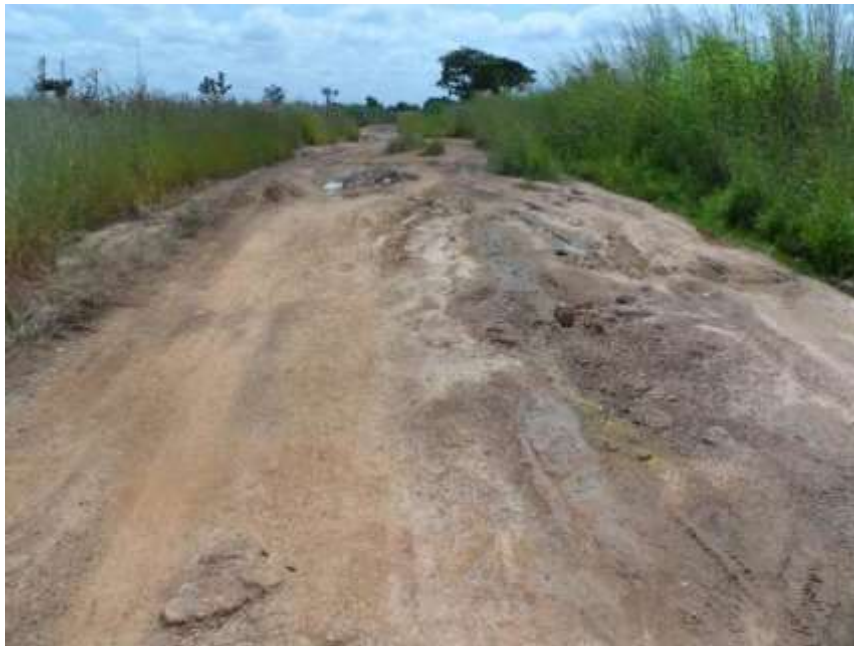
Figure 37: Eroded, poorly drained section of road with laterite outcrops

At km 7.1 -7.5, the road should be constructed in accordance with the cross section shown in Figure 36. The existing eroded, poorly drained surface with localised laterite outcrops (Figure 37) must be ripped, shaped and compacted (with heavy high amplitude rolling on exposed laterite hardpan areas attempting to induce fractures and avoid perched water tables), raised where necessary to allow adequate and effective side-and mitre-drains to be installed and then surfaced with a selected gravel wearing course. The gravel wearing course must comply fully with the requirements in the Ghana Standard Specifications for Roads Manual, in terms of Grading Coefficient and Shrinkage Product. The laterites seen on site (borrow pit at about km 2.1) and being used locally, although not tested during this investigation, mostly appear visually to comply with these requirements. In addition, construction must be of the highest quality (as indicated in the Standard Specifications or better), particularly the compaction

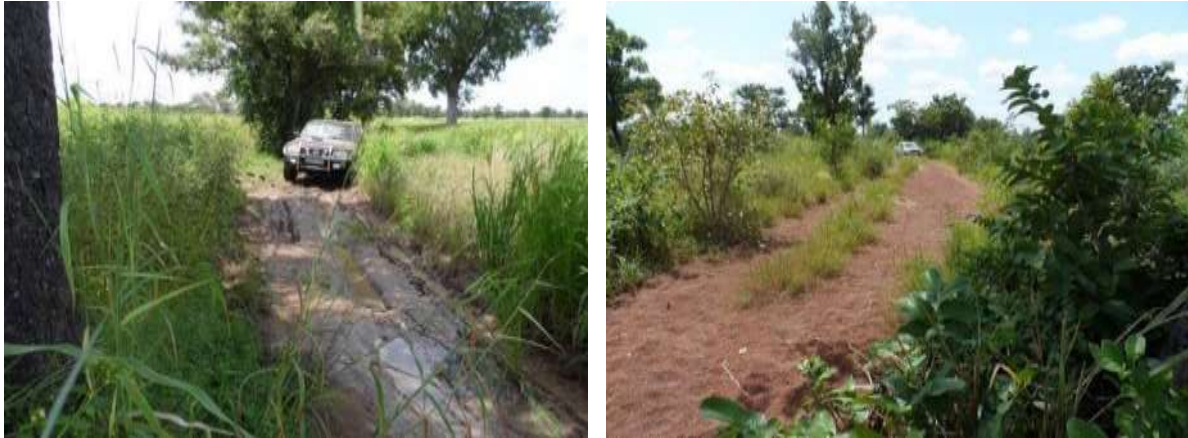
Most of the existing earth roads consist of loose sand/fine gravel, mud or exposed laterite hardpan and are not shaped to remove water through any drainage system (Figure 38). Upgrading and shaping of the road as suggested in Figure 36 will eliminate the impassability and drainage problem provided that the wearing course materials are of the prescribed quality and are placed and compacted according to specification.

Figure 38: Existing muddy and fine gravel earth road with passability problems

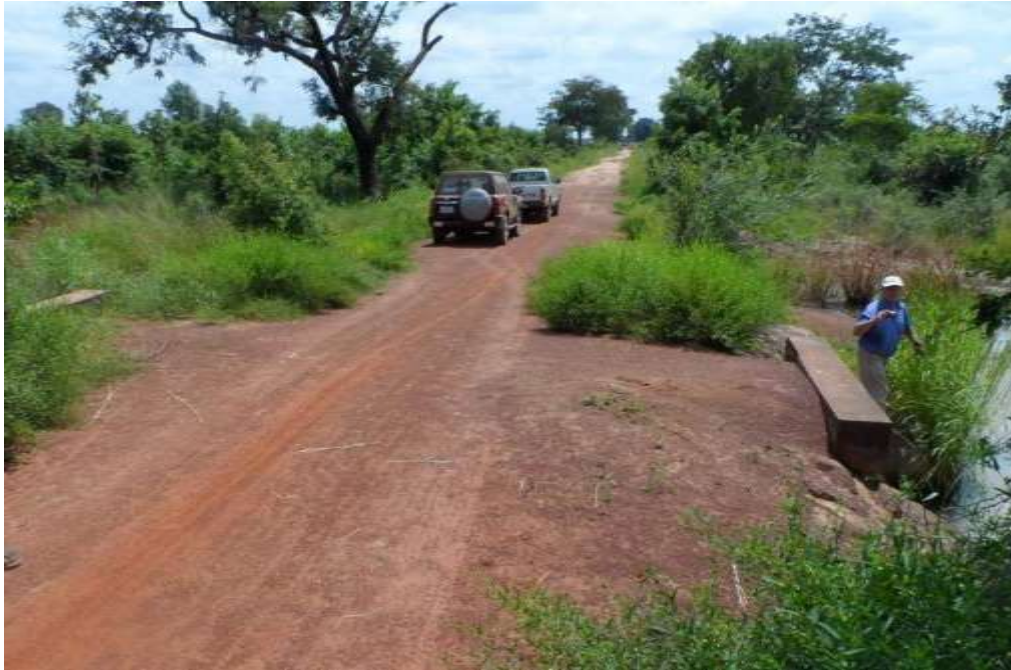
Although the current alignment has little attention paid to drainage, there are a few structures along the road. The culverts at about km 8.85, although effective show evidence of overtopping and the associated erosion in the areas where mortared stone pitching has not been applied (Figure 39).

Figure 39: Erosion around culvert head-walls

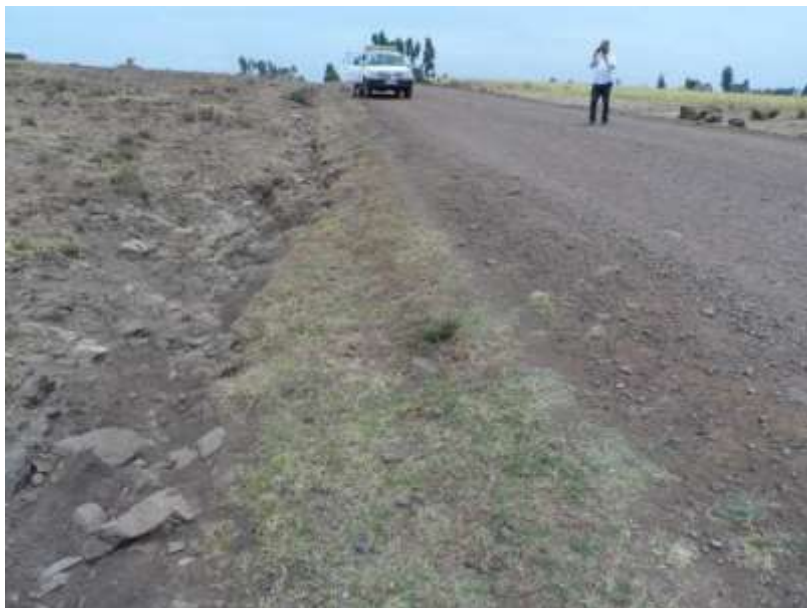
Between the start of the road and the trial sections at km 33, the road consists of cinder gravel wearing course mostly placed directly on the expansive clay subgrade. The wearing course material contains a large proportion of oversize gravel that results in a poor riding quality in many places. Good side-drainage is evident in many places, although there has been significant erosion in some of these drains (Figure A.5).

Figure A.5: Cinder gravelled road with erosion of side drains

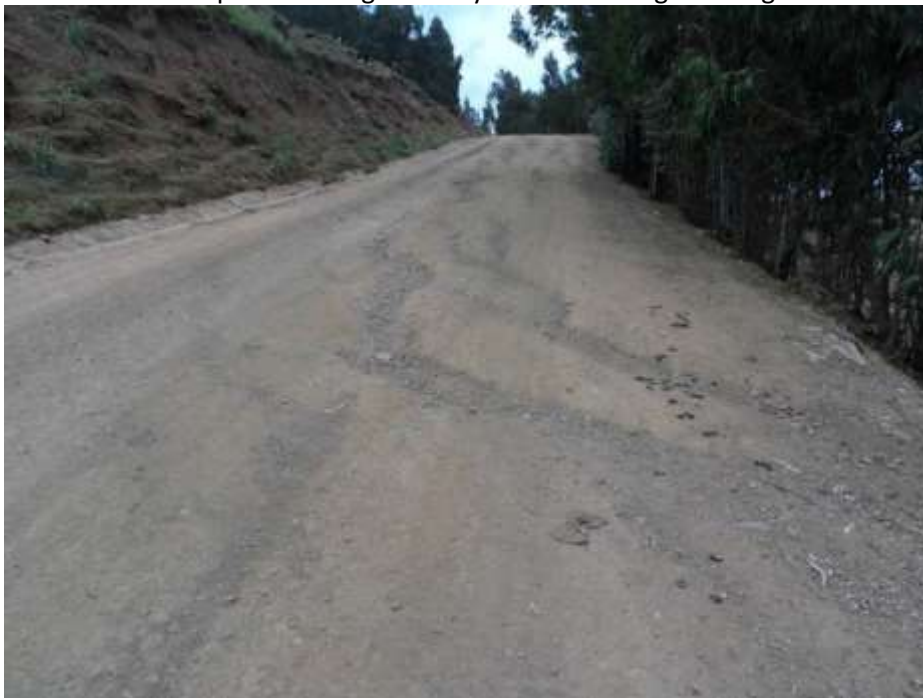
After the trial sections, the road continues mostly with a crushed basalt wearing course, although this has been lost in places. On some of the grades, even with side-drains, significant erosion of the wearing course has occurred, indicating that the shape of the road is inadequate (Figure A.9). Although the crushed basalt makes a strong wearing course structurally, it is poor in terms of the lack of cohesion (low plasticity) and is susceptible to raveling and erosion. The addition of some clay binder to the material would produce a significantly better wearing course gravel.

Figure A.9: Section of road with lined side-drain but showing excessive longitudinal (becoming transverse) erosion

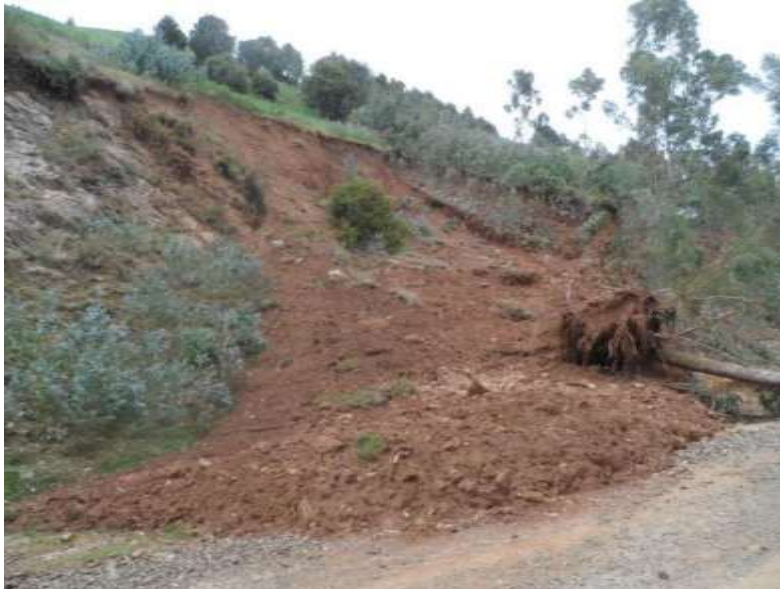
Figure A.10: Landslide at km 44.6

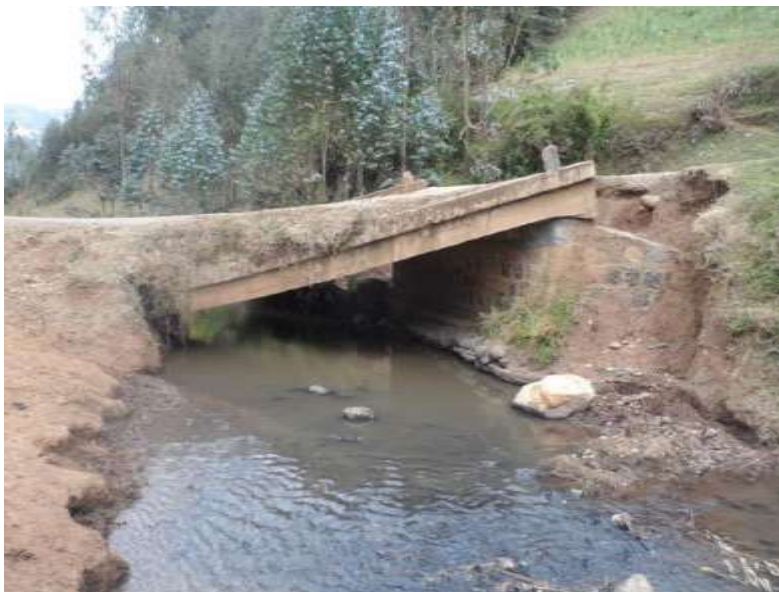
At km 47.4 a small concrete bridge has collapsed. It is not sure whether this was the result of overloading or flooding, but inspection indicated that the western abutment had appeared to have tilted (Figure A.13). The collapsed section of the bridge had been restored to road level using local gravel. The evidence suggests that the collapse was water related as a diversion channel with another drainage structure had been constructed to confine the stream to a straight path. This, however, did not appear to be too effective (Figure A.14) as the south side (downstream) was totally silted up and the northern side (upstream) had only a small area of the pipes open.

Figure A.13: Collapsed bridge at km 47.4

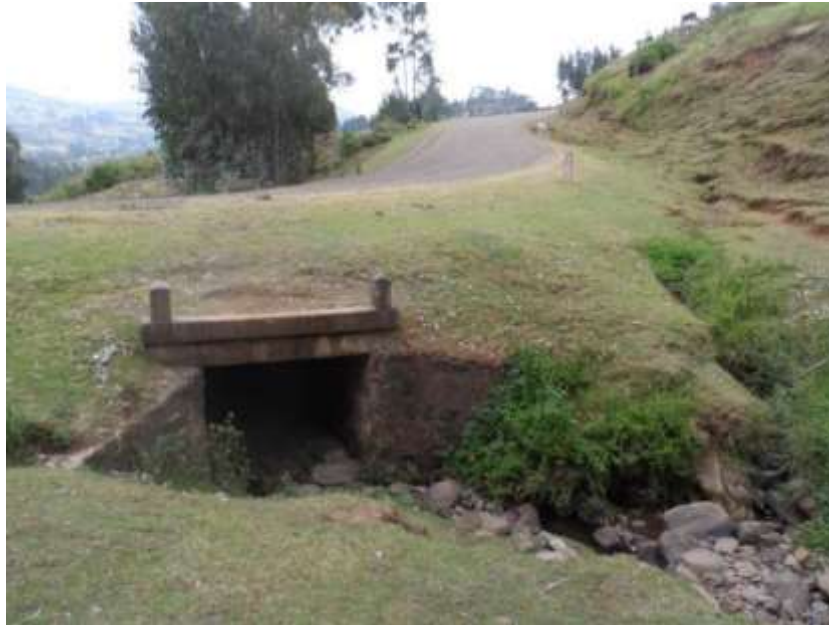
Figure A.15: Small concrete bridge with eroded inlet channels

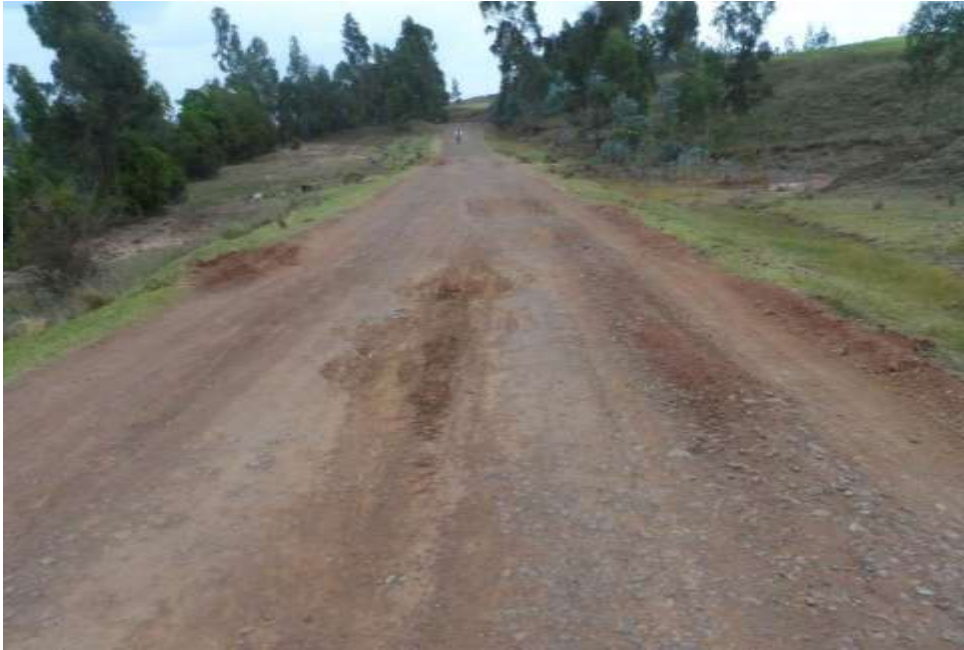
Figure A.16: Shear failures resulting from localised drainage problems

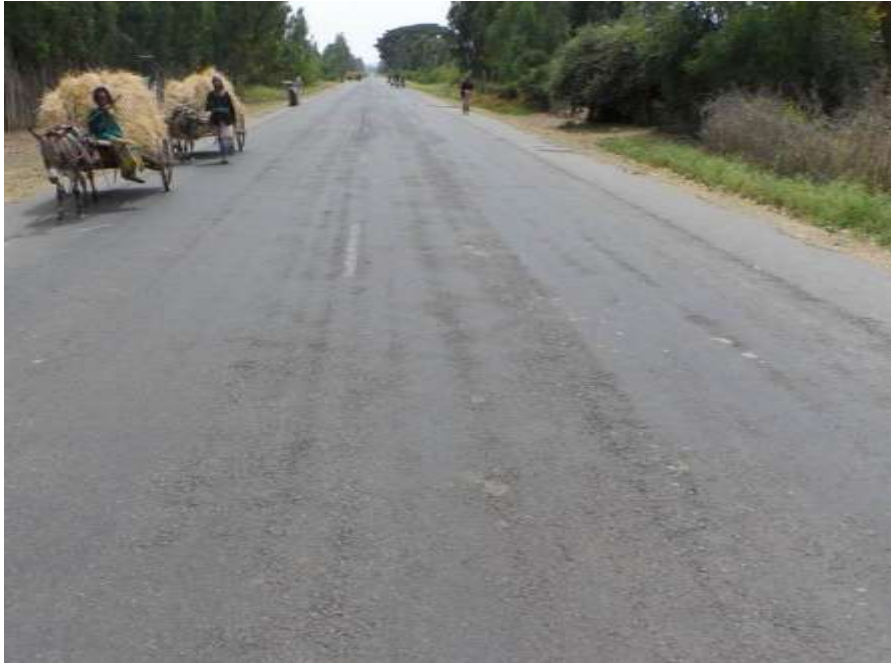
Figure A.20: Streaky nature of the double seal

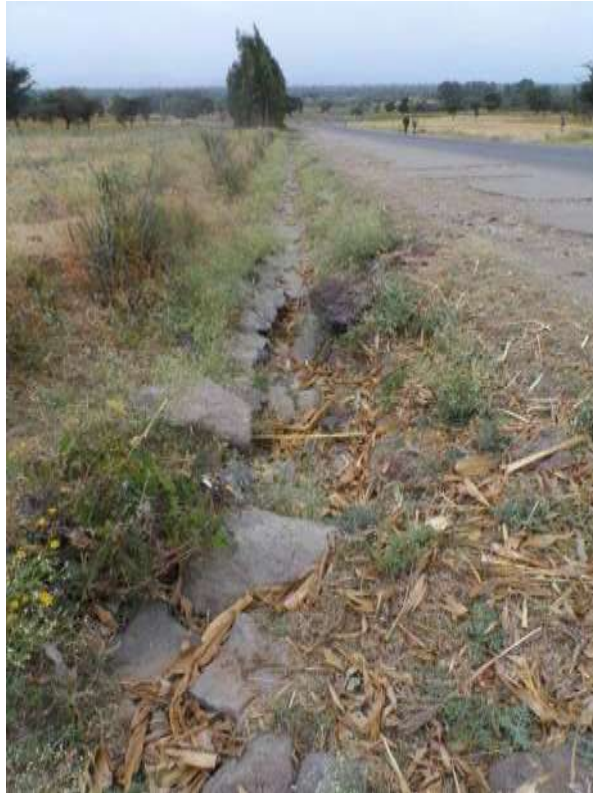
Figure A.22: Damage to mortared stone pitched side drain and continued edge-break problems

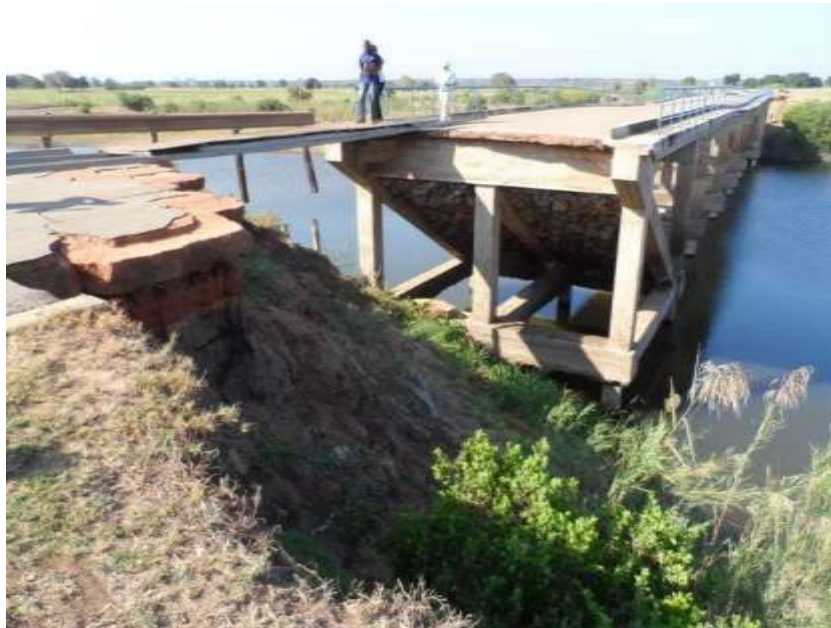
Figure B.5: Loss of bridge approach fills and collapse of one pier during 2012 flooding

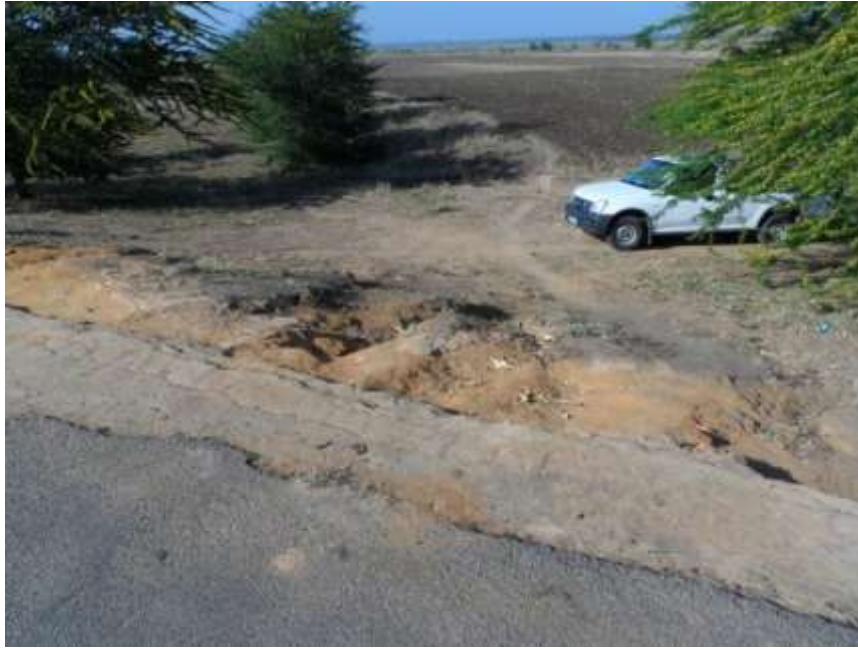
Figure B.6: Erosion of track caused by vehicle movements

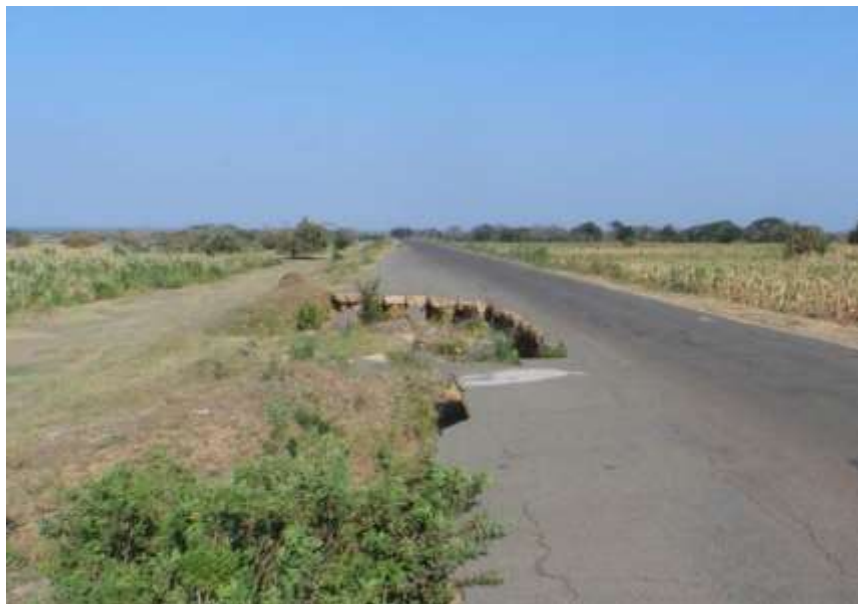
Figure B.7: Localised loss of road and embankment caused by turbulent flow around termite mounds

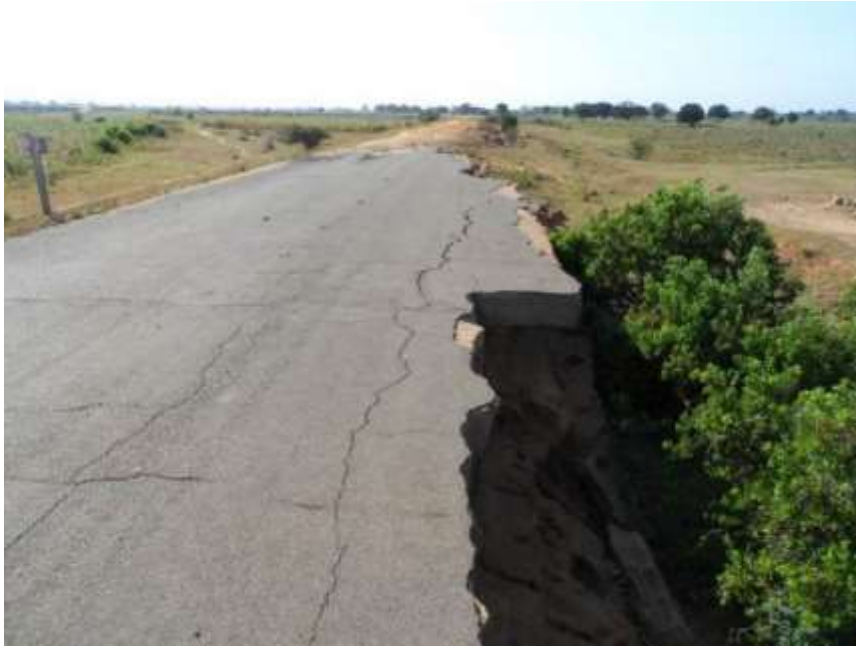
Figure B.8: Damage to embankment and loss of road at lowest point

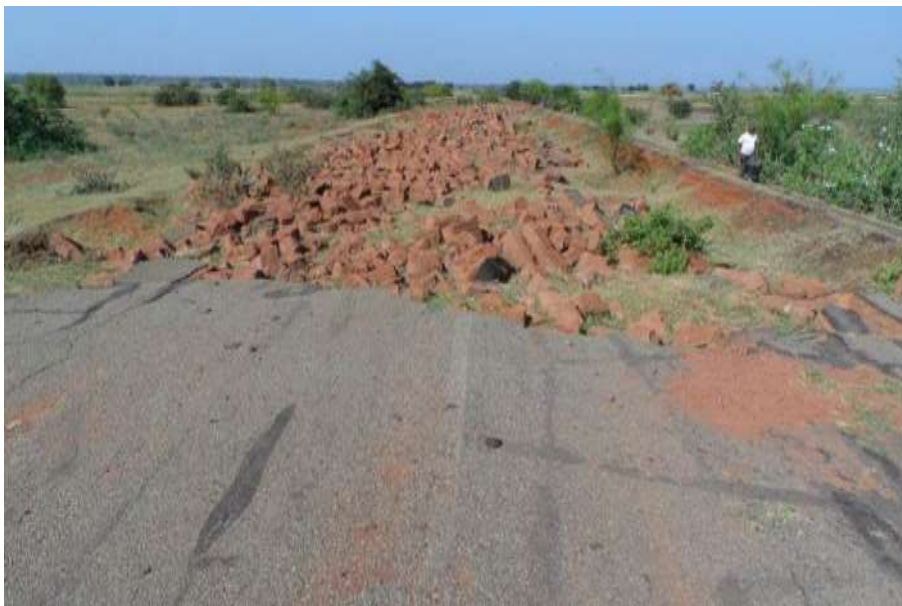
Figure B.9: Total loss of road and embankment caused by overtopping and undermining from the downstream side

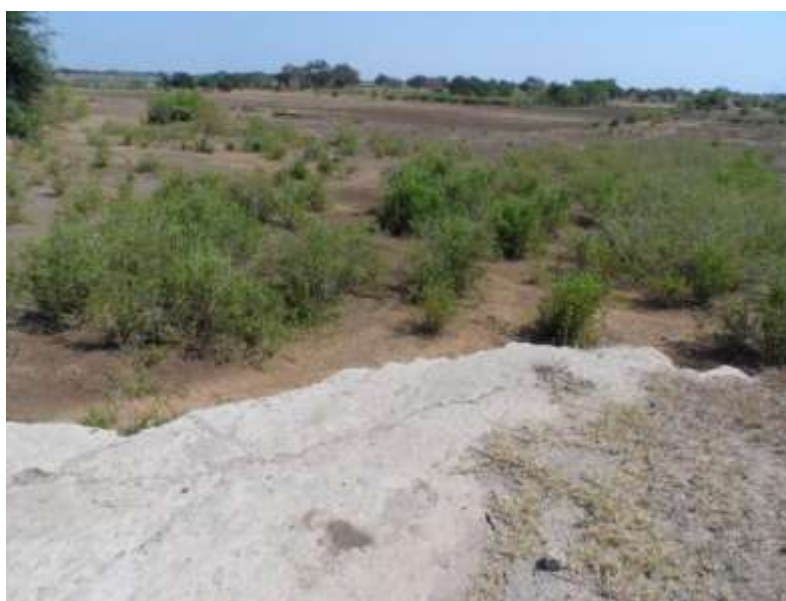
Figure B.11: Total loss of embankment due to flooding

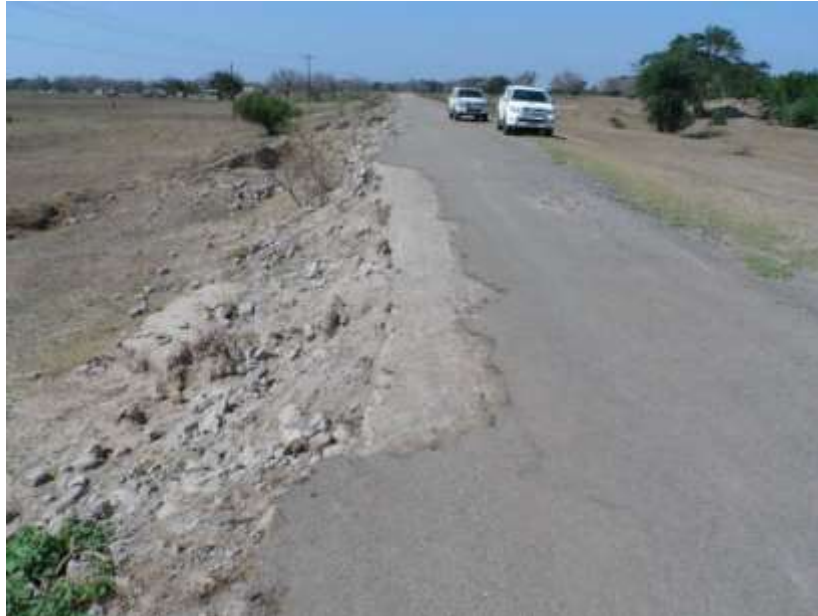
Figure B.12: Damage to embankment due to overtopping on approach to site in photograph above

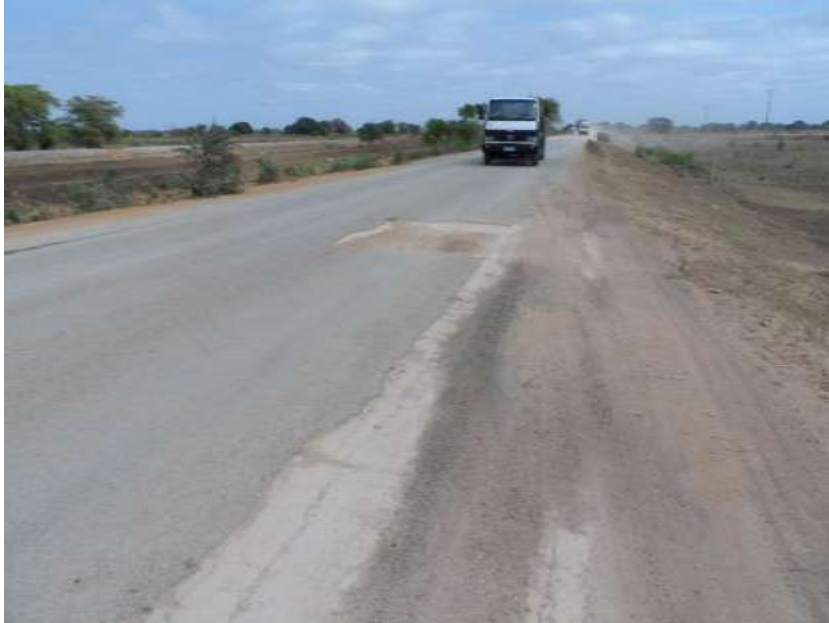
Figure B.32: Loss of seal due to water penetrating at edge of seal

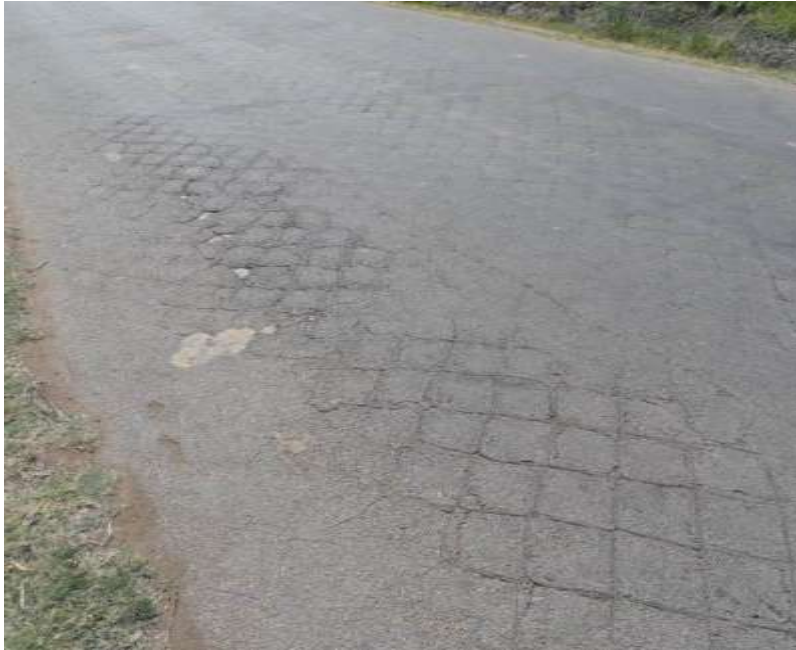
Figure B.34: Open cracks reflecting through from actual Geocell grids

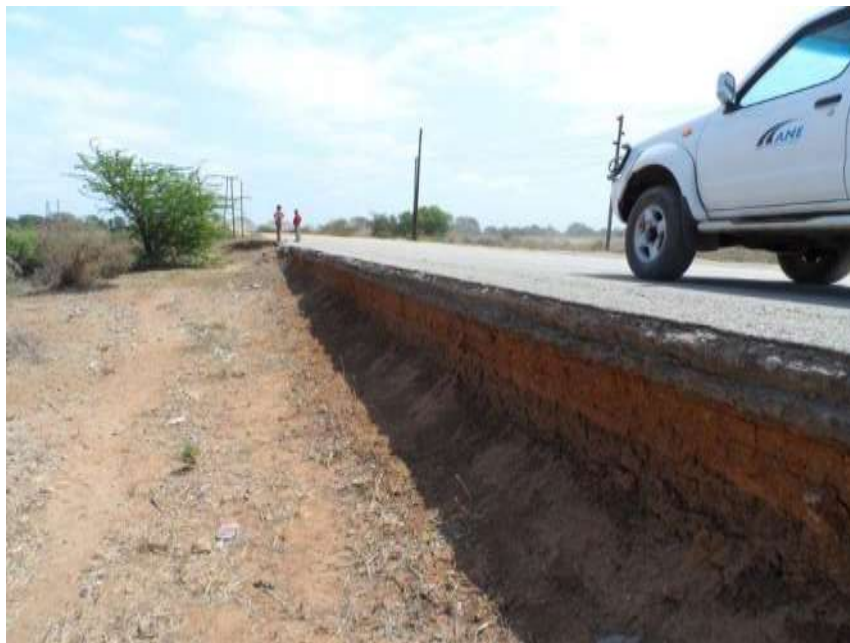
Figure B.36: Undercutting of downstream part of road due to water flowing across it

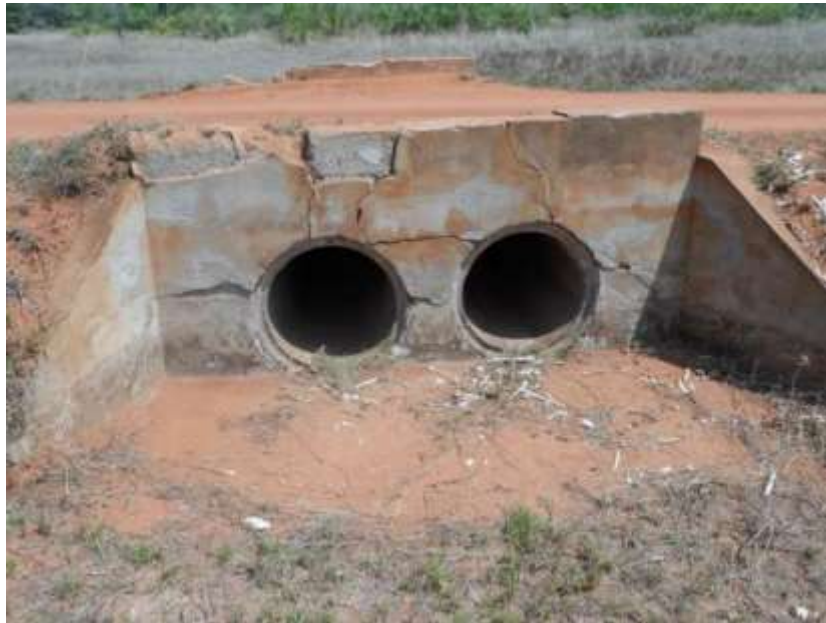
Figure B.39: Culvert allowing equalisation of water where road has severed floodplain area – note damage and potential for further damage when soaked

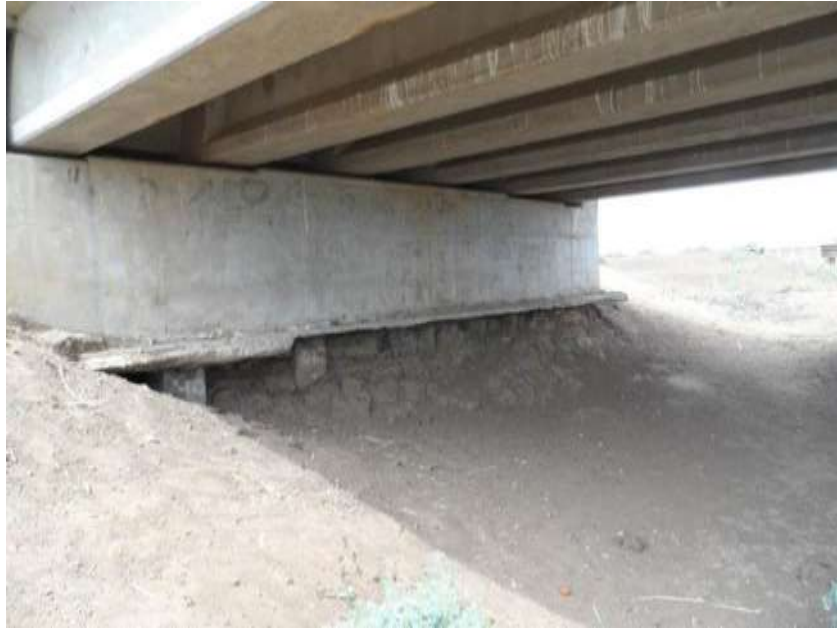
Figure B.40: Erosion of fill around abutments during flooding

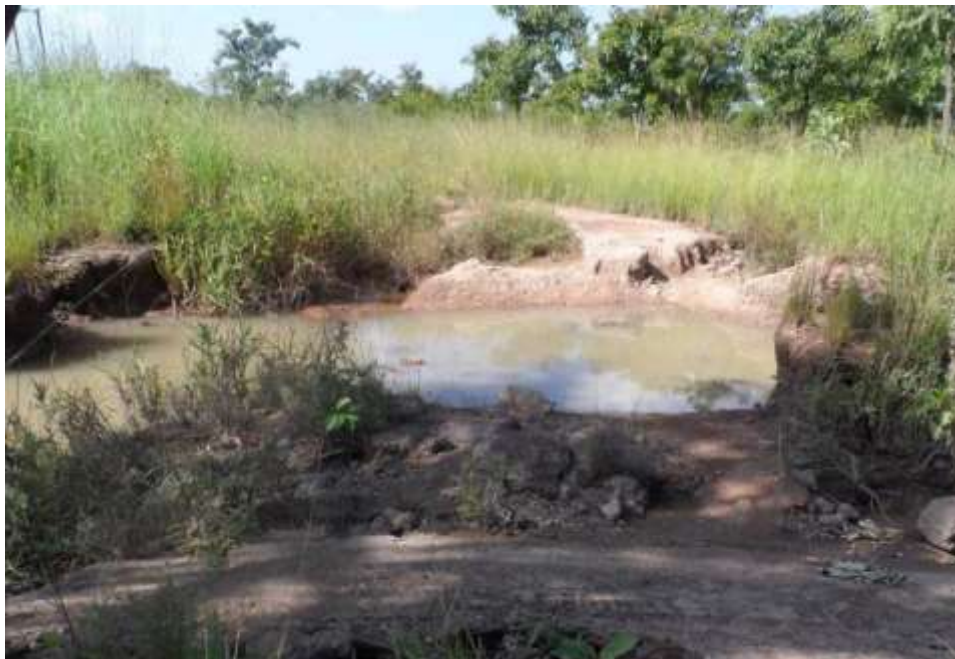
Figure C.4: Site of culvert washed away and due to be replaced

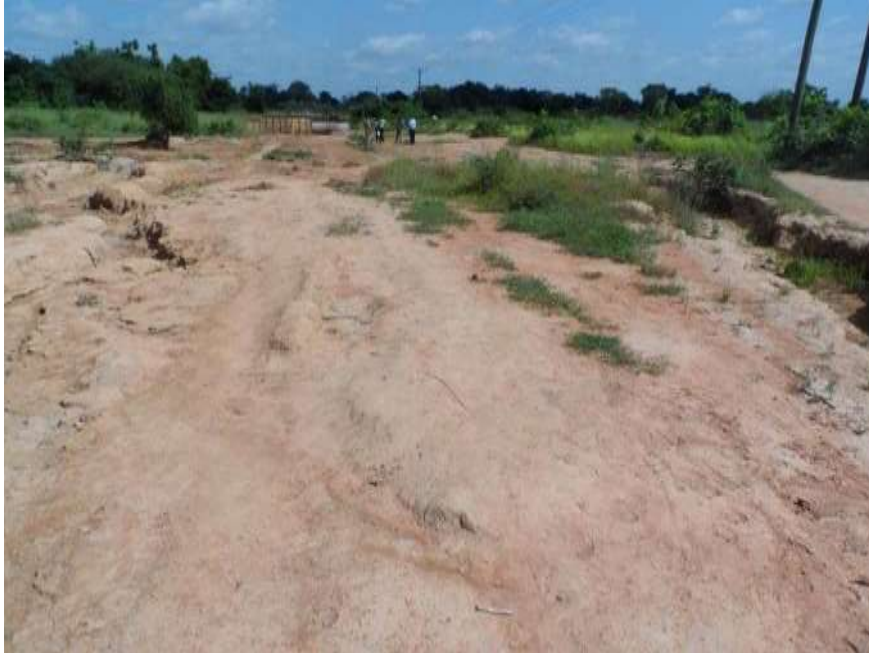
Figure C.5: Erodible materials that will require careful drainage design

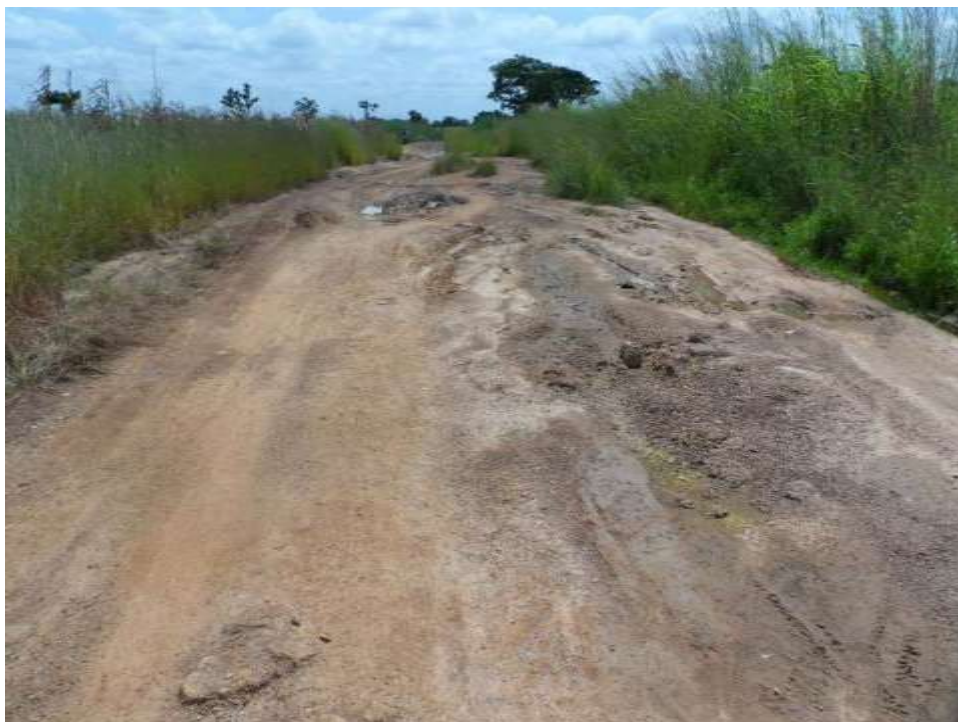
Figure C.7: Poorly drained area with weak silty material

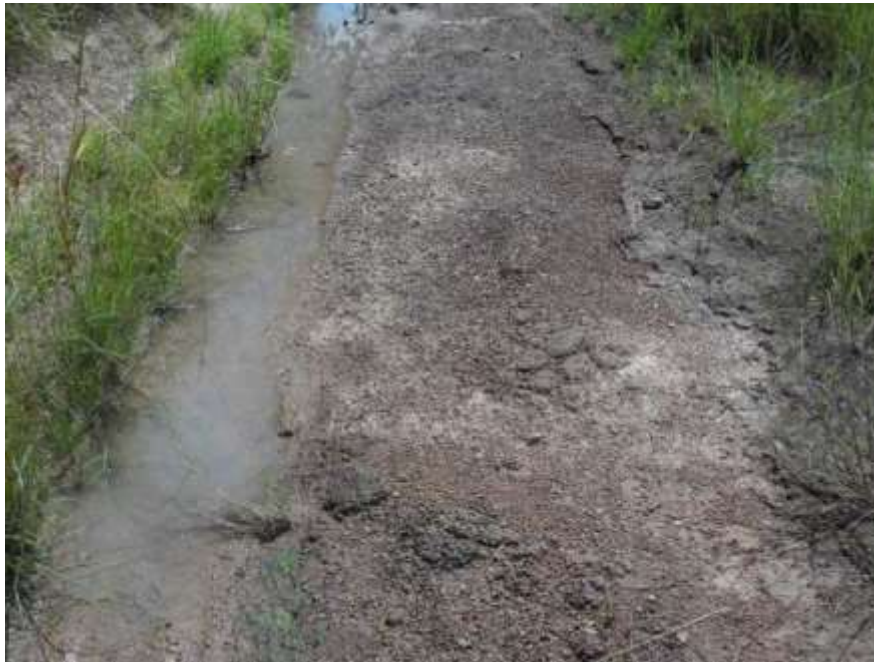
Figure C.8: Perched water table on hardpan laterite outcrops

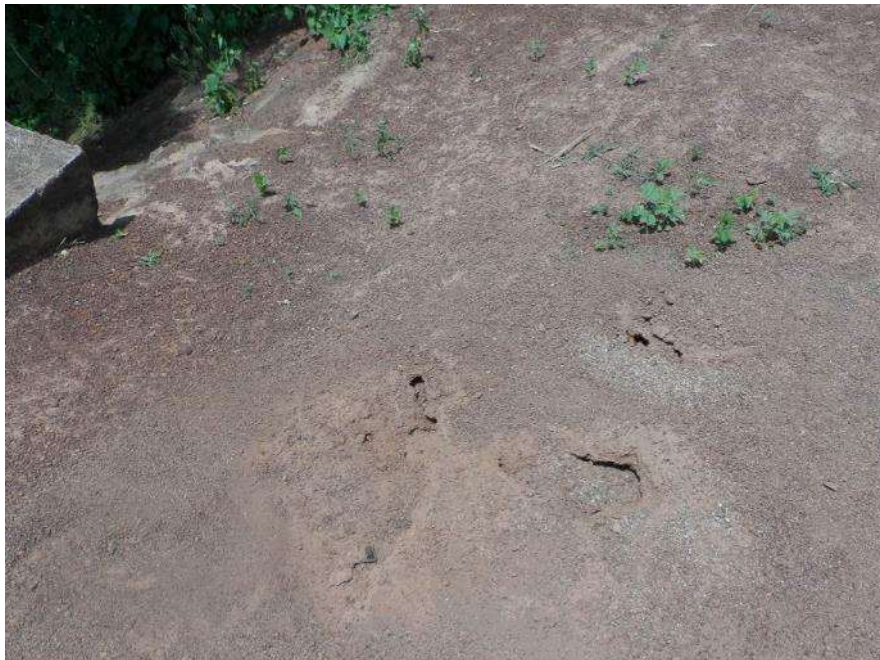
Figure C.11: Initiation of ant nest in embankment

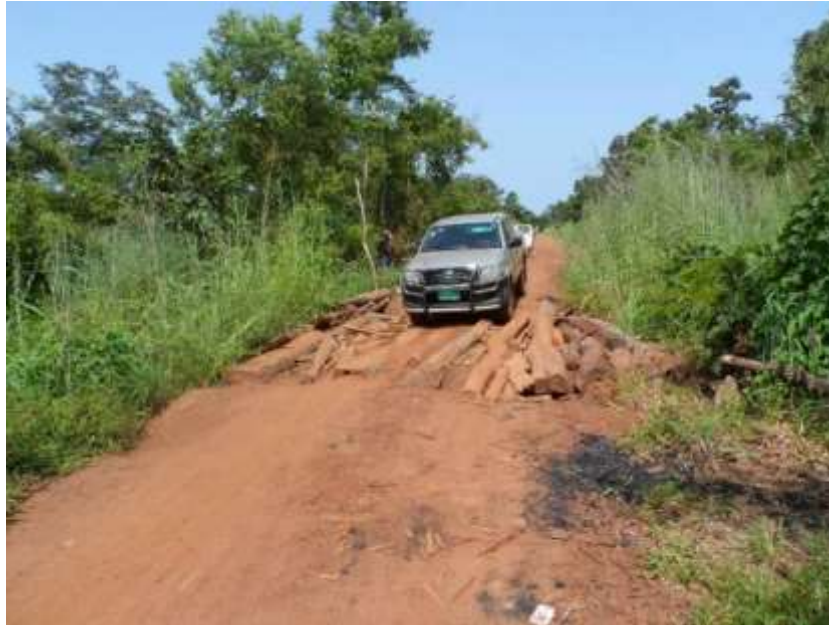
Figure C.16: Collapsed culvert repaired using logging off-cuts

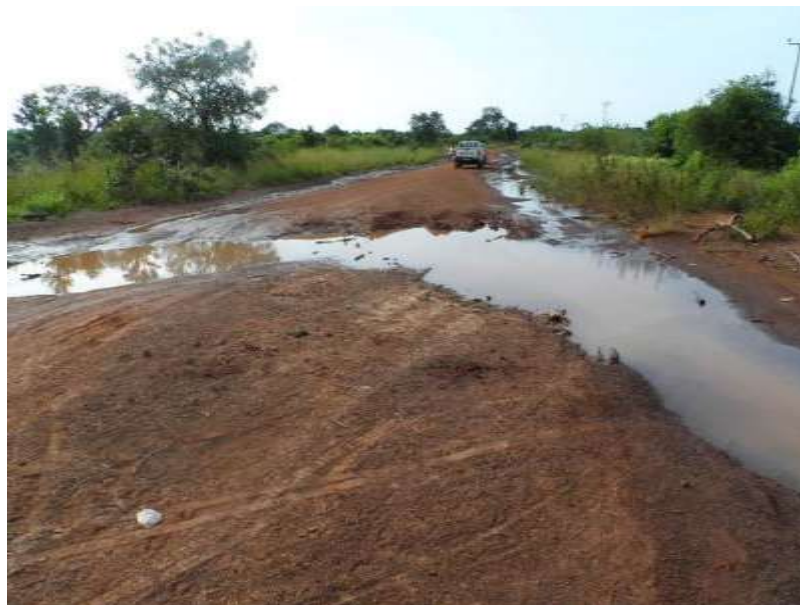
Figure C.17: Poor drainage due to perched water tables and ineffective pipe culverts

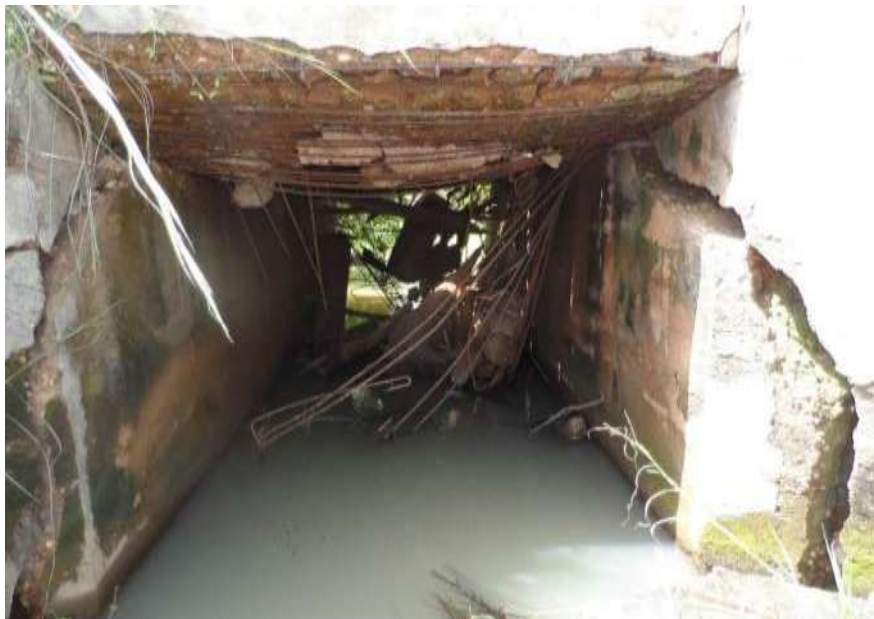
Figure C.19: Collapsed concrete bridge showing severe damage to deck, abutments and wing-walls.

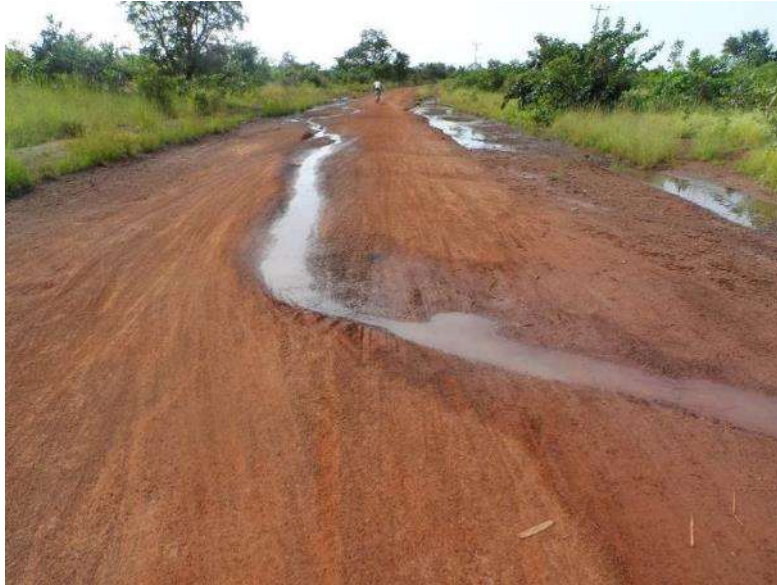
Figure C.22: Erosion of road surface and side drains
