Fatal CO poisoning on board motor cruiser *Vasquez* while moored at Cardiff Yacht Club 12 November 2016

SUMMARY

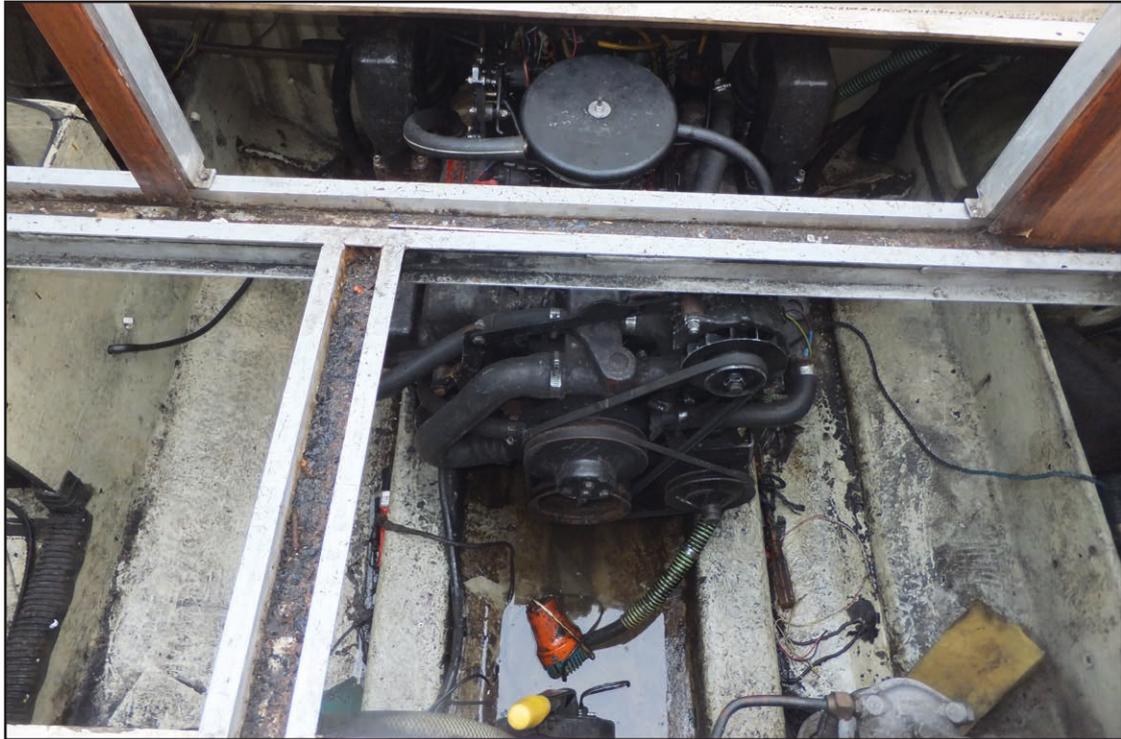
The boat was driven by an inboard V6 Volvo Penta AQ225F petrol engine that was naturally aspirated (**Figure 3**). The vessel was fitted with an OMC stern drive (**Figure 4**), which provided the boat's propulsion. It was not possible to determine if the stern drive was original or had been fitted later in the boat's life. The engine had a wet-exhaust system, whereby cooling water, which was sucked in via ports in the stern drive, was combined with the engine exhaust gas and expelled from the stern drive through the hub of the propeller.

Figure 3: Volvo Penta AQ225F petrol engine

Since buying *Vasquez* the owner had not used it frequently for trips, although he had visited the boat to check it and to start the engine periodically while at its mooring. During his ownership one major piece of work, costing over £1000, was undertaken on the engine by a local marine professional. However, it is believed that no regular servicing had been undertaken during the last 5-6 years.

- It is important to seek professional advice and regularly service a boat's engine, in accordance with the manufacturer's guidelines, to ensure it remains reliable and safe to use.

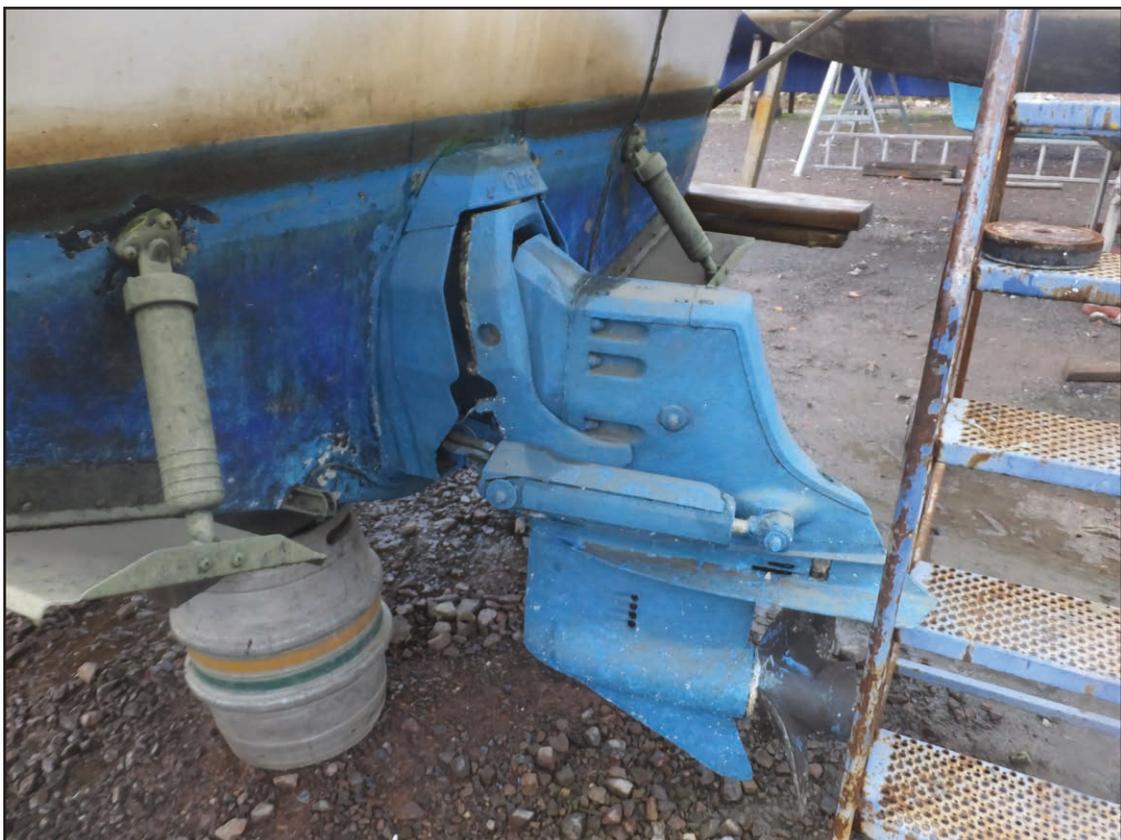
Figure 4: OMC stern drive

During the trip, the engine temperature had run very high, so after returning to the yacht club the boat was lifted out of the water. The cooling water inlets on the stern drive were found blocked. The stern drive was cleaned off and re-antifouled, and the oil in the stern drive was changed.

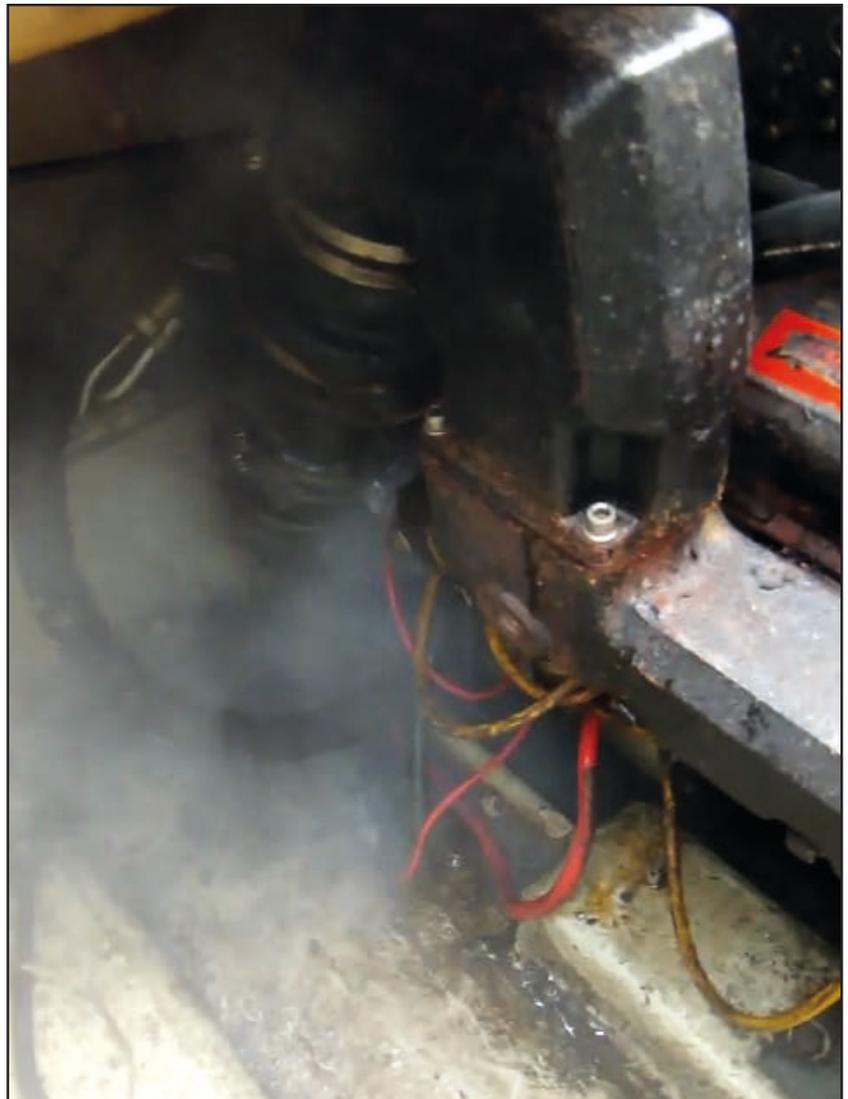
The CO was found to have originated from the rubber bellows of the wet-exhaust system of the engine, which was not only leaking gas but also water. The boat's engine had not been regularly serviced, and evidence revealed that the exhaust system of the engine had been modified during the boat's life.

The local Volvo agent was then contracted to conduct an inspection of the engine and to establish the source of the CO leak. With the engine stopped and the boat afloat, a small water leak was apparent emanating from the rubber bellows on the wet-exhaust system. With the engine running, a considerable amount of exhaust fumes and water were emitted from the port and starboard bellows (**Figure 5**).

Figure 5: Exhaust leak from rubber bellows

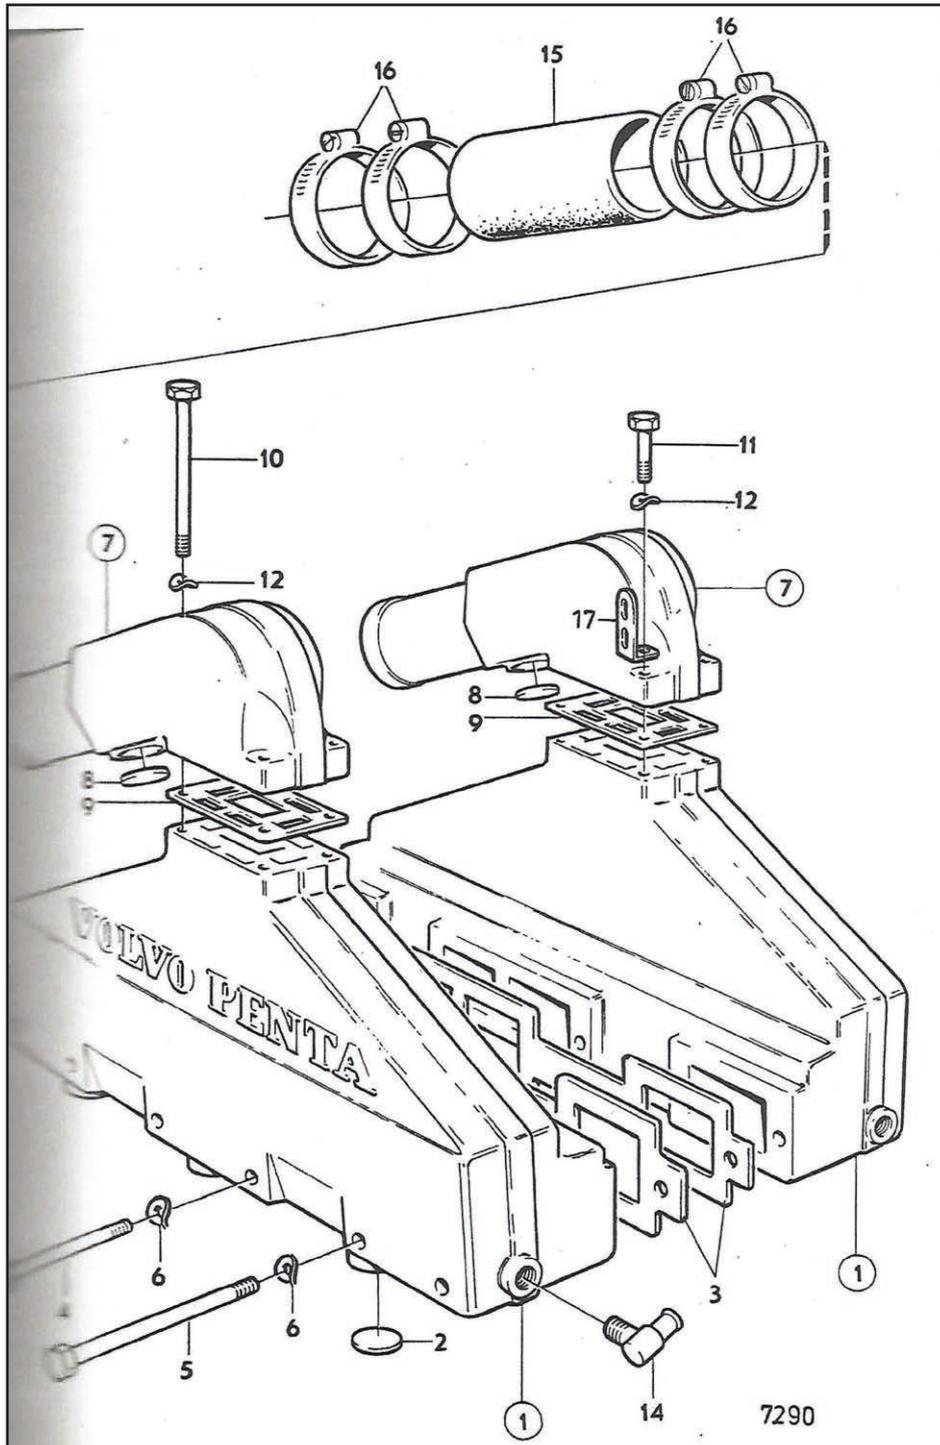
- The exhaust manifolds were not original (**Figure 6**).
- The exhaust risers were not original (**Figure 7**).
- The cow horn castings had been cut down (**Figure 7**).
- The exhaust elbow had been connected on both sides of the engine with two unequal rubber bellows and a stepped aluminium tube retained by stainless steel hose clips (**Figure 7**).

Figure 6: Drawing of original exhaust manifolds

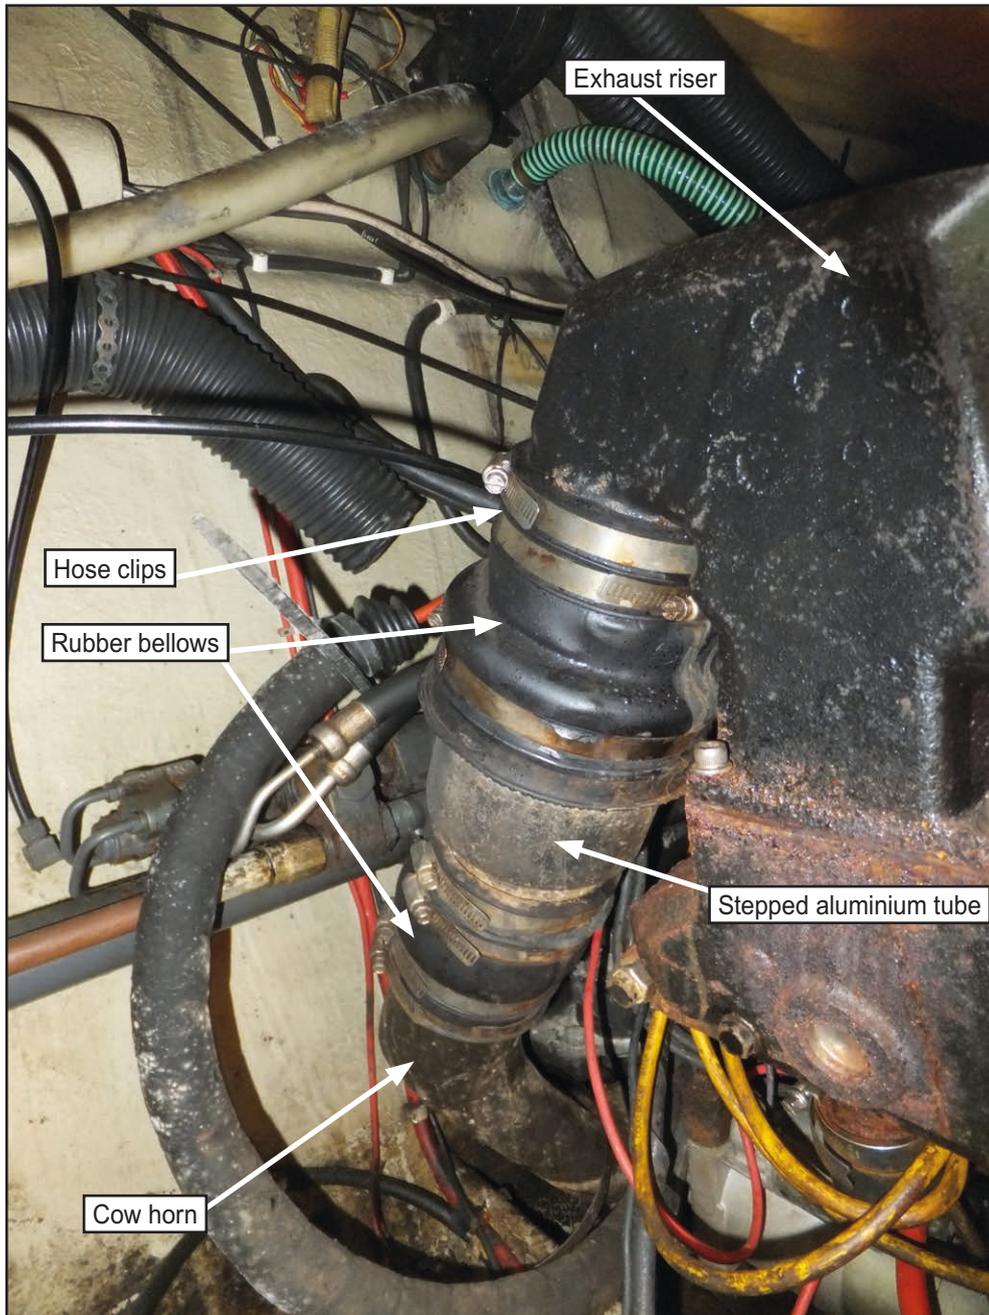
Although it could not be confirmed, the lack of corrosion on the bolts attaching the risers to the exhaust manifold suggested that the exhaust system had been included in the work carried out in the last 3-4 years.

Figure 7: Exhaust riser and rubber bellows

Although the full maintenance history of *Vasquez's* engine could not be determined, it was apparent that the exhaust system had been modified and two rubber bellows added to the wet-exhaust pipework. Rubber bellows on a wet-exhaust system are vital in maintaining the watertight integrity of a boat and it is advisable to inspect them regularly and replace them every 2-3 years, as the rubber can harden and deteriorate. In this case, in addition to the rubber bellows being older than 3 years, the trial trip during which the engine overheated probably damaged the rubber. This ultimately led to a water/exhaust fumes leak, which caused *Vasquez's* cabin to slowly flood and CO gas to enter the engine compartment while the engine was running.
