SERIOUS INCIDENT

Aircraft Type and Registration:	Airbus A319-111, G-EZEW	
No & Type of Engines:	2 CFM CFM56-5B5/P turbofan engines	
Year of Manufacture:	2004 (Serial no: 2300)	
Date & Time (UTC):	30 June 2016 at 1008 hrs	
Location:	On departure from Bristol Airport	
Type of Flight:	Commercial Air Transport (Passenger)	
Persons on Board:	Crew - 6	Passengers - 144
Injuries:	Crew - None	Passengers - None
Nature of Damage:	None	
Commander's Licence:	Airline Transport Pilot's Licence	
Commander's Age:	38 years	
Commander's Flying Experience:	8,500 hours (of which 6,500 were on type) Last 90 days - 164 hours Last 28 days - 43 hours	
Information Source:	AAIB Field Investigation

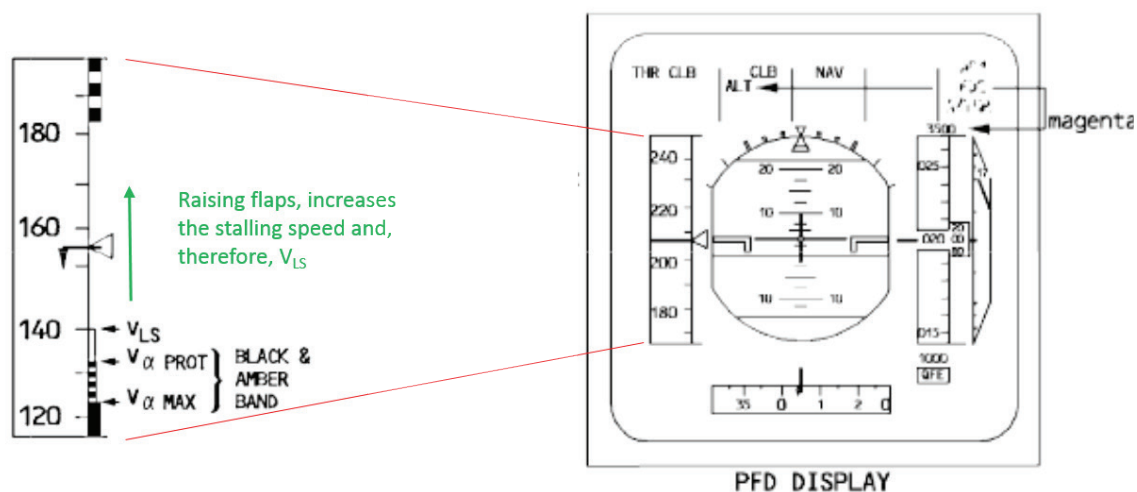
Figure 1

After the flaps were selected up, the PF saw the V_{LS} ⁴ indication on the PFD⁵ "shoot up" to 180 kt, 30 kt above the current speed (Figure 1). He asked the PM to extend the flaps again and the PM moved the flap lever back to position 1, which caused the slats to begin to extend. The aircraft was at 710 ft RA and 183 kt. The V_{LS} indication reduced below the instantaneous airspeed and, when the aircraft accelerated to S speed⁶, the PF moved the thrust levers to the CLB detent to reduce thrust to the climb setting. The PF asked for the slats to be retracted, which the PM did at approximately 850 ft RA and, passing 870 ft RA, the autopilot was engaged and the climb continued.

The V_{LS} indication moves up the airspeed scale on the PFD when the flaps are raised
