SERIOUS INCIDENT

Aircraft Type and Registration:	Airbus A320-214, G-EZWX
No & Type of Engines:	2 CFM56-5B4/3 turbofan engines
Year of Manufacture:	2014 (Serial no: 6192)
Date & Time (UTC):	28 November 2016 at 1303 hrs
Location:	En route Edinburgh to Hamburg
Type of Flight:	Commercial Air Transport (Passenger)
Persons on Board:	Crew - 6 Passengers - 172
Injuries:	Crew - None Passengers - None
Nature of Damage:	Static inverter overheated
Commander's Licence:	Airline Transport Pilot's Licence
Commander's Age:	44 years
Commander's Flying Experience:	6,316 hours (of which 4,138 were on type) Last 90 days - 142 hours Last 28 days - 26 hours
Information Source:	AAIB Field Investigation

Synopsis

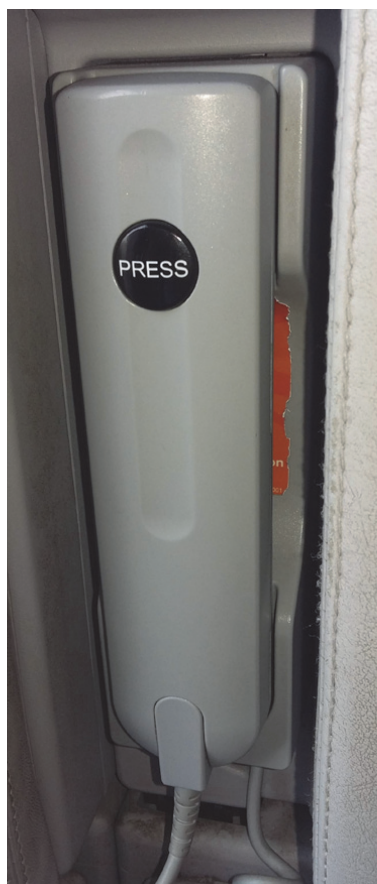
Figure 1

G-EZWX forward attendant position handset in its cradle

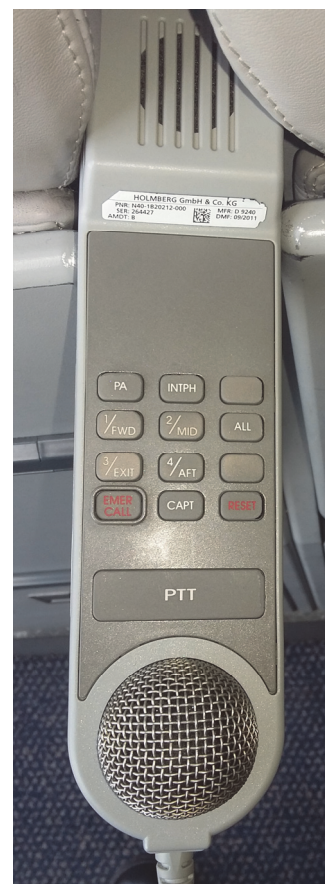
Figure 2

G-EZWX forward attendant position handset keypad
