## ACCIDENT

<b>Aircraft Type and Registration:</b>	Reims Cessna F150M, G-BDZC
<b>No &amp; Type of Engines:</b>	1 Continental Motors Corp O-200-A piston engine
<b>Year of Manufacture:</b>	1976 (Serial no: 1316)
<b>Date &amp; Time (UTC):</b>	17 October 2016 at 1021 hrs
<b>Location:</b>	Bourn Airfield, Cambridgeshire
<b>Type of Flight:</b>	Private
<b>Persons on Board:</b>	Crew - 1                      Passengers - 1
<b>Injuries:</b>	Crew - 1 (Fatal)    Passengers - 1 (Serious)
<b>Nature of Damage:</b>	Aircraft destroyed
<b>Commander's Licence:</b>	Private Pilot's Licence (A)
<b>Commander's Age:</b>	58 years
<b>Commander's Flying Experience:</b>	363 hours (of which 9 were on type) Last 90 days - 7 hours Last 28 days - 2 hours
<b>Information Source:</b>	AAIB Field Investigation

## Synopsis

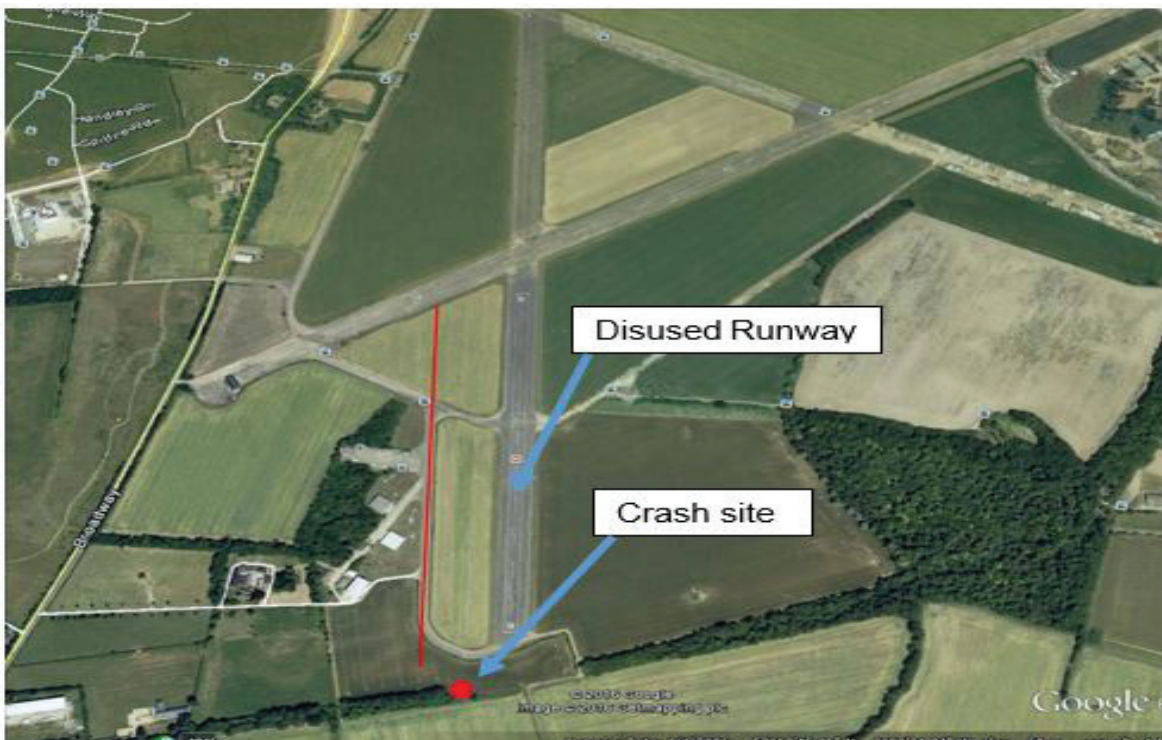
**Figure 2**

The aircraft had come to rest against some trees located on the southern boundary of the airfield (Figure 2). The accident site was some metres to the left of the extended centreline of the runway.

View of airfield showing accident site location relative to the extended centreline of the runway (red line). The 'old', disused runway is visible to the right.

The trees on the southern boundary ran in an approximately east-west direction and had a gap in line with the old runway. The aircraft had come to rest in a steep, nose-down attitude against the trees at the western edge of the gap. The trees were up to about 40 ft high and

it was apparent that, apart from some light branches and foliage having become dislodged, there had not been a severe impact from the aircraft. Marks on the ground close to the base of the trees indicated that the aircraft had struck the ground in a near vertical attitude on its nose and outboard left wing. It had then rocked over onto the outboard region of the right wing before coming to rest with the tail resting lightly in the upper branches of a tree. It was concluded that the impact with the ground was consistent with the aircraft being in a spin to the left, with the velocity vector primarily in the downwards, as opposed to horizontal, direction.

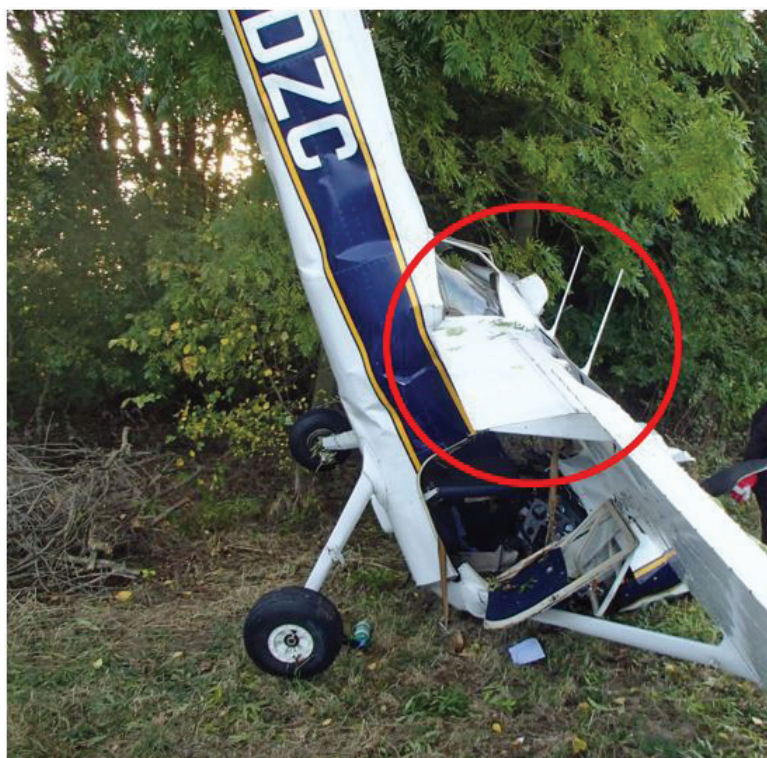
**Figure 3**

It was observed that the flaps were at their maximum deflection of 40°. The inboard end of the right flap was in contact with the right hand side of the rear windscreen and the fuselage skin immediately below, causing distortion. There were no scrape marks or abrasion damage to either; it was therefore concluded that the flaps were in this position prior to impact (Figure 3).

As-found flap position, showing damage to rear windscreen and sill structure below

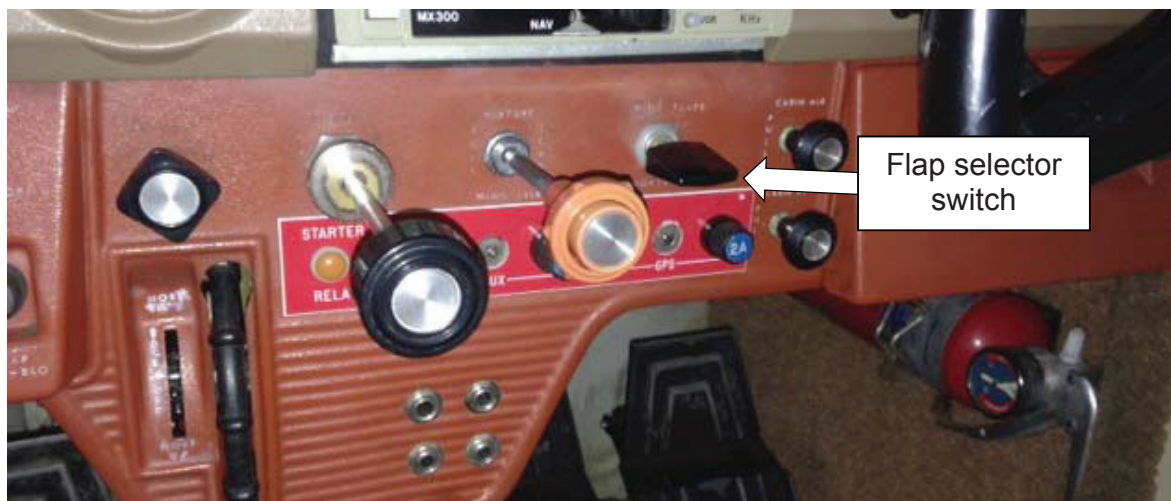
**Figure 4a**

Wing flap selection on G-BDZC was controlled by a switch on the lower centre instrument panel (Figure 4a). To extend the wing flaps the switch must be held against spring pressure in the DOWN position; when released the switch will return to the centre NEUTRAL/OFF position. To retract the flaps the switch had to be selected and held to the UP position; the switch would return, under spring pressure, to the neutral position when released. It would take

approximately 9 seconds to fully extend the flaps in flight and 6 seconds to retract them. The flap switch did not give a visual indication of the selected flap position.

C150 flap selector switch as fitted to G-BDZC

The flaps were seen to be fully deployed during the pilot's pre-flight inspection and it was not determined whether they were ever retracted subsequently. The flap switch on this aircraft did not give any visual cue of the flap position, unlike the otherwise similar C152 aircraft. Thus, the flap may have remained deployed until takeoff, or it may have been re-deployed prior to takeoff. In the latter case the pilot would not have intended to deploy full flap, so its selection would have been accidental. To deploy the flap to 40° requires a sustained action on the switch for about 9 seconds, so it is unlikely that this would be achieved by an accidental input, although it remains a possibility.

It is recommended that the Civil Aviation Authority promulgates to flying instructors the need for specific training to highlight the differences between the C150 and C152 flap switch designs. Training should also include the effect on aircraft performance and handling of Flap 40°.

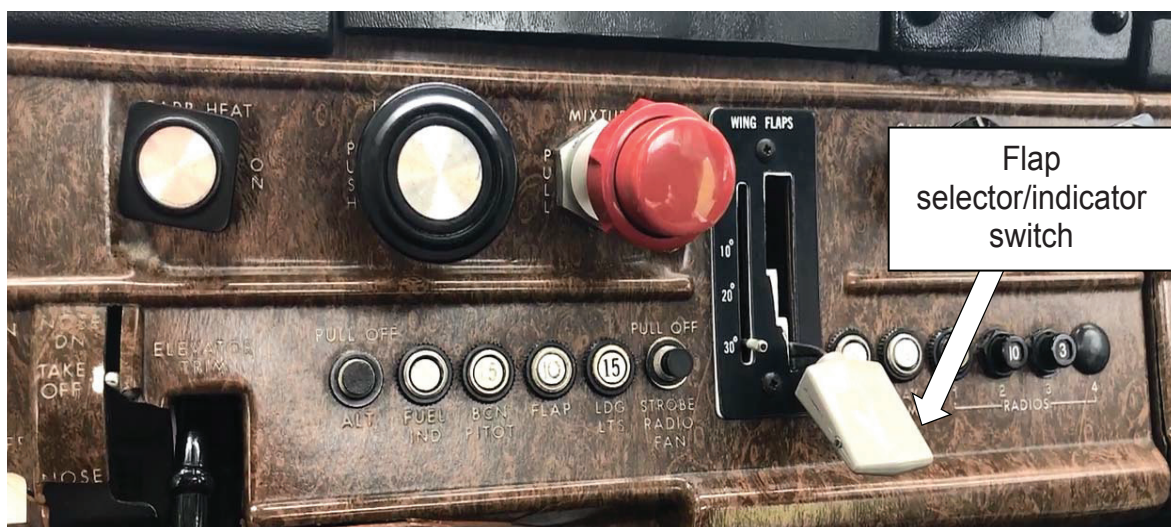
**Figure 4b**

The final production models of the C150 were fitted with a re-designed flap selector with detents for the flap positions and a position indicator located beside the switch. The C152 flap selection and indication is similar (Figure 4b), but the maximum flap travel was reduced from 40° to 30°.

C152 flap selector/indicator switch
