**ACCIDENT**

<b>Aircraft Type and Registration:</b>	1) SZD-51-1 'Junior' glider, G-CLJK 2) Cessna 150L, G-CSFC
<b>No &amp; Type of Engines:</b>	1) None 2) One Continental Motors O-200-A piston engine
<b>Year of Manufacture:</b>	1) 1991 2) 1973
<b>Date &amp; Time (UTC):</b>	4 December 2016 at 1231 hrs
<b>Location:</b>	7.5 nm south of Leicester Airport
<b>Type of Flight:</b>	1) Private 2) Training
<b>Persons on Board:</b>	1) Crew - 1                      Passengers - None 2) Crew - 2                      Passengers - None
<b>Injuries:</b>	1) Crew - 1 (Fatal)      Passengers - N/A 2) Crew - 2                      Passengers - N/A
<b>Nature of Damage:</b>	G-CLJK aircraft destroyed, G-CSFC major damage to right wing
<b>Commander's Licence:</b>	1) Glider Pilot's Licence 2) Commercial Pilot's Licence
<b>Commander's Age:</b>	1) 70 years 2) 26 years
<b>Commander's Flying Experience: (G-CLJK)</b>	1,054 hours (of which 1,048 were on gliders) Last 90 days - 12.5 hours Last 28 days - 4 hours

**Synopsis**

Two aircraft collided in VFR conditions in Class G airspace; neither aircraft was receiving an ATC service. The investigation concluded that neither pilot saw the other aircraft in sufficien

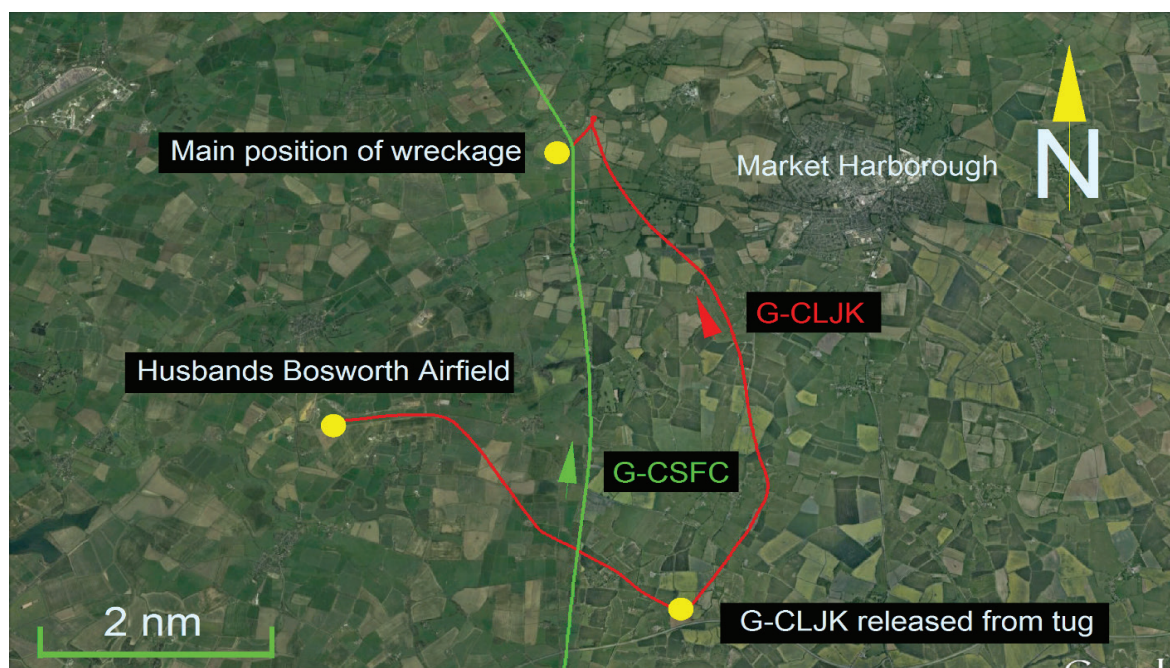
Figure 1 provides the radar and flight logger-derived tracks of G-CSFC and G-CLJK in the minutes before and after the collision. Figure 2 plots the position of both aircraft, commencing at a separation of just less than 1 nm, with the relative positions identified at eight second intervals and angular sizes of about 0.5° when viewed from each aircraft. Figure 3 plots the relative position of other aircraft at the time of the collision. For clarity, the radar track of G-CSFC has been illustrated in Figure 1, 2 and 3.

Radar and flight logger tracks of G-CSFC and G-CLJK

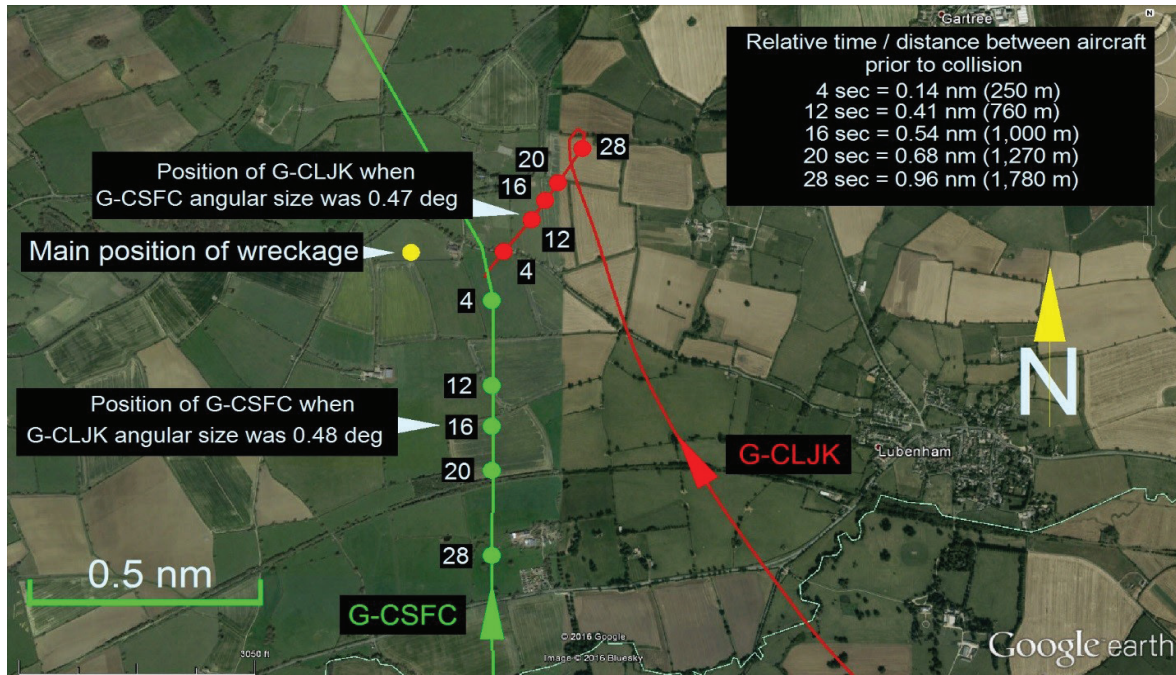
Figure 2

Relative positions of G-CSFC and G-CLJK prior to collision

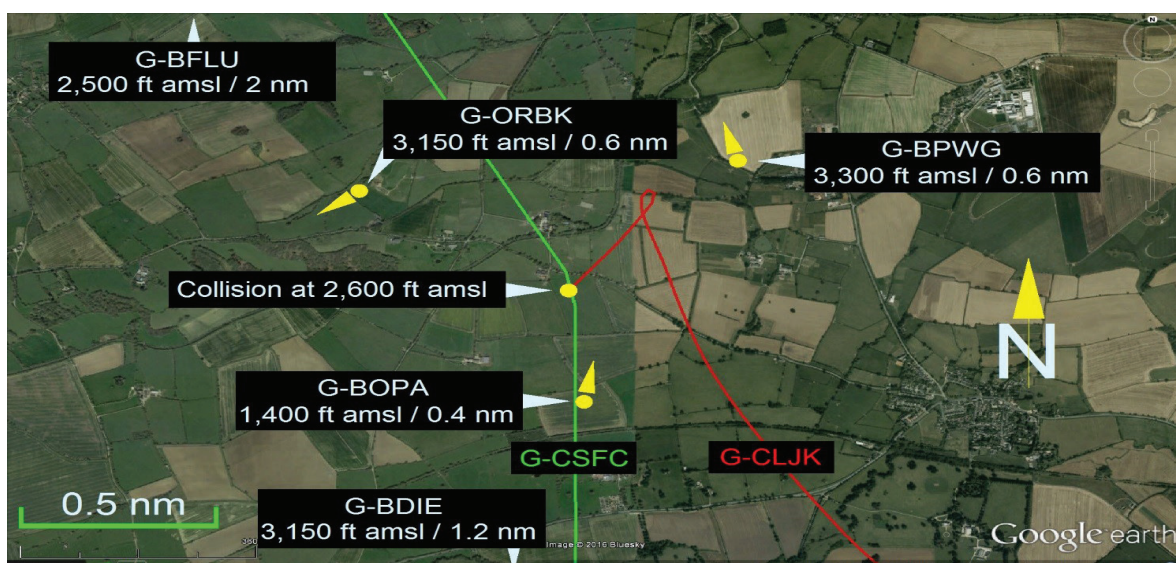
Figure 3

- G-BFLU was ahead and to the left of G-CSFC at 2,500 ft amsl and a distance of 2 nm.
- G-BPWG was to the right of G-CSFC at 3,300 ft amsl, at a relative bearing of about 40° and a distance of 0.6 nm.
- G-ORBK was ahead and to the left of G-CSFC at about 2,600 ft amsl and a distance of 0.6 nm.
- G-BOPA was almost directly behind G-CSFC at about 1,400 ft amsl and at a distance of 0.4 nm.
- G-BDIE was 1.2 nm to the south of the accident position at 3,150 ft amsl.

Relative positions of other aircraft at the time of collision
