INCIDENT

Aircraft Type and Registration:	Agusta A109S Grand, G-PBWR
No & Type of Engines:	2 Pratt & Whitney Canada PW207C turboshaft engines
Year of Manufacture:	2007 (Serial no: 22050)
Date & Time (UTC):	5 May 2017 at 1030 hrs
Location:	London Stansted Airport
Type of Flight:	Commercial Air Transport (Passenger)
Persons on Board:	Crew - 1 Passengers - 1
Injuries:	Crew - None Passengers - None
Nature of Damage:	Failure of left side horizontal stabiliser
Commander's Licence:	Airline Transport Pilot's Licence
Commander's Age:	42 years
Commander's Flying Experience:	3,983 hours (of which 1,152 were on type) Last 90 days - 50 hours Last 28 days - 24 hours
Information Source:	Aircraft Accident Report Form submitted by the pilot

Synopsis

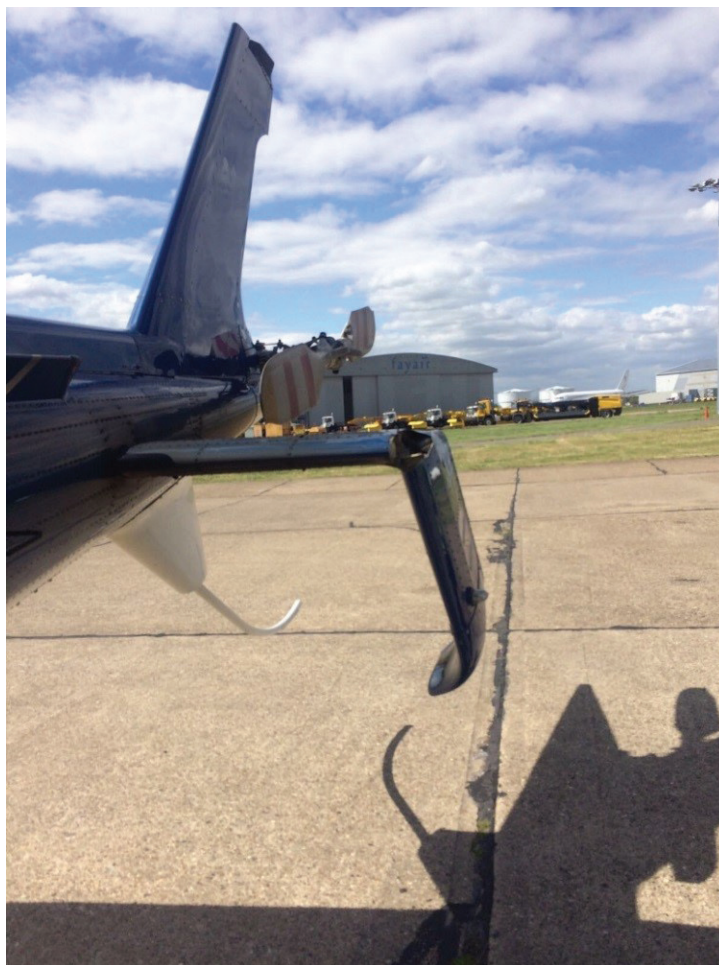
Figure 1

On arrival the ground staff indicated there was a problem with the aircraft. On inspection, the pilot observed that the left side horizontal stabiliser had failed at approximately mid-span. The failed portion had remained attached by sections of its skin and electrical cabling, (Figure 1).

View of failed horizontal stabiliser, looking aft

The horizontal stabiliser fitted to this helicopter was included in EASA Airworthiness Directive (AD) 2011-0150, which requires repetitive inspection in the area of the failure and, depending on findings, corrective action. The repetitive inspection was required every 50 flying hours and it had last been completed on this aircraft approximately 45 hours previously, with no adverse findings. The failure was reported to the regulator via the mandatory occurrence reporting scheme (MOR) and the failed part was returned to the manufacturer for detailed examination.

Prompted by this event, the manufacturer issued a Service Bulletin providing new instructions for a one-time inspection and new repetitive inspections at a reduced inspection threshold and interval. As a result of this and its own safety assessment, EASA issued Emergency Airworthiness Directive AD 2017-0085-E, on 12 May 2017, to mandate these instructions.
