INCIDENT

Aircraft Type and Registration:	Agusta AW139, PH-EUJ
No & Type of Engines:	2 Pratt & Whitney Canada PT6C-67C turboshaft engine
Year of Manufacture:	2013 (Serial no: 31511)
Date & Time (UTC):	19 February 2017 at 0839 hrs
Location:	Leman 27B Platform, North Sea
Type of Flight:	Commercial Air Transport (Passenger)
Persons on Board:	Crew - 2 Passengers - 9
Injuries:	Crew - None Passengers - None
Nature of Damage:	None
Commander's Licence:	Airline Transport Pilot's Licence
Commander's Age:	41 years
Commander's Flying Experience:	8,000 hours (of which 2,975 were on type) Last 90 days - 105 hours Last 28 days - 43 hours
Information Source:	Aircraft Accident Report Form submitted by the pilot

Synopsis

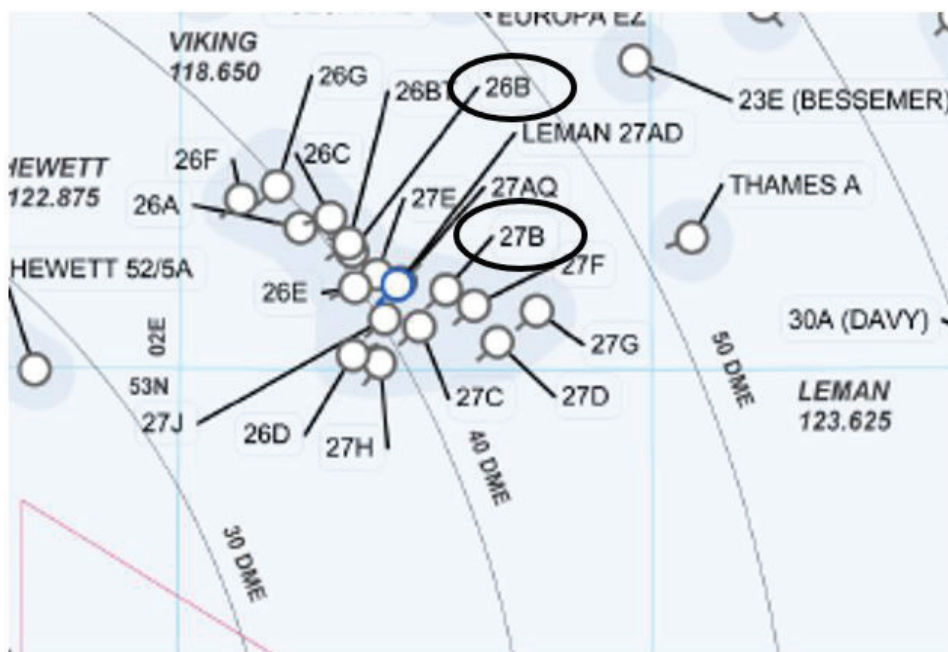
Figure 1

Rig map of Leman Field (Leman 27B is denoted as 27B, Shell Leman 26B as 26B)
