## ACCIDENT

<b>Aircraft Type and Registration:</b>	Maule MXT-7-160 Star Rocket, G-BUXD
<b>No &amp; Type of Engines:</b>	1 Lycoming O-320-B2D piston engine
<b>Year of Manufacture:</b>	1993 (Serial no: 17001C)
<b>Date &amp; Time (UTC):</b>	28 April 2017 at 1110 hrs
<b>Location:</b>	Eaglescott Airfield, Devon
<b>Type of Flight:</b>	Private
<b>Persons on Board:</b>	Crew - 1      Passengers - 1
<b>Injuries:</b>	Crew - None    Passengers - None
<b>Nature of Damage:</b>	Aircraft extensively damaged
<b>Commander's Licence:</b>	Private Pilot's Licence
<b>Commander's Age:</b>	52 years
<b>Commander's Flying Experience:</b>	183 hours (of which 20 were on type) Last 90 days - 7 hours Last 28 days - 7 hours
<b>Information Source:</b>	Aircraft Accident Report Form submitted by the pilot

## Synopsis

The aircraft stalled after the pilot flew a go-around after losing sight of the runway.

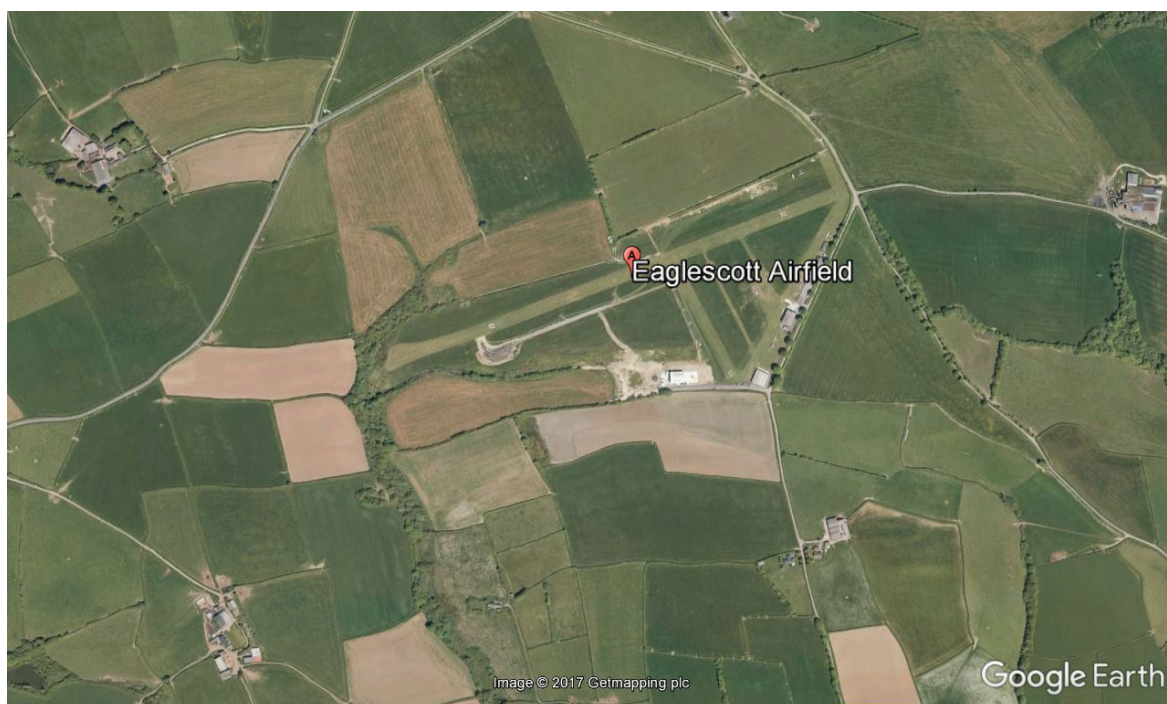
**Figure 1**

Eaglescott Airfield has two grass runways and the western end of the airfield is surrounded by fields with a similar alignment to Runway 07 (Figure 1). The airfield instructions for visiting pilots is that Prior Permission is Required (PPR) by telephone and the arrival procedure is to make a radio call 10 miles out and then fly a standard overhead join at 2,000 ft QFE and a left-hand circuit at 800 ft.

With a passenger sitting in the front right seat, it would have been difficult for the pilot in the left seat to remain in sight of the runway when flying a right-hand circuit close to the airfield. As shown in Figure 1, the number of nearby fields with similar 'east-west' alignment to that of Runway 07 may have made identification of the runway more difficult.
