ACCIDENT

Aircraft Type and Registration:	Slingsby T67M MkII Firefly, G-BNSP	
No & Type of Engines:	1 Lycoming AEIO-320-D1B piston engine	
Year of Manufacture:	1987 (Serial no: 2044)	
Date & Time (UTC):	17 April 2017 at 1225 hrs	
Location:	Turweston Aerodrome, Northamptonshire	
Type of Flight:	Private	
Persons on Board:	Crew - 1	Passengers - None
Injuries:	Crew - None	Passengers - N/A
Nature of Damage:	Axle, nosewheel and fittings fell apart, nose landing gear fork bent	
Commander's Licence:	Airline Transport Pilot's Licence	
Commander's Age:	53 years	
Commander's Flying Experience:	9,745 hours (of which 186 were on type) Last 90 days - 126 hours Last 28 days - 47 hours	
Information Source:	Aircraft Accident Report Form submitted by the pilot and inquiries made by the AAIB

Synopsis

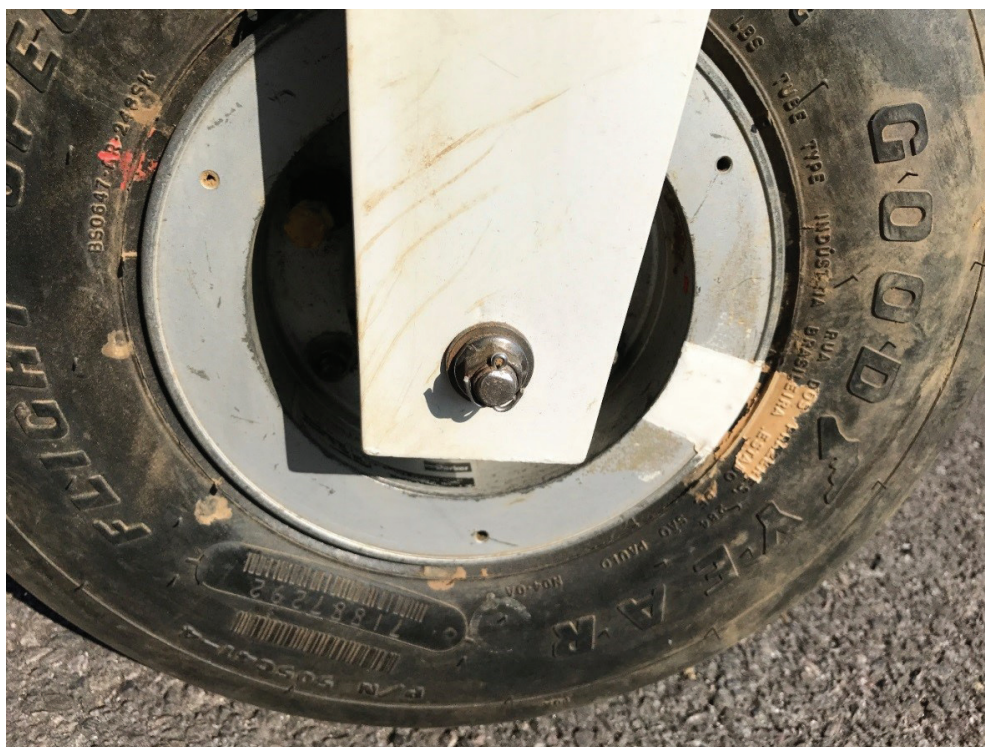
Figure 1

Anecdotal evidence suggests that there have been a problems in the past on other T67 aircraft, whereby, for no apparent reason, the K-nut has loosened and detached. However, there is no mandatory occurrence report (MOR) data to support this. In addition, there are no reports to the Type Certificate holder that would indicate any tendency for the nut to detach. However, during this investigation it became apparent that other operators and maintenance organisations had taken action to address this problem and had introduced a safety split pin outboard of the K-nut. An example is shown in Figure 1.

Safety split pin outboard of the K-nut

The Type Certificate holder has carried out its own assessment of this incident and is considering an additional modification to introduce improved positive locking of the axle assembly. Their intention is to issue a Service Bulletin (SB) and will discuss with the CAA whether it should be mandated by an Airworthiness Directive (AD).
