ACCIDENT

| Aircraft Type and Registration: | Smith DSA-1 Miniplane, G-BTGJ | |
| Date & Time (UTC): | 23 April 2017 at 1040 hrs | |
| Location: | Henstridge Airfield, Somerset | |

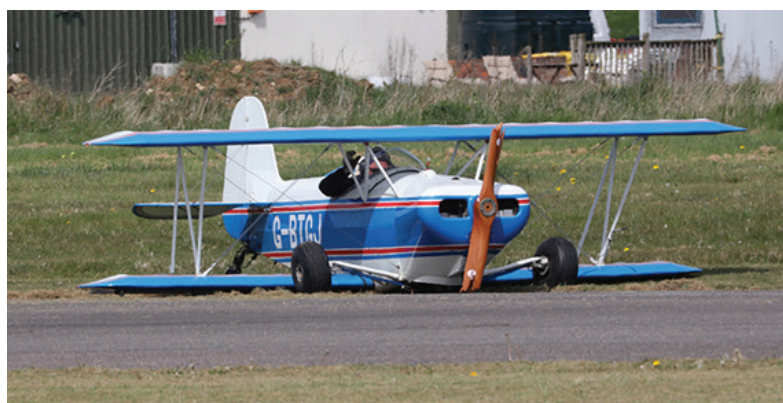
**Figure 1**

During the landing flare on the asphalt Runway 25 at Henstridge the pilot lost sight of an aircraft landing ahead. He pushed forward on the control column to check the runway in front was clear, and then pulled the column back to continue the flare. He believes that because he did not apply any power during this manoeuvre, the airspeed reduced too much and the aircraft stalled and descended quickly towards the runway. Both main landing gear legs collapsed on impact and the wooden propeller shattered. The aircraft then slid a short distance along the runway until the tip of the lower right wing contacted the surface and the aircraft span right through 180°. It came to rest on grass area beside the runway (Figure 1) and the uninjured pilot climbed out without assistance.

G-BTGJ after it came to a halt with collapsed main landing gear legs and shattered propeller.
Photo reproduced courtesy of Mr Martin Rendall
