## ACCIDENT

<b>Aircraft Type and Registration:</b>	Magni M16C, G-CIZK	
<b>No &amp; Type of Engines:</b>	1 Rotax 914ULS piston engine	
<b>Year of Manufacture:</b>	2016 (Serial no: 16-16-9534)	
<b>Date &amp; Time (UTC):</b>	17 June 2017 at 1449 hrs	
<b>Location:</b>	Popham Airfield, Hampshire	
<b>Type of Flight:</b>	Training	
<b>Persons on Board:</b>	Crew - 1	Passengers - None
<b>Injuries:</b>	Crew - None	Passengers - N/A
<b>Nature of Damage:</b>	Significant damage to rotor blades, rotor head and mast. Airframe distorted and propeller blades destroyed.	
<b>Commander's Licence:</b>	Student	
<b>Commander's Age:</b>	54 years	
<b>Commander's Flying Experience:</b>	22 hours (of which 22 were on type) Last 90 days - 11 hours Last 28 days - 2 hours	
<b>Information Source:</b>	Aircraft Accident Report Form submitted by the student pilot and input from his instructor

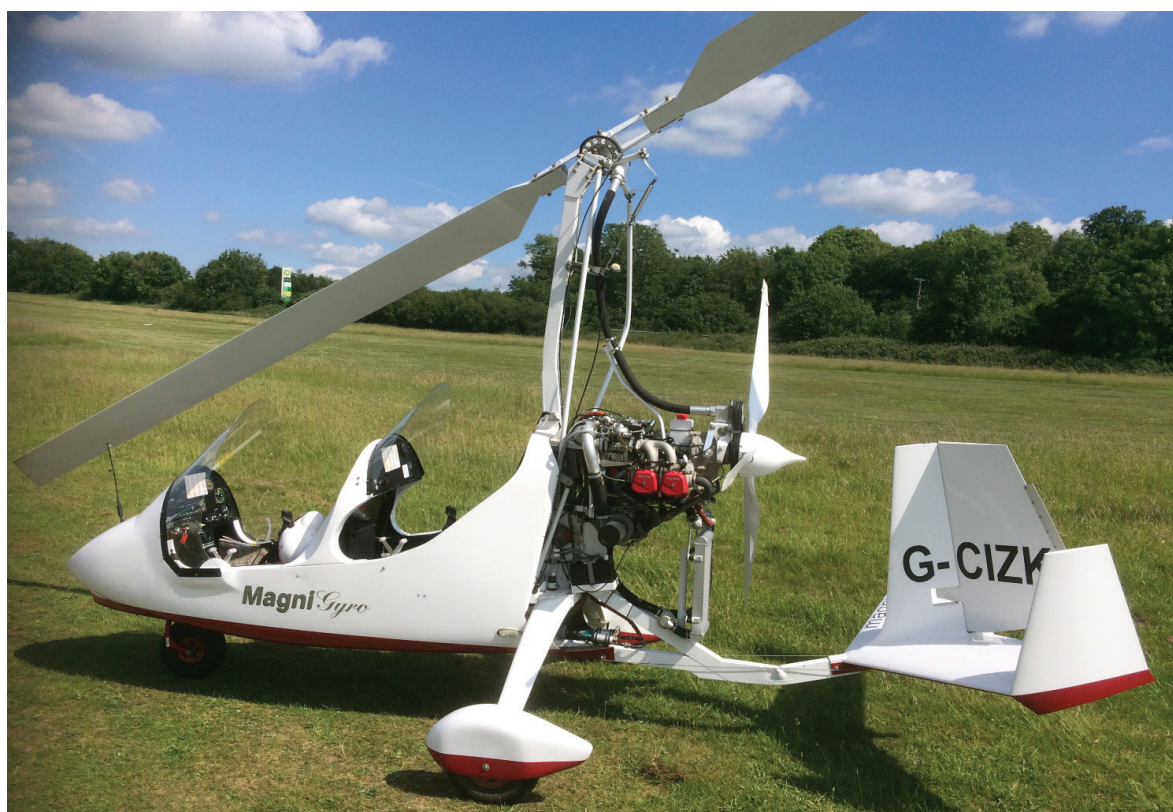
**Figure 1**

After watching the accident, the instructor commented that a normal landing involves touching down on the mainwheels and then moving the control stick back gradually, to initially keep the nosewheel off the ground as the gyroplane slows. On this occasion the student rapidly moved the control stick fully back and he then lost control.

Magni M16C Tandem Trainer, G-CIZK after the accident with distortion of the rotor system and control rods evident
